Inspection Report

**565 Trowbrook Road
Atlanta, Georgia 30350**

Inspection Date August 21, 2020
Inspector Jay Cao
www.HouseChecked.com
jc@housechecked.com
(678)557-8958
interNACHI Certified Inspector, GA Registered Professional Engineer

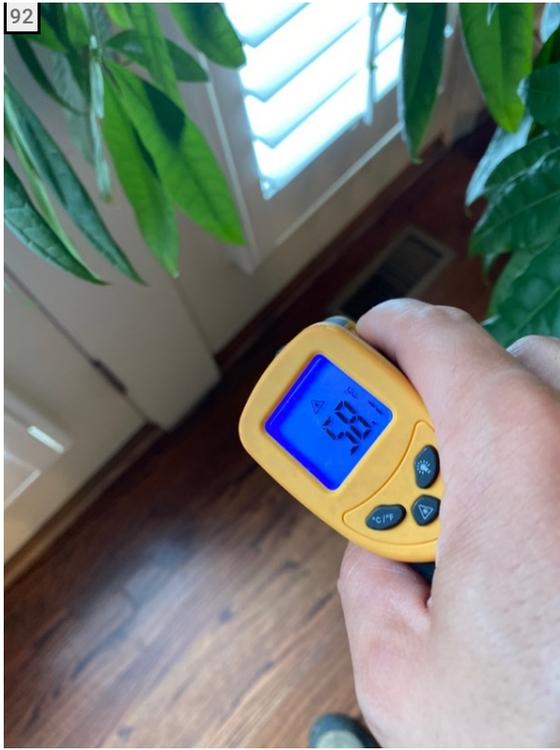
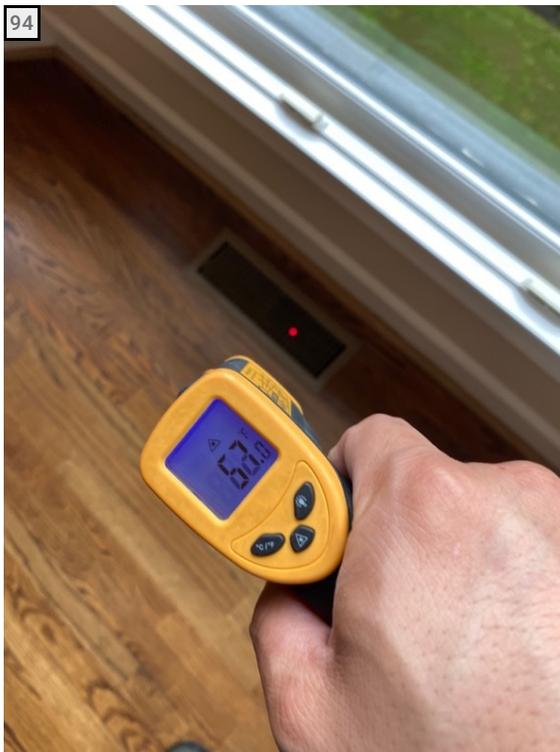
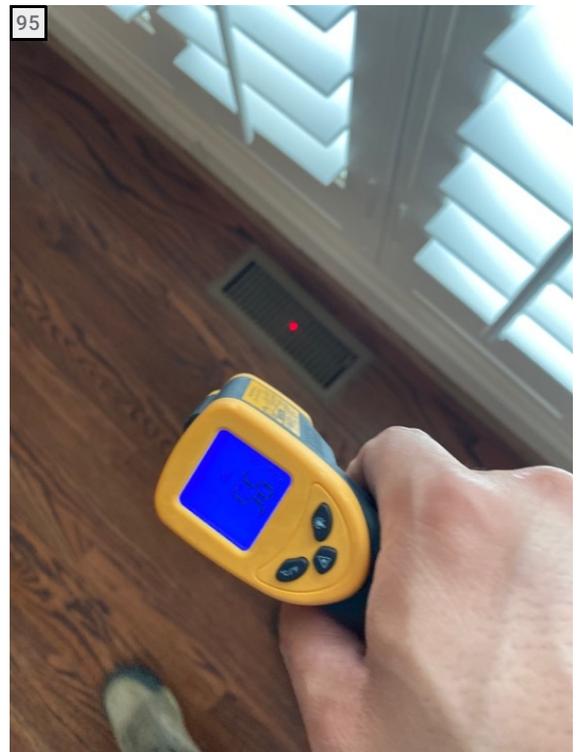
Location Basement

✓ **AC-Evaporator Coil 1**

In Working Order

AC cooling was turn on, AC appeared in working condition. set point was 60F

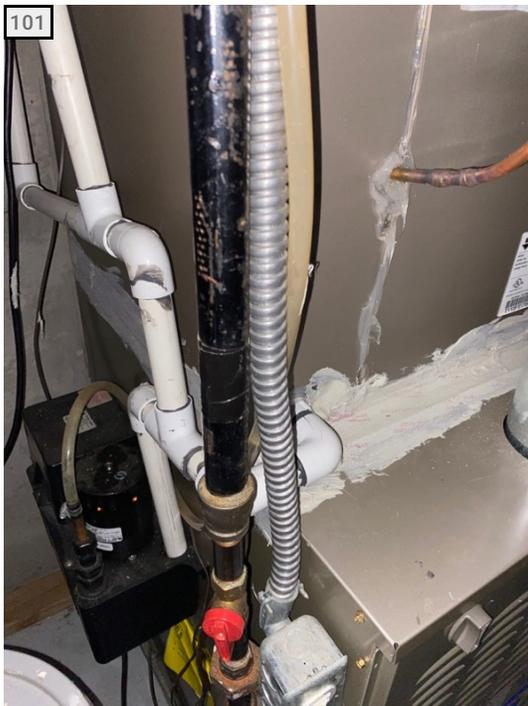
Location Basement

condensate line has a good slope

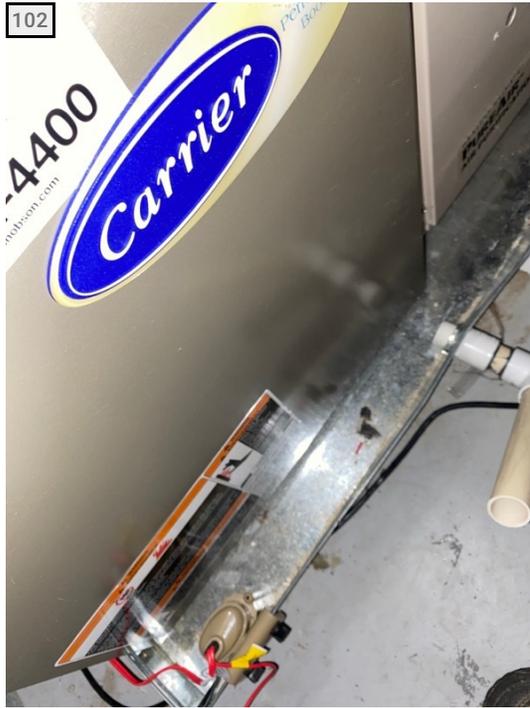
Location Basement

wet pan is clean, no water signs

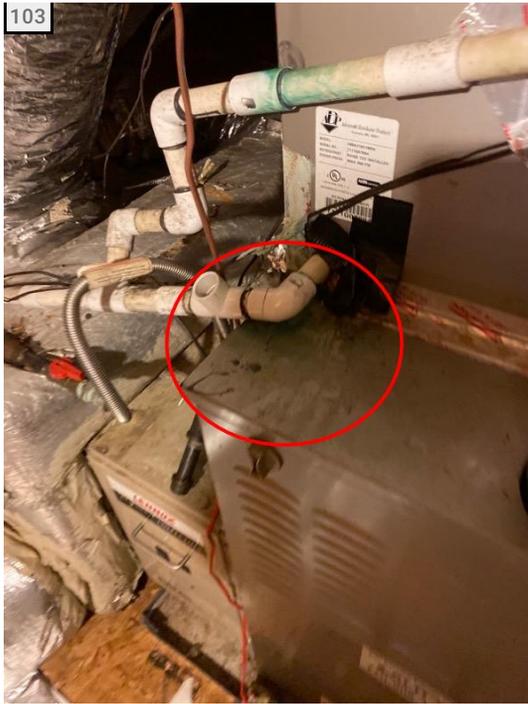
Location Attic

AC-Evaporator Coil 2

Moderate Concern

leak mark noted further evaluation needed

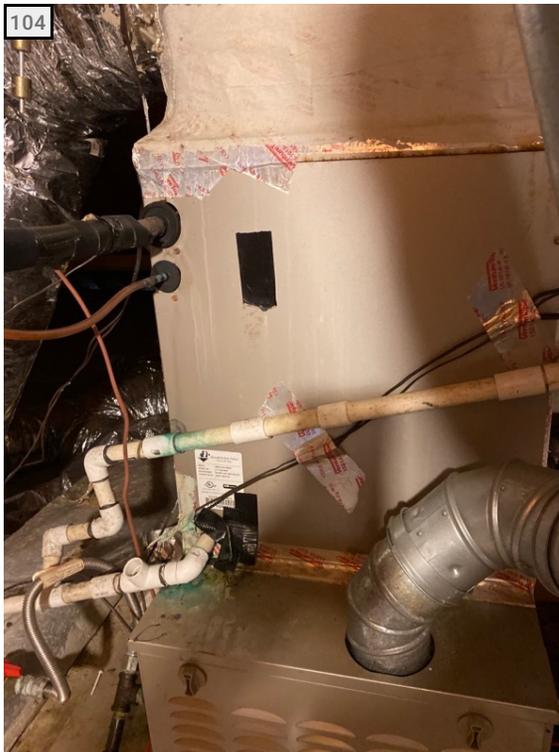
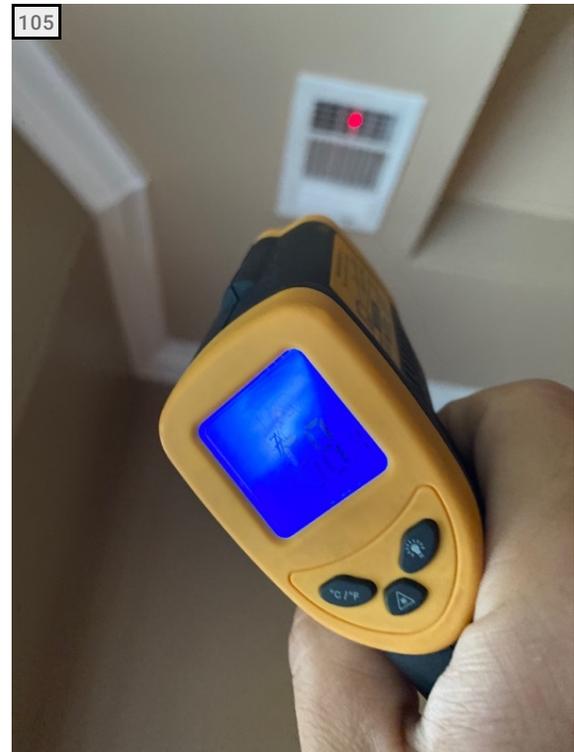
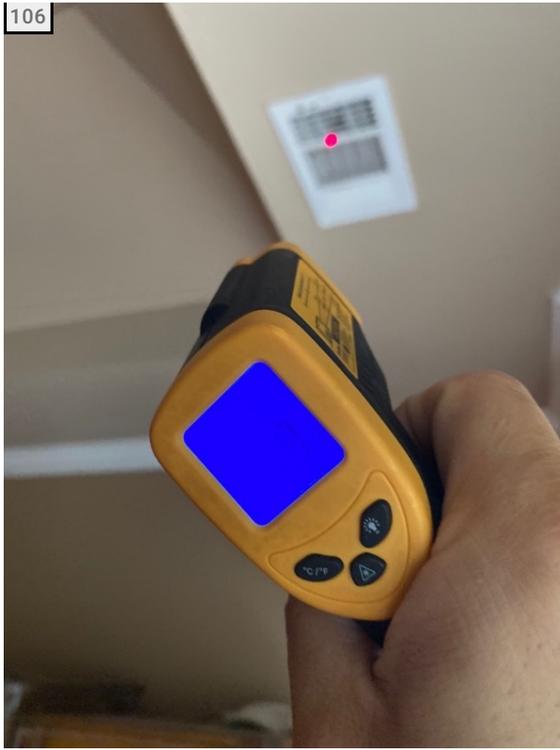
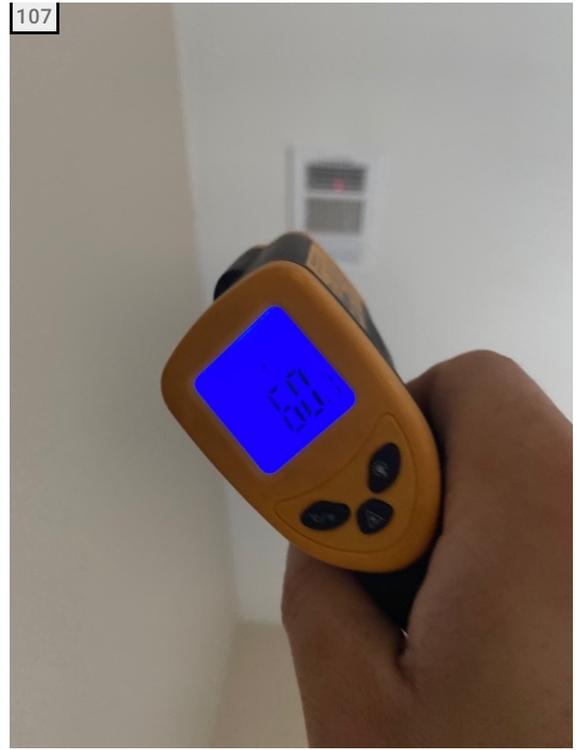
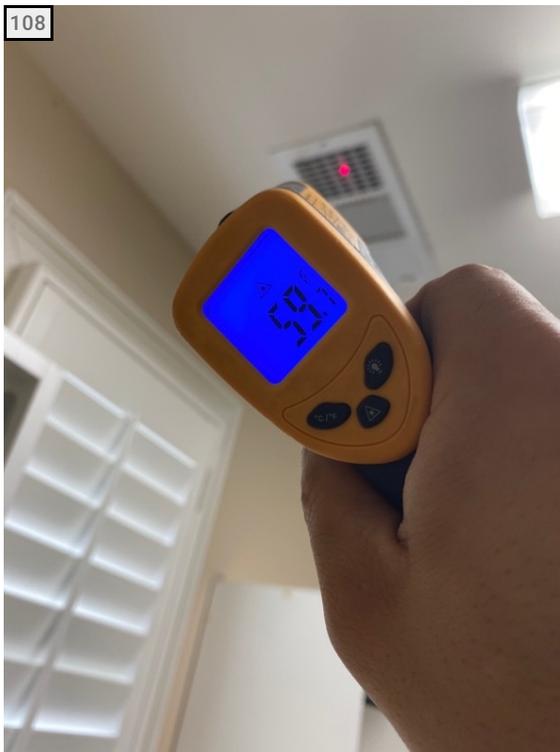
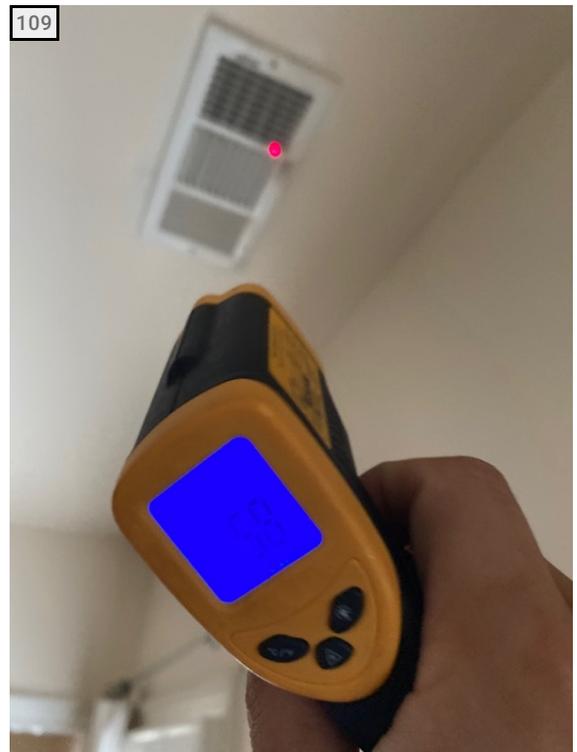
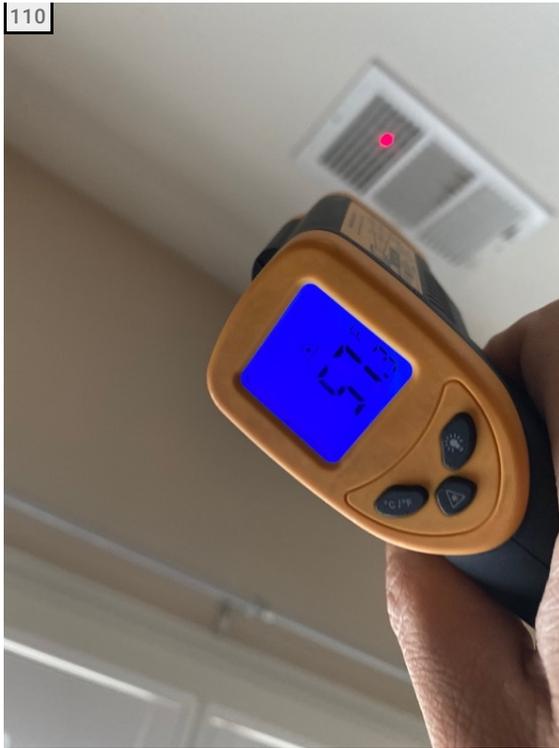
Location Attic

AC cooling was turn on, AC appeared in working condition. set point was 60F

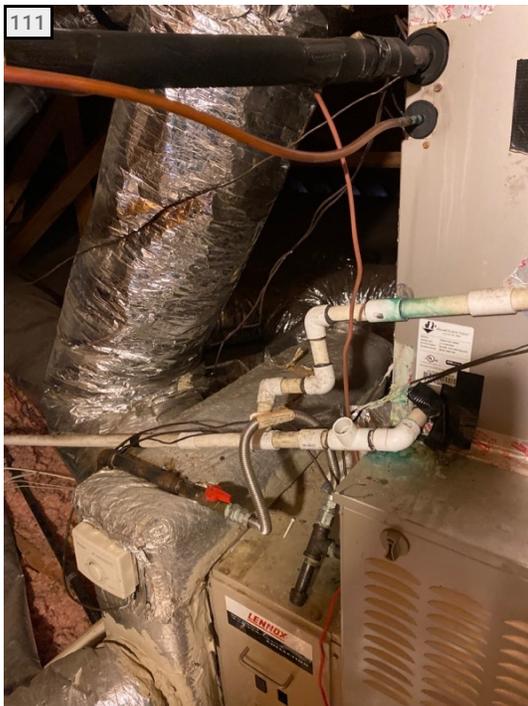
Location Attic

condensate line has a good slope

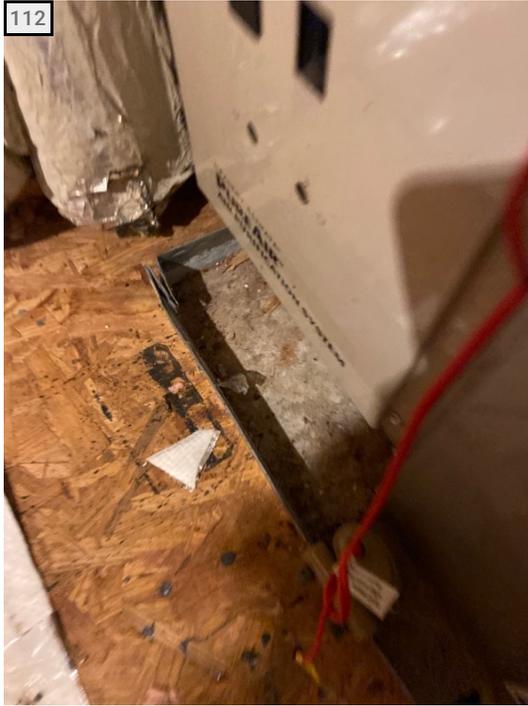
Location Attic

wet pan is clean, no water signs

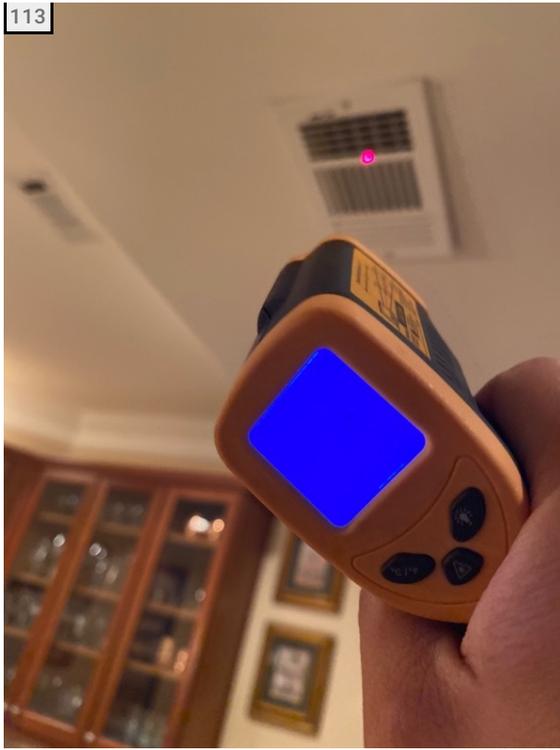
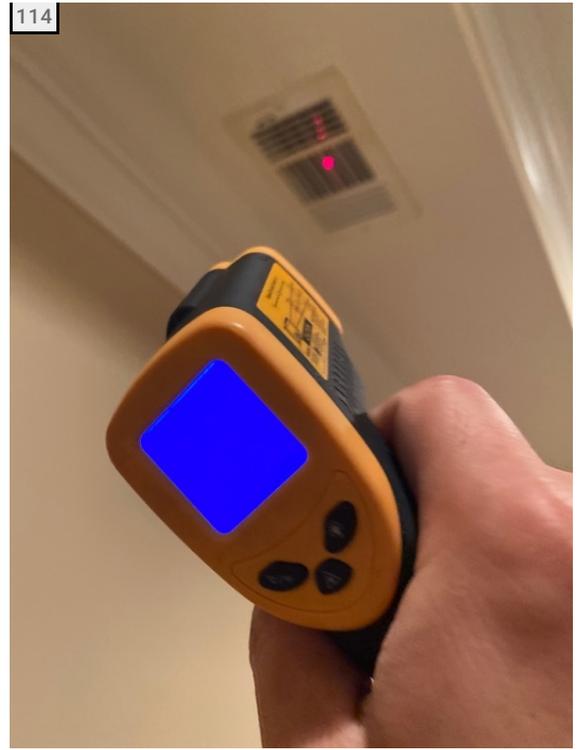
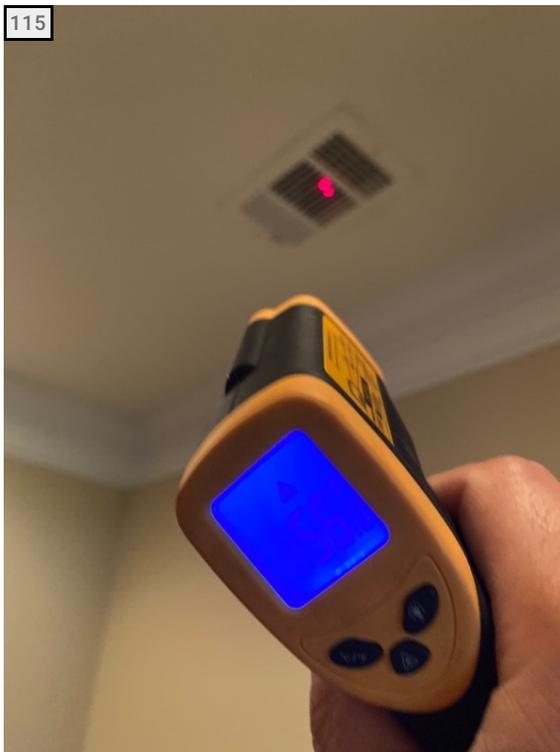
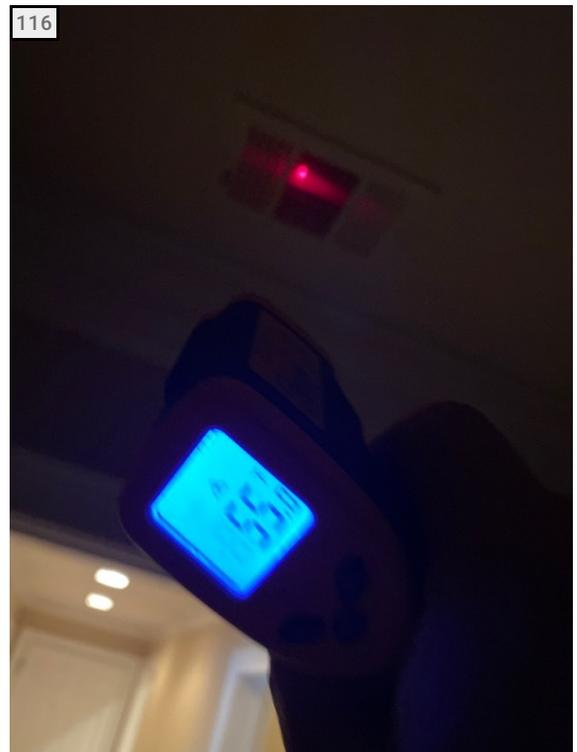
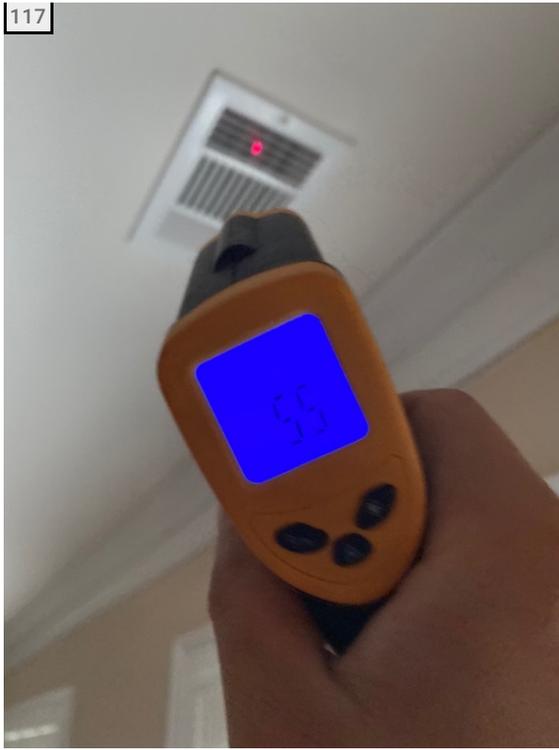
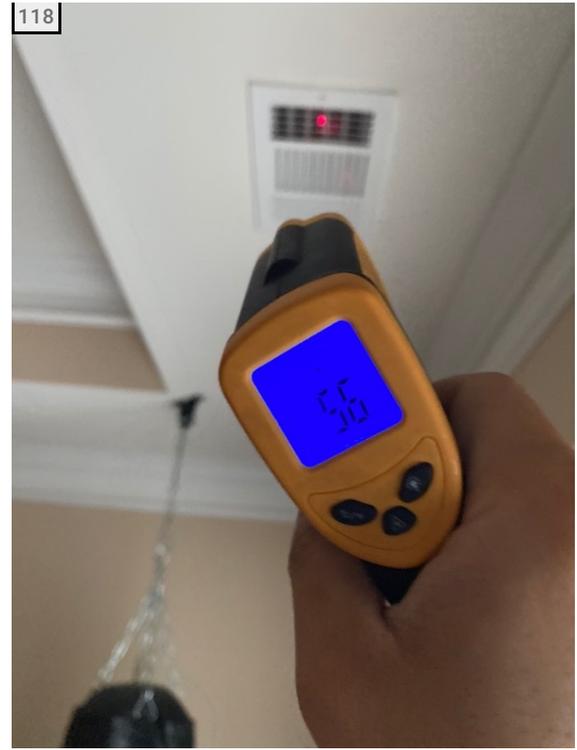
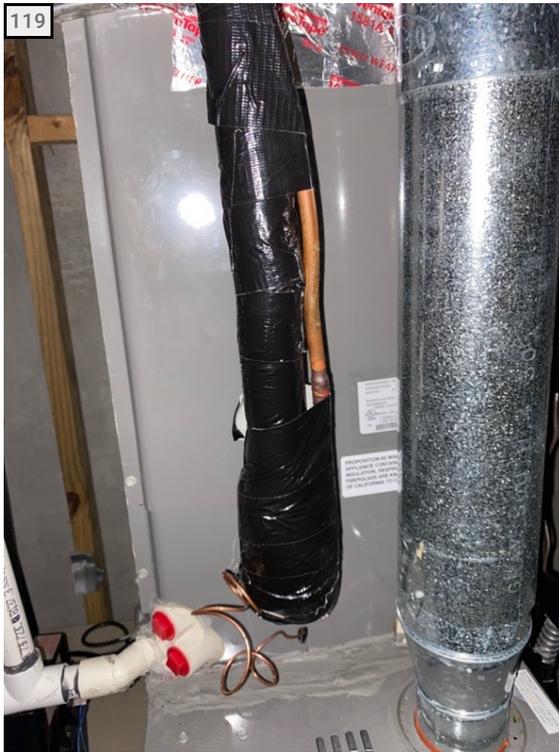
Location Basement

AC cooling was turn on, AC appeared in working condition. set point was 60F

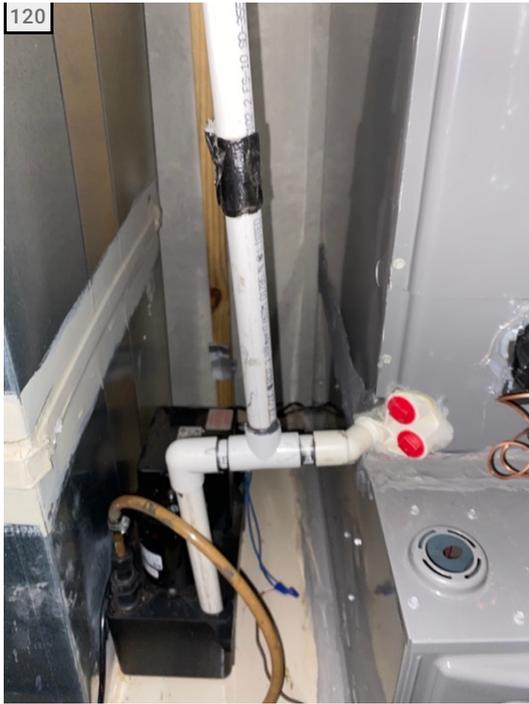
Location Basement

condensate line has a good slope

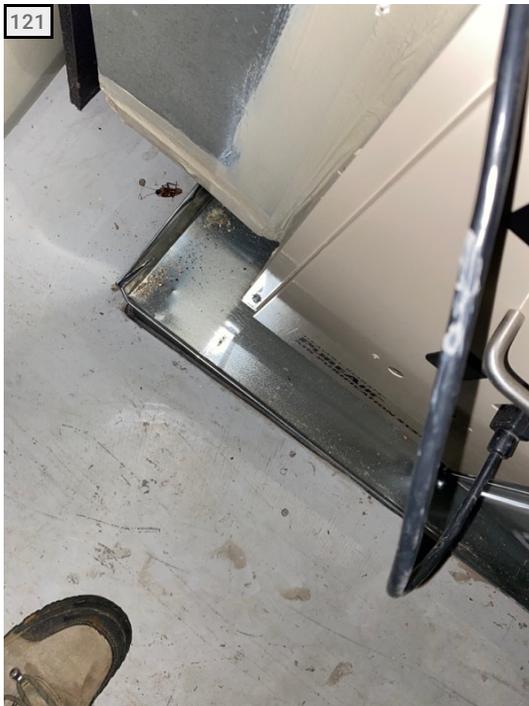
Location Basement

wet pan is clean, no water signs

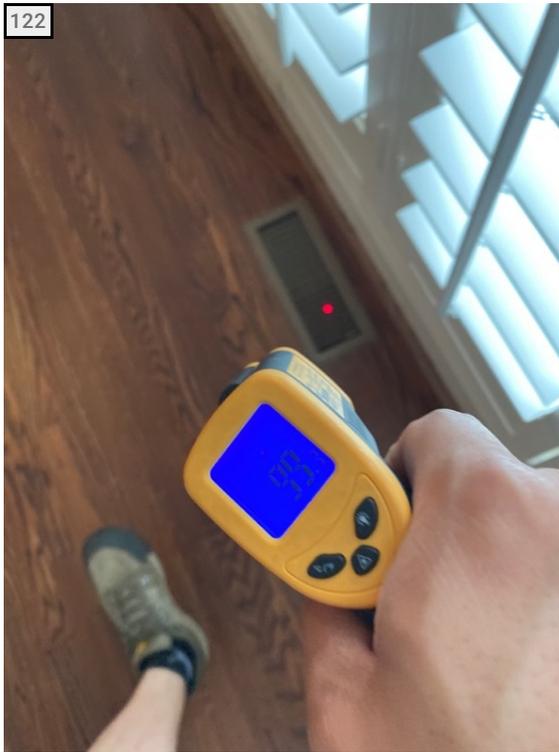
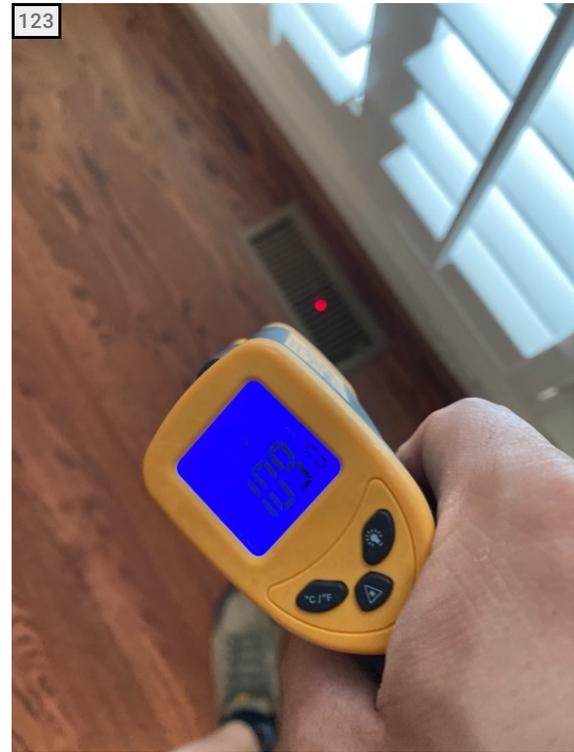
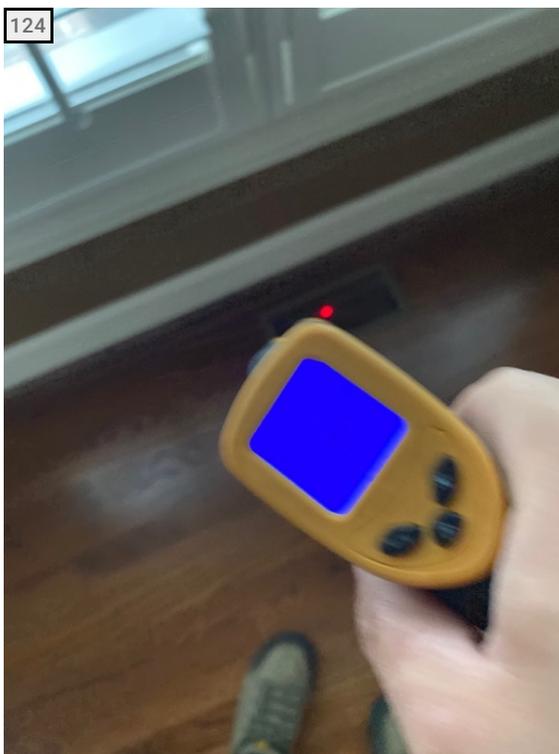
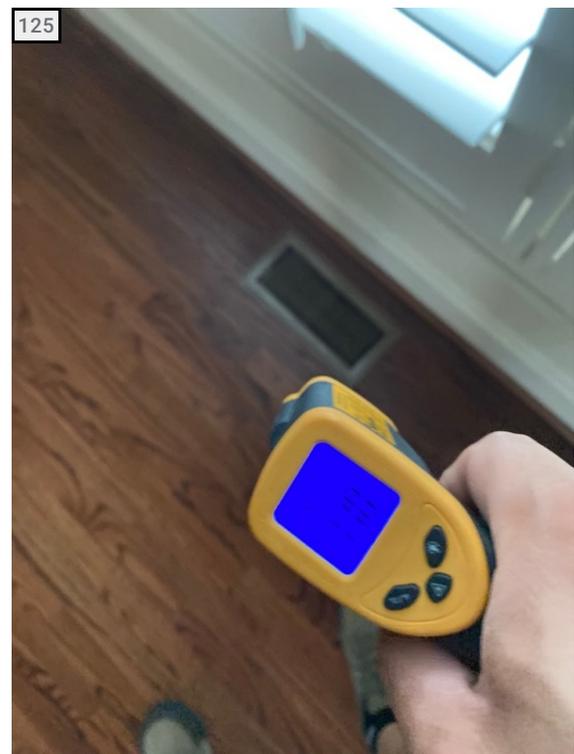
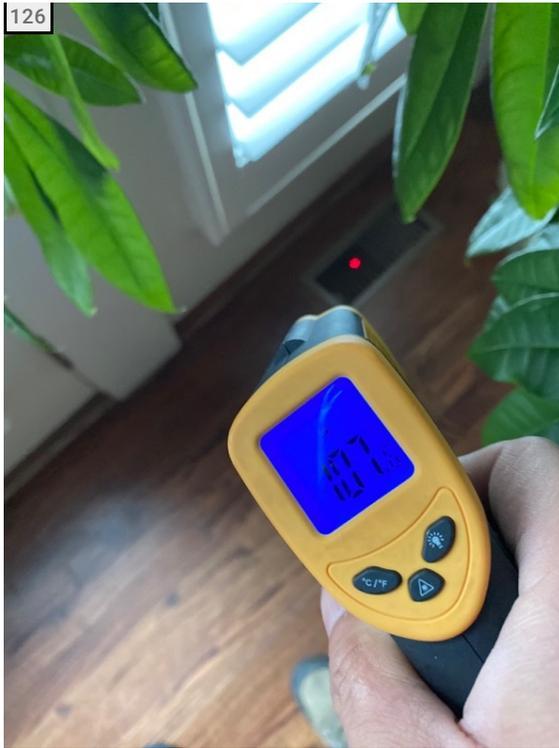
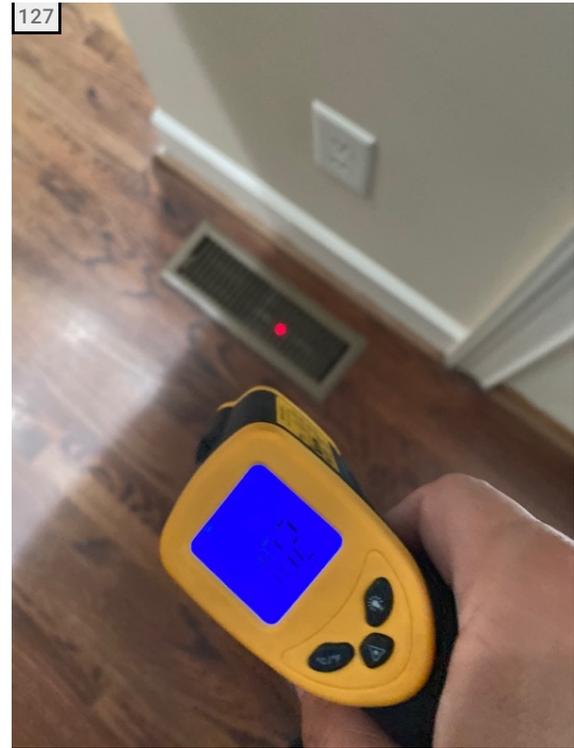
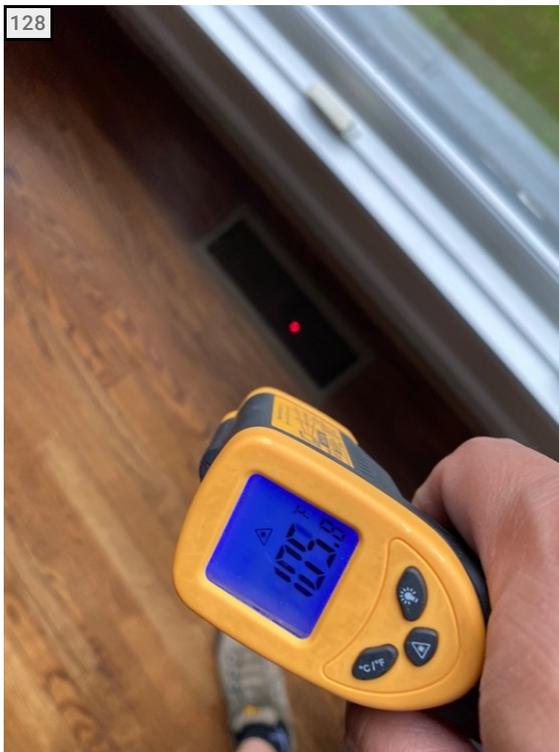
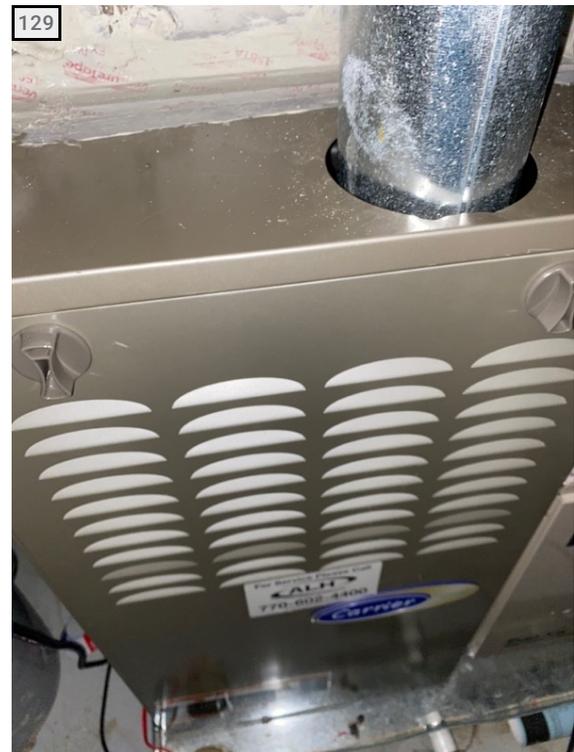
Location Basement

Unit was in working condition at the time of inspection set point was 80F

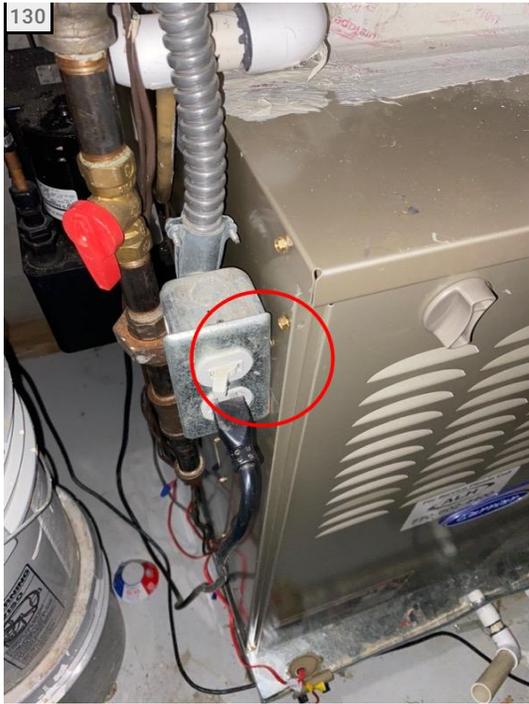
Location Basement

electrical safety switch noted

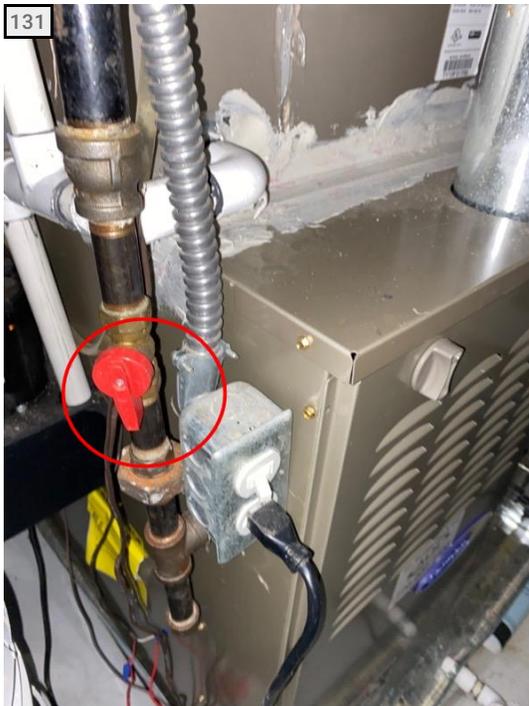
Location Basement

furnace main gas shut-off valves noted

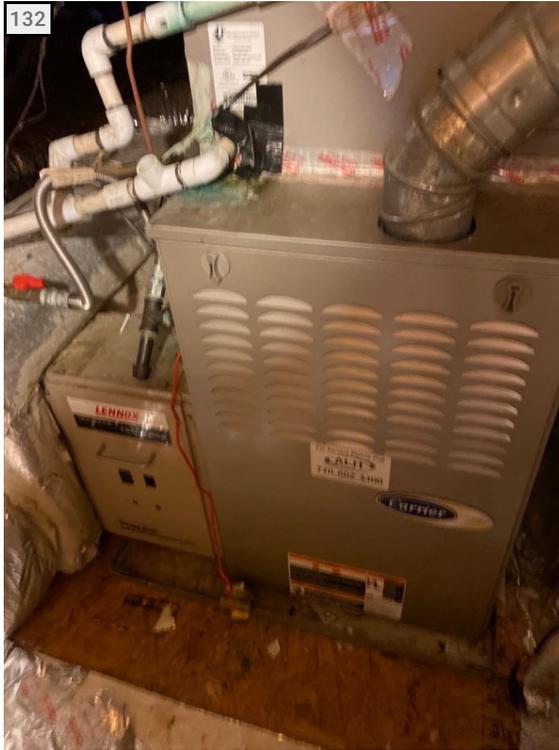
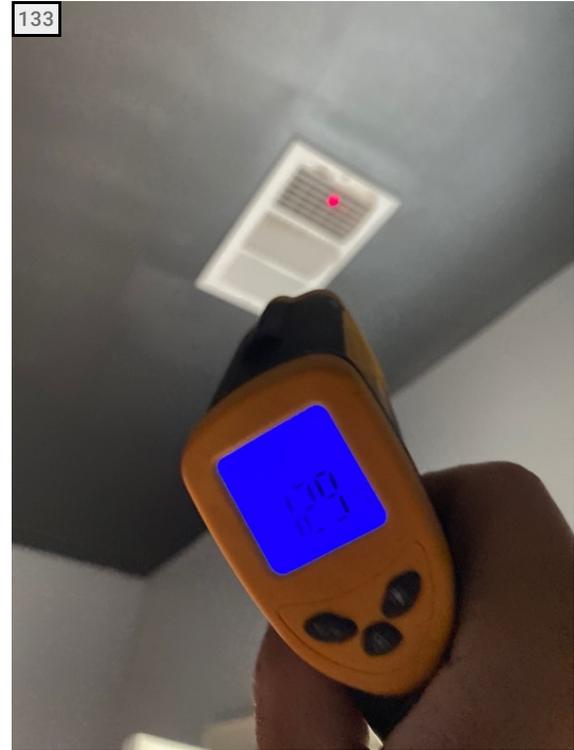
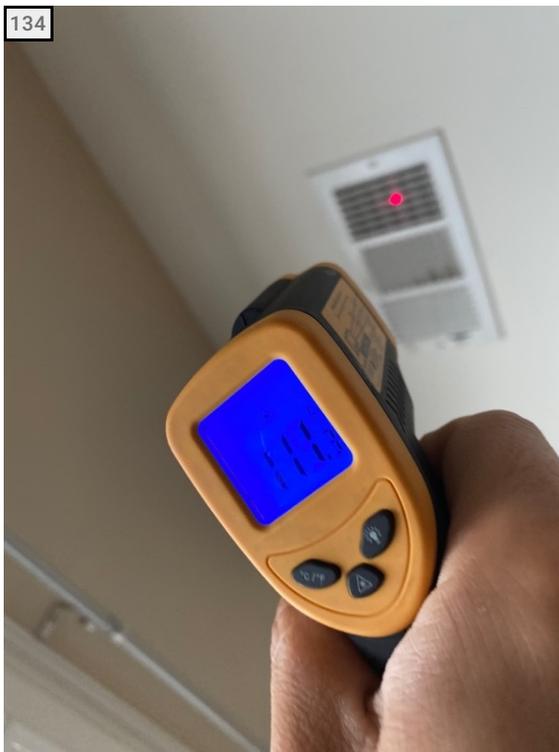
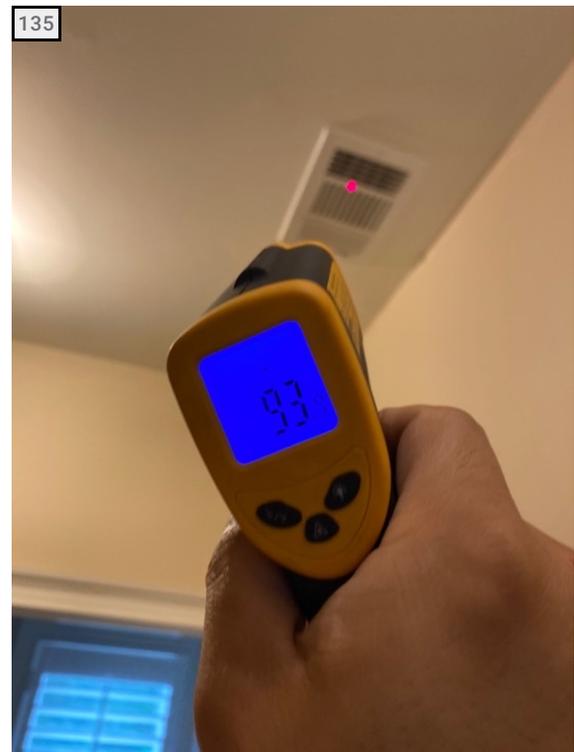
Location Attic

Unit was in working condition at the time of inspection set point was 80F

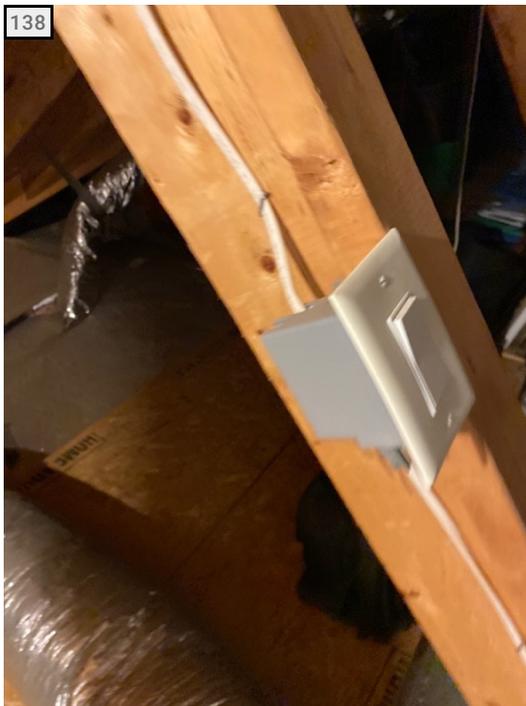
Location Attic

electrical safety switch noted

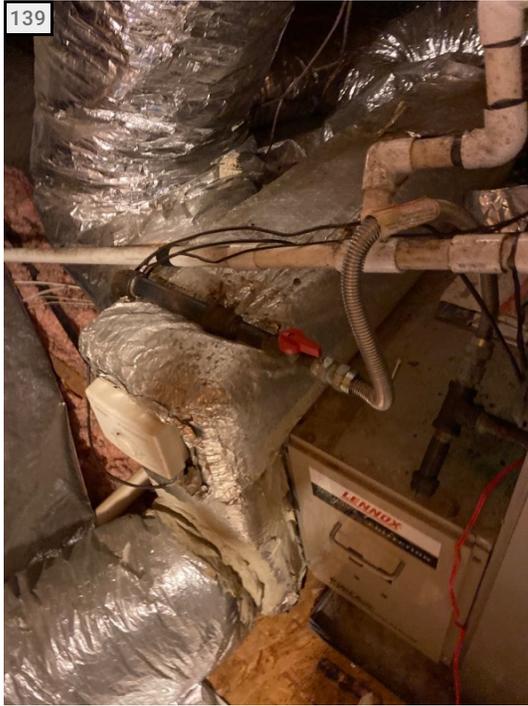
Location Attic

furnace main gas shut-off valves noted

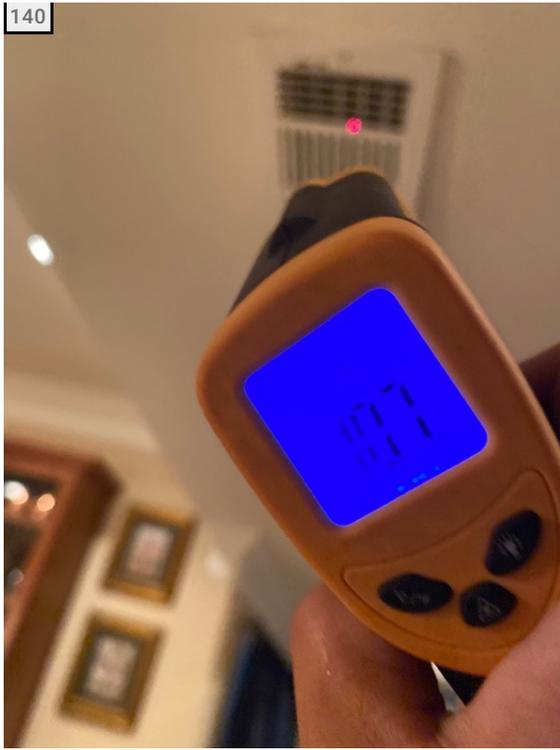
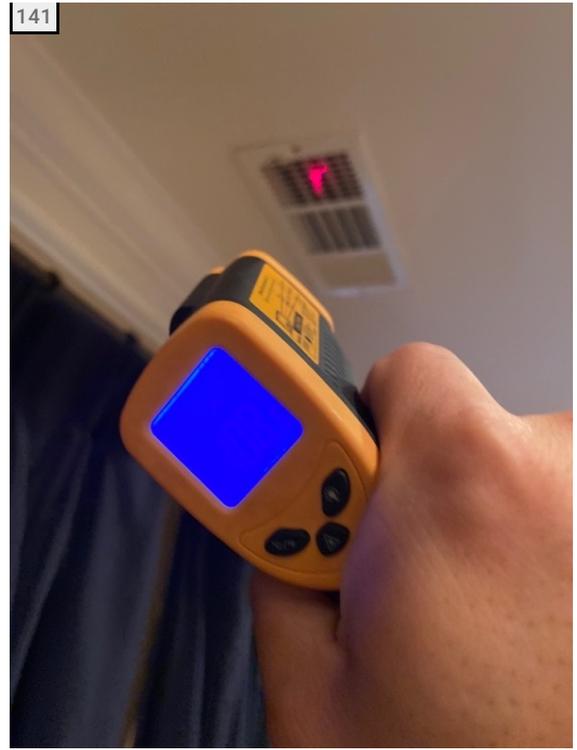
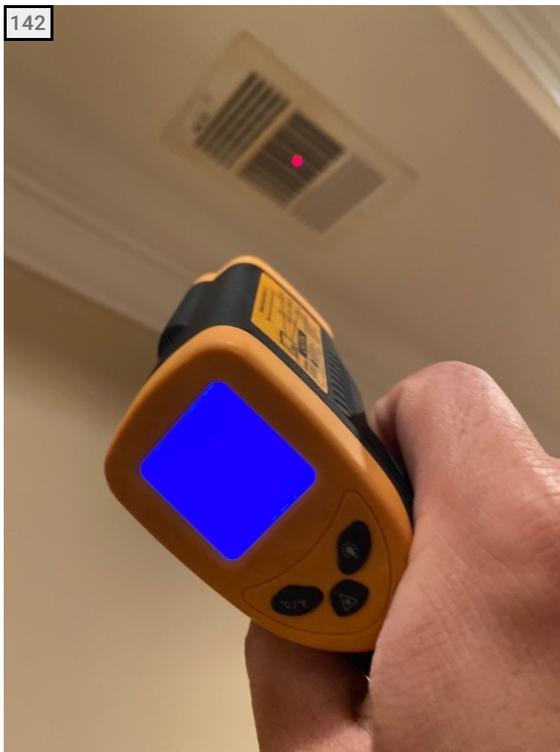
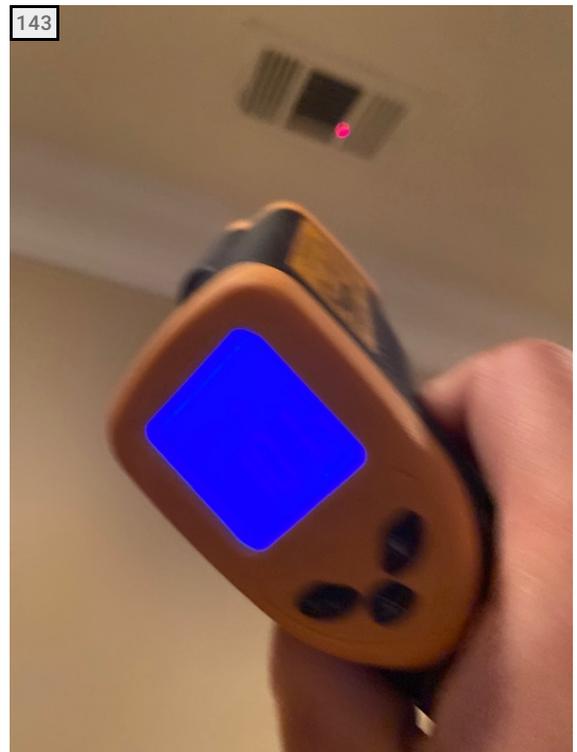
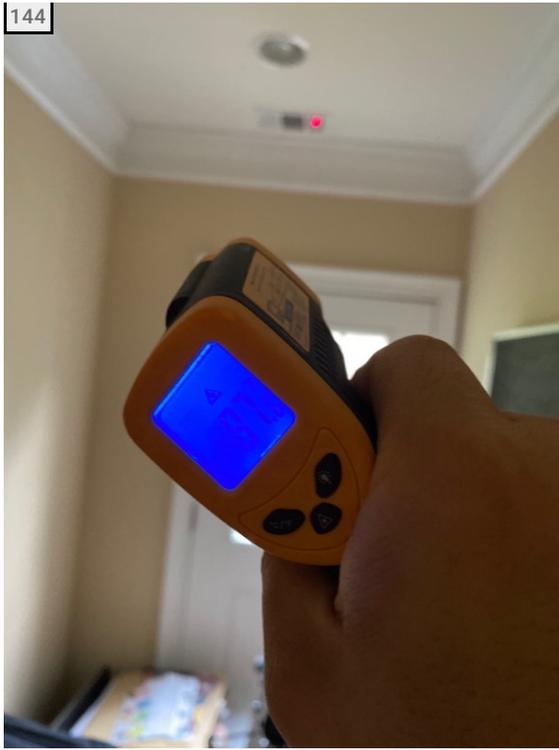
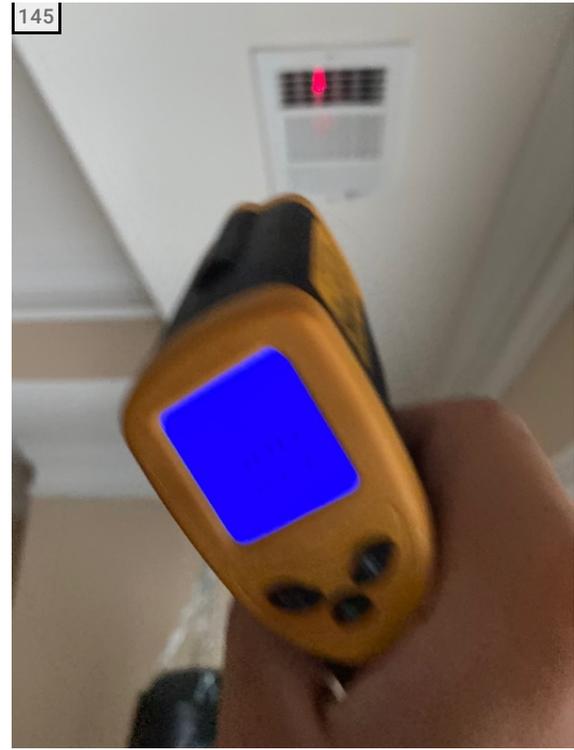
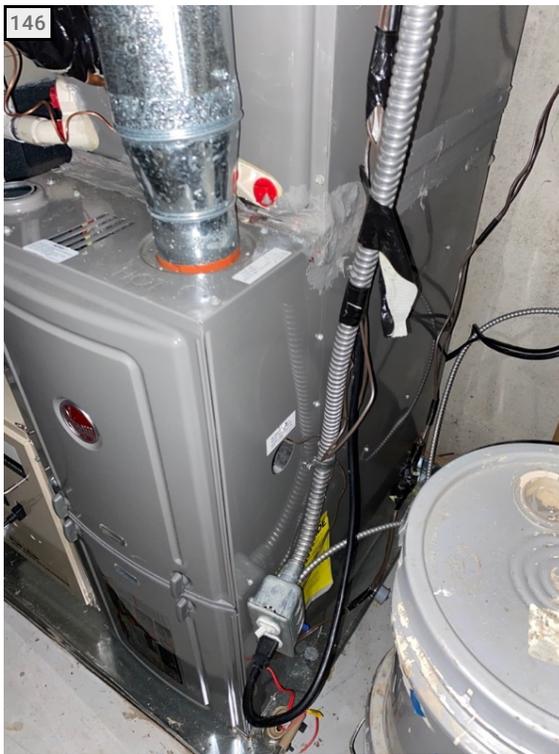
Location Basement

Unit was in working condition at the time of inspection set point was 80F

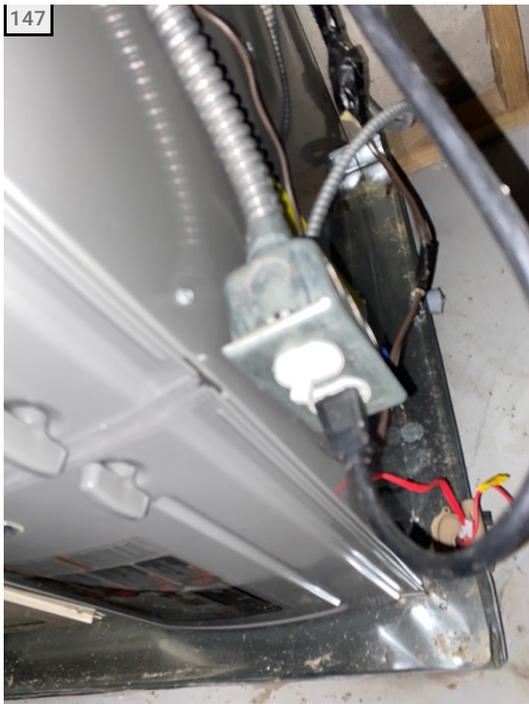
Location Basement

electrical safety switch noted

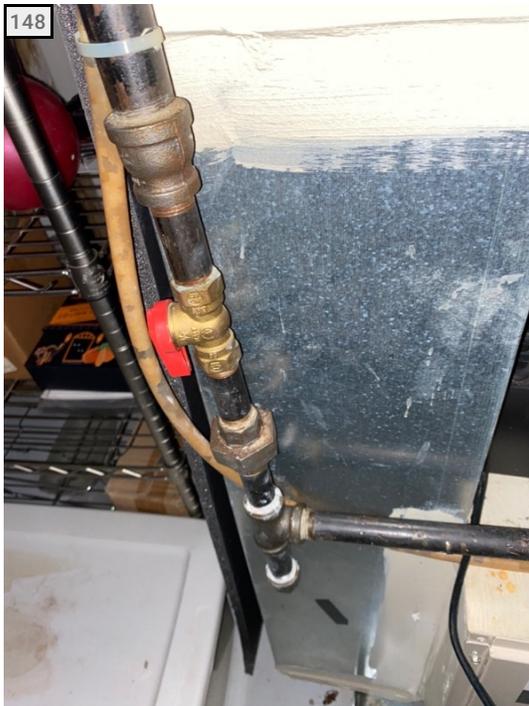
Location Basement

furnace main gas shut-off valves noted

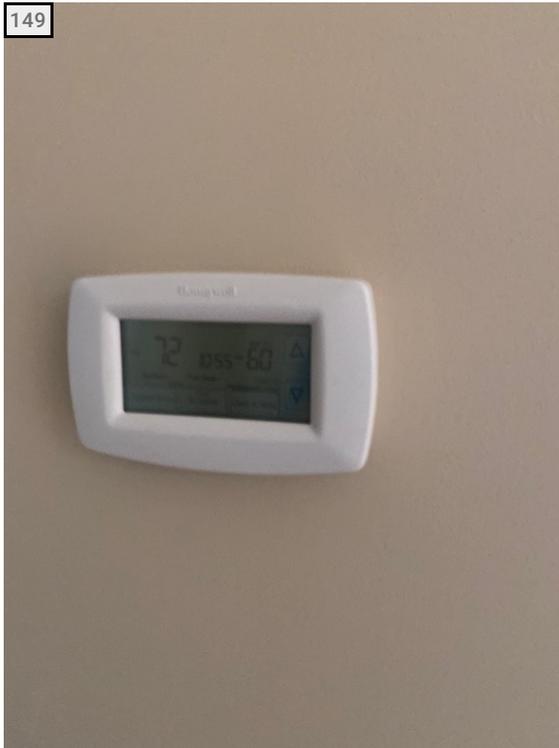
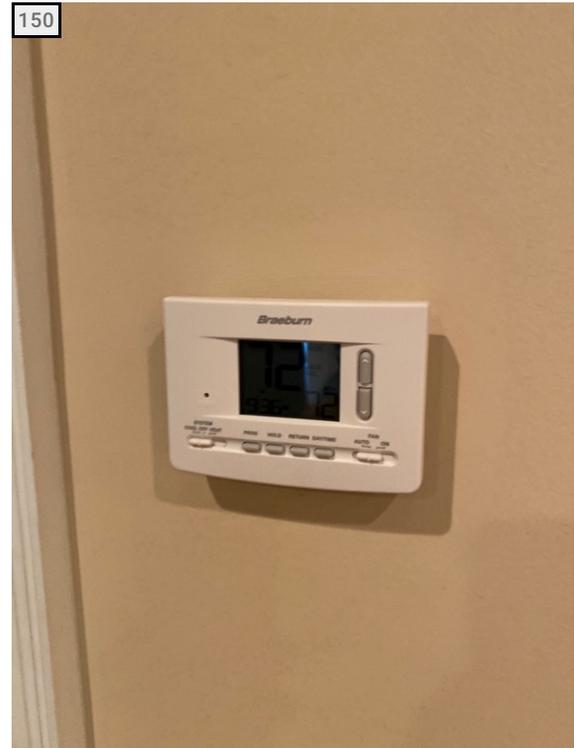
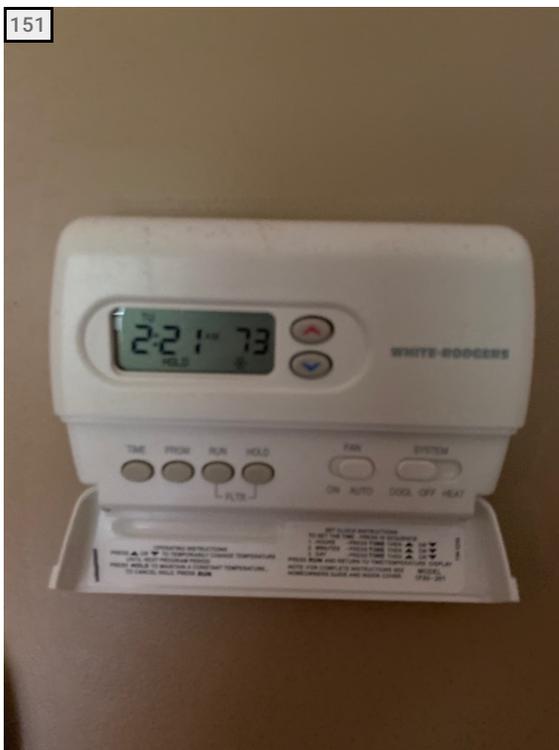
Location Hallway and Stairs, Basement, 1st Bedroom

working condition

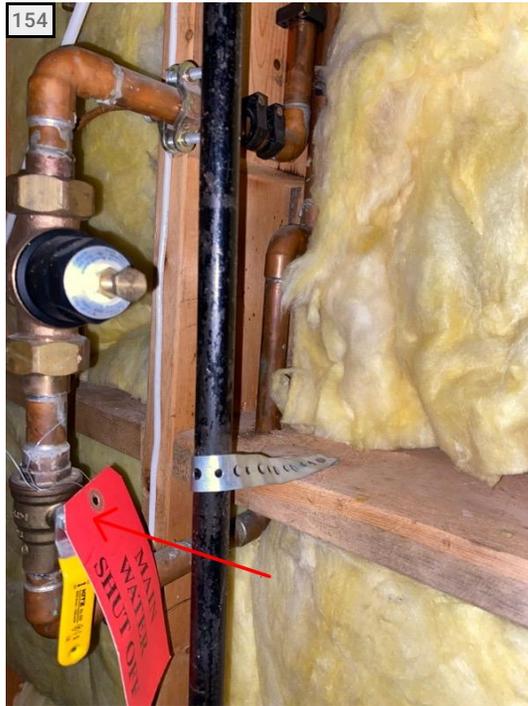
Location Basement

In Working Order**main water cut valve noted**

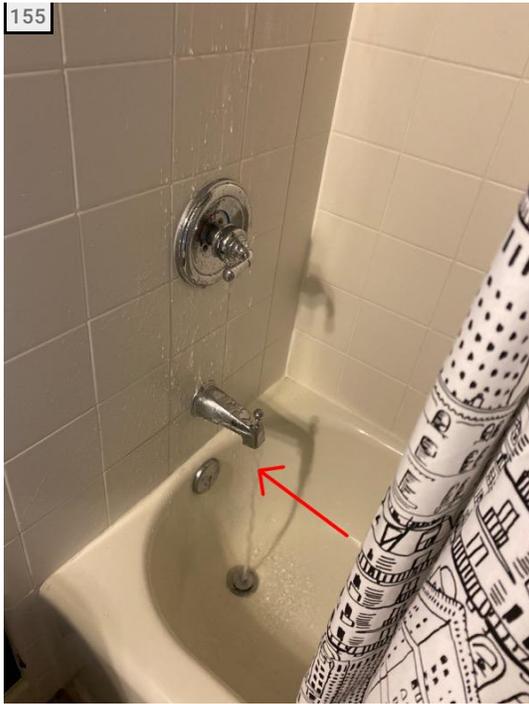
Moderate Concern**Spout diverter is leaking**

Impact The leak may become a nuisance. If not repaired, calcium deposits may form at the base of the valve and water flow to the shower head will be reduced

Suggested Action Replace the tub spout including the diverter

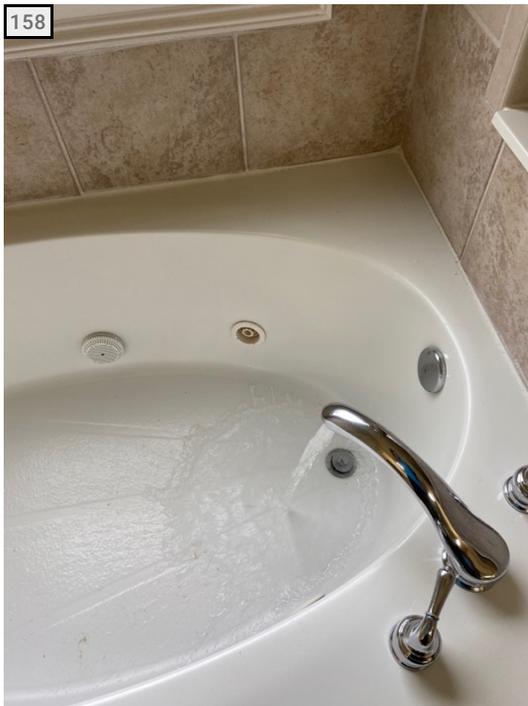
Location 1st Bathroom

working order
