Inspection Report

**565 Trowbrook Road
Atlanta, Georgia 30350**

Inspection Date August 21, 2020
Inspector Jay Cao
www.HouseChecked.com
jc@housechecked.com
(678)557-8958
interNACHI Certified Inspector, GA Registered Professional Engineer

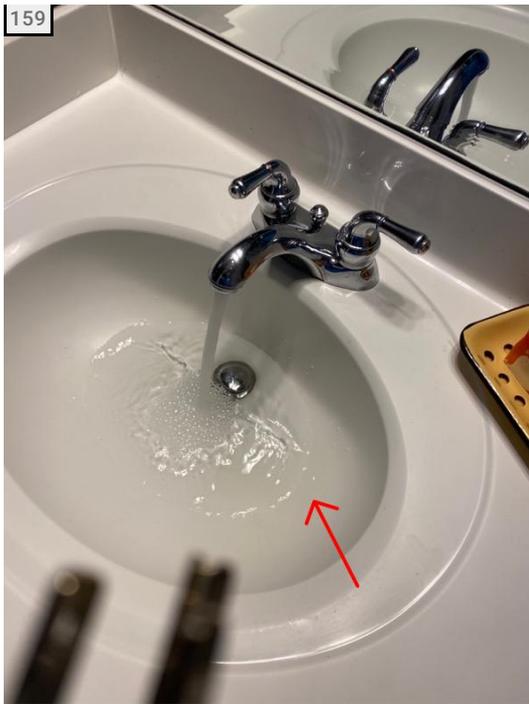
Location 2nd Bathroom

Moderate Concern

Suggested Action Clear the drain of debris with a rodder (vs. chemical)

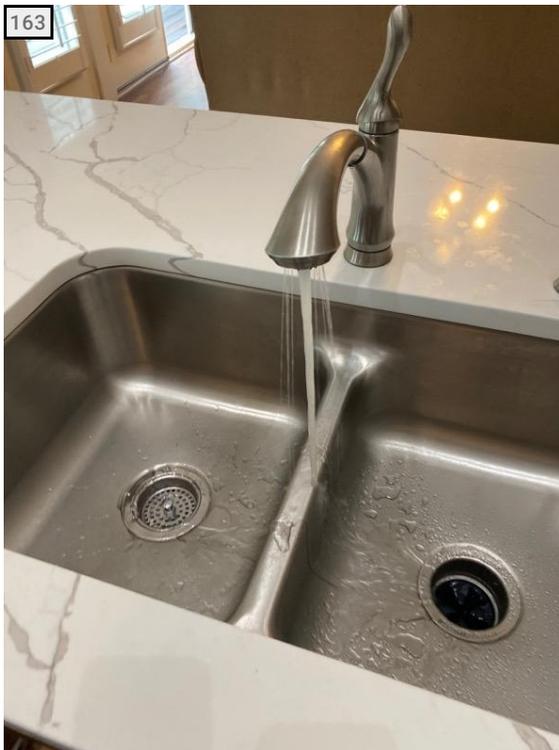
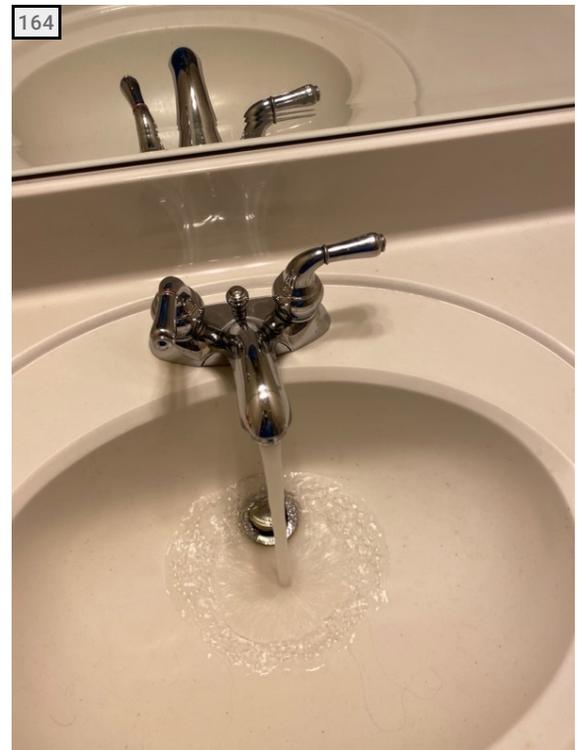
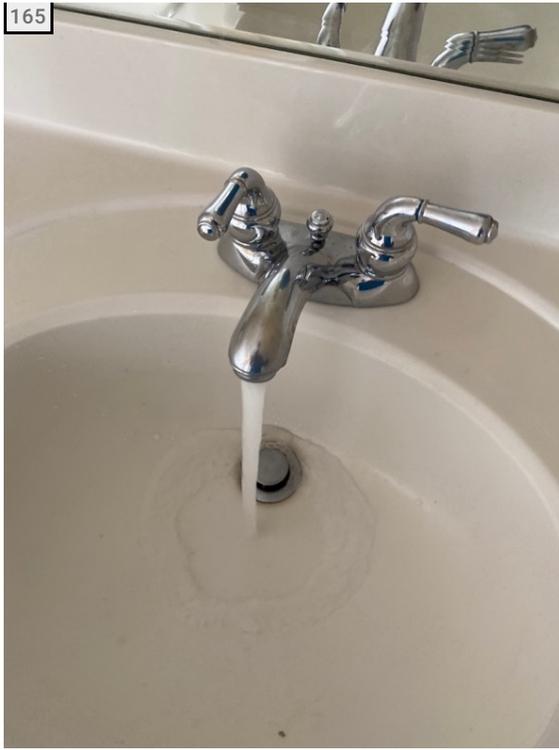
Location Kitchen, 3rd Bathroom, 4th Bathroom

working condition

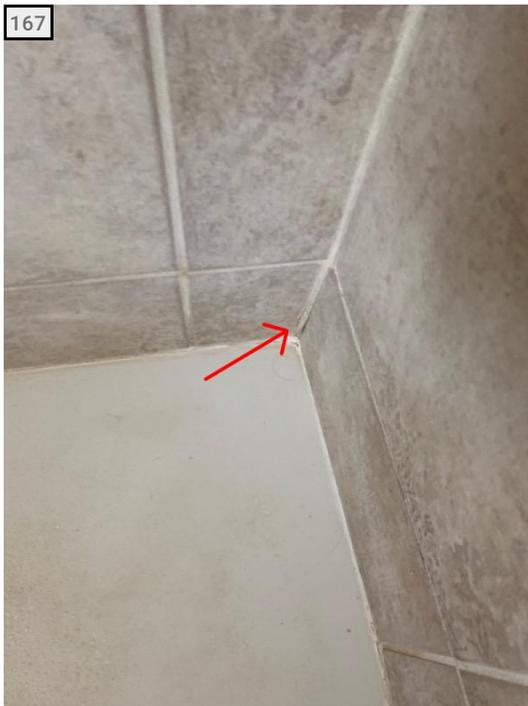
Location 1st Bathroom

Caulking/grout or sealant deterioration

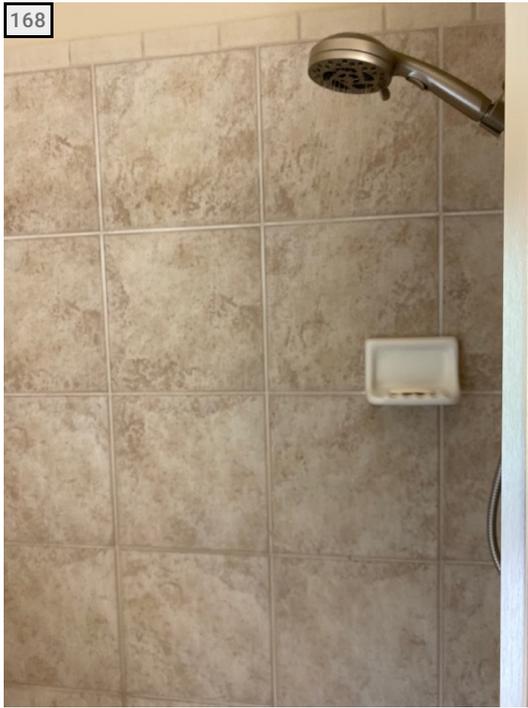
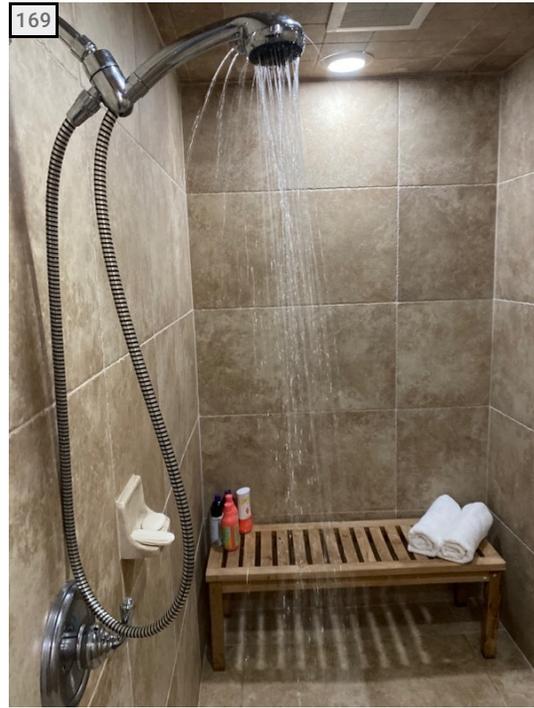
Location 1st Bathroom, 4th Bathroom

working order

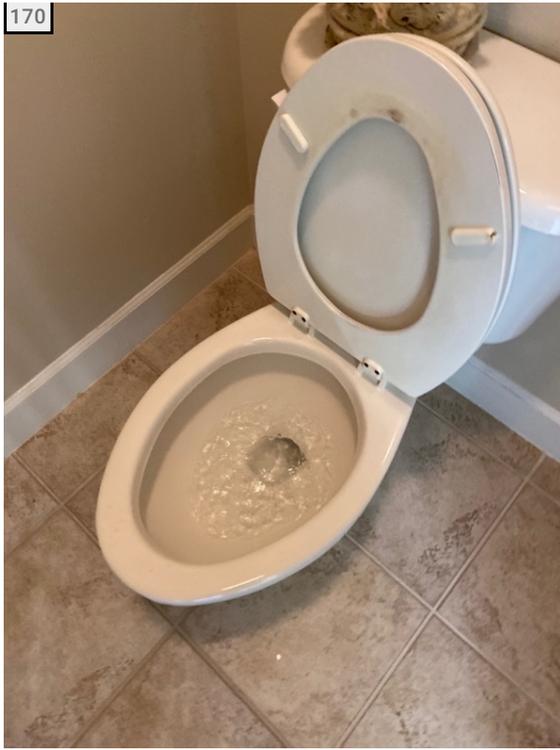
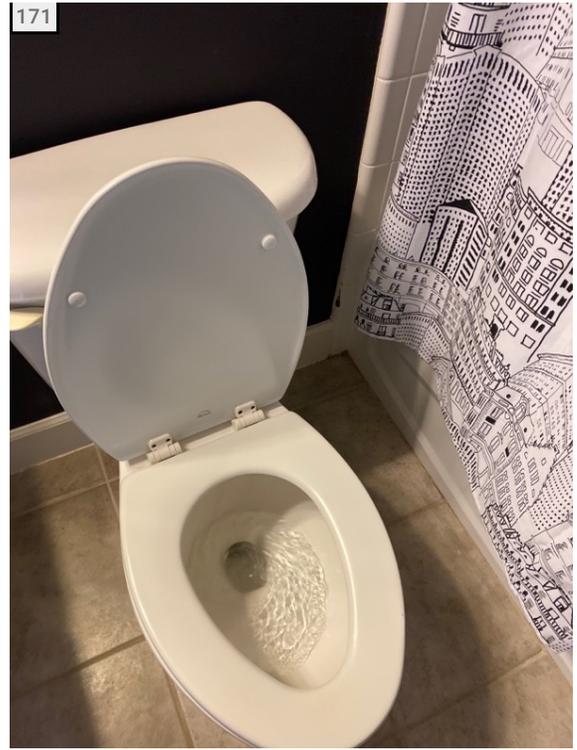
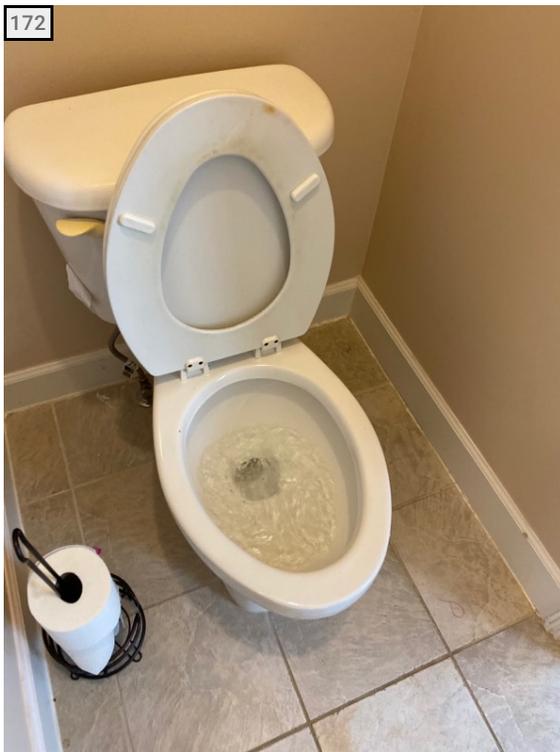
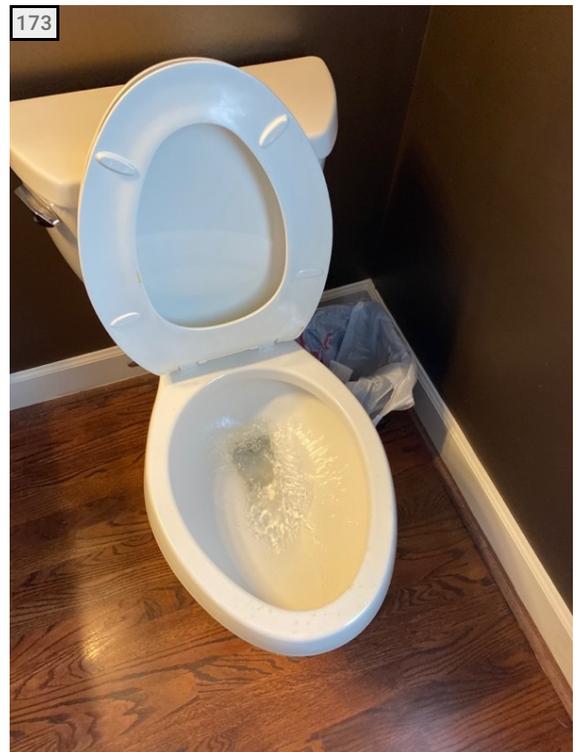
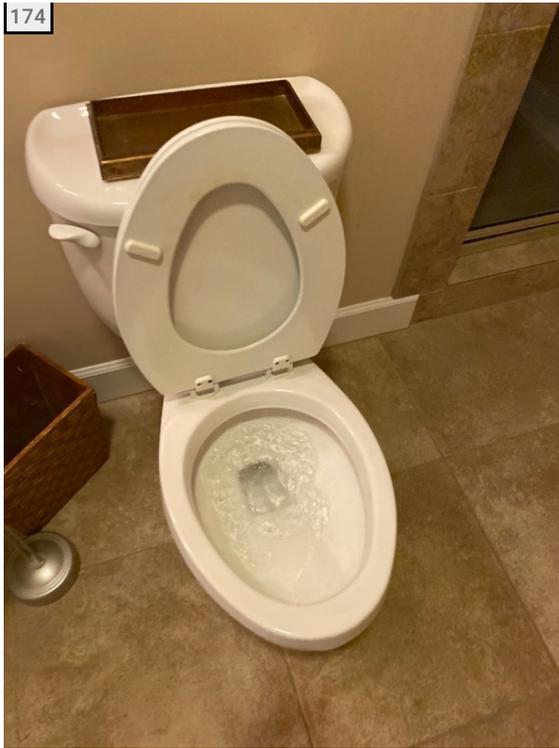
Location Partial Bathroom, 1st Bathroom, 2nd Bathroom, 3rd Bathroom, 4th Bathroom

working order

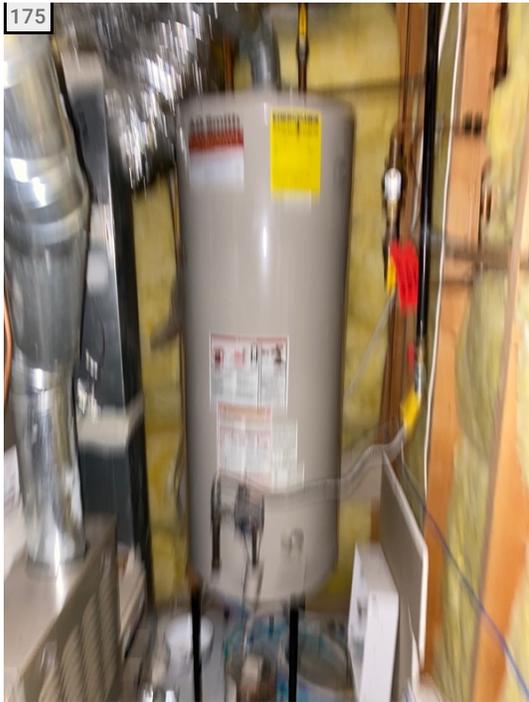
Location Basement

appear working at the time of inspection

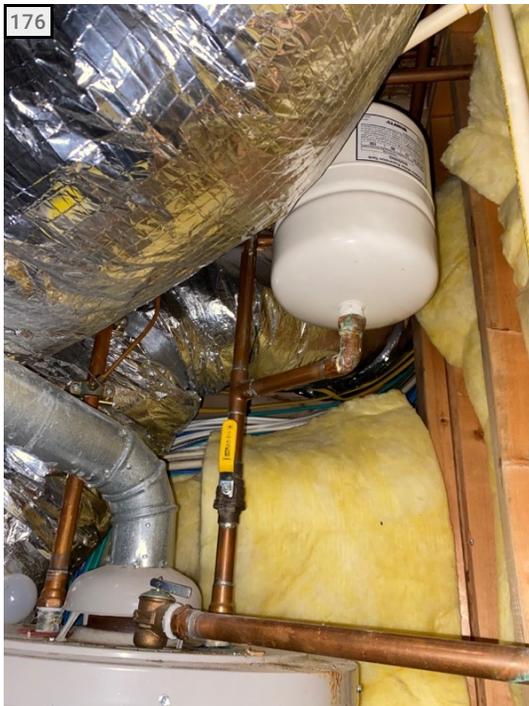
Location Basement

expansion tank noted

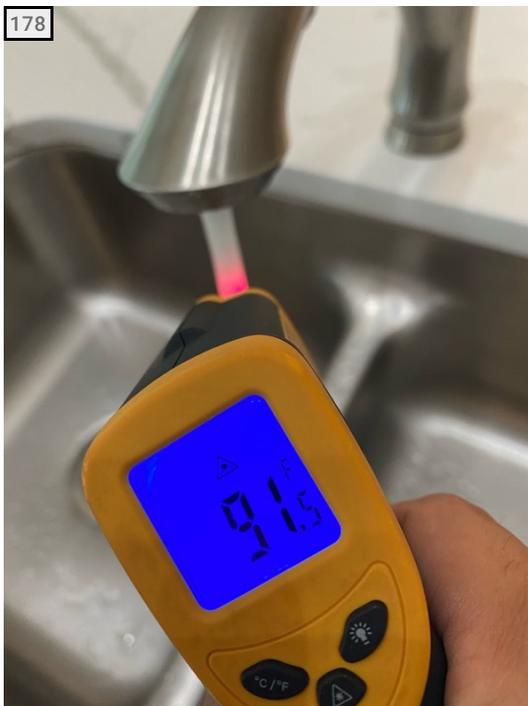
Location Basement

temperature is in normal range

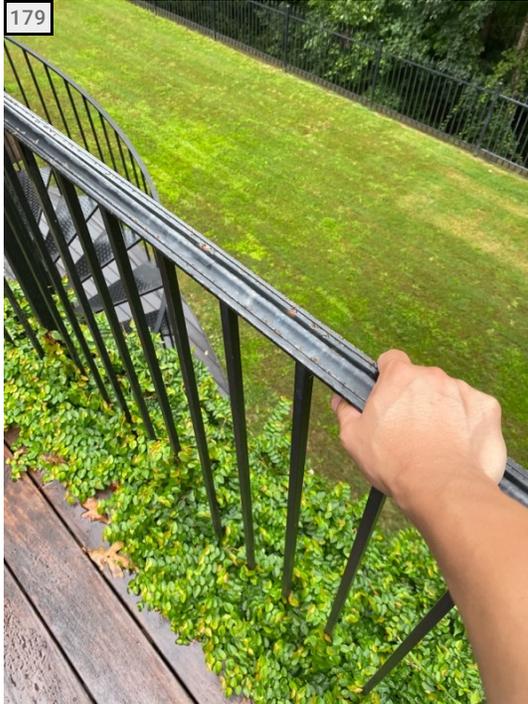
4. **Balcony, Deck or Porch(Exterior: Ground View):** Railing is loose

Railing is loose

Location	Exterior: Ground View
Impact	The stability of the railing is significantly reduced
Suggested Action	Repair or replace the railing
