# Inspection Report

**Property Address:**  
8970 Ridgemont Dr NE  
Atlanta GA 30350

**Residential Inspector of America**

<b>Date:</b> 7/30/2020	<b>Time:</b> 09:00:00 AM	<b>Report ID:</b> 073020MG1051
<b>Property:</b> 8970 Ridgemont Dr NE Atlanta GA 30350	<b>Customer:</b> Mark Jagor	<b>Real Estate Professional:</b> Katie Brinkman

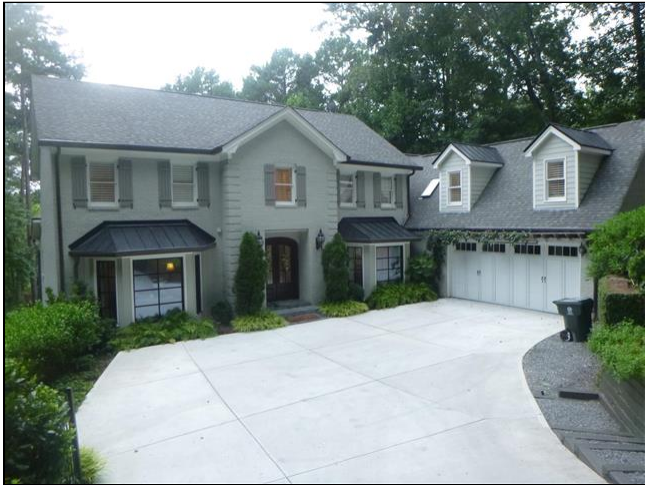
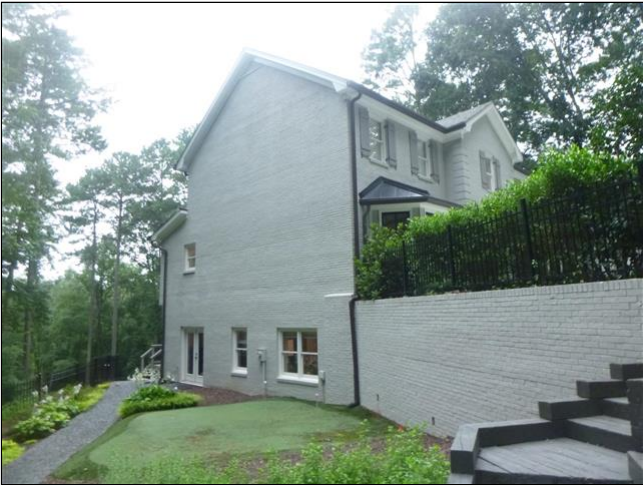
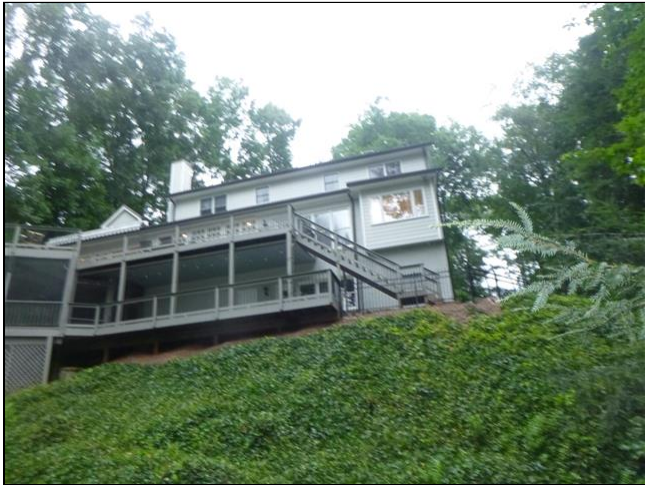
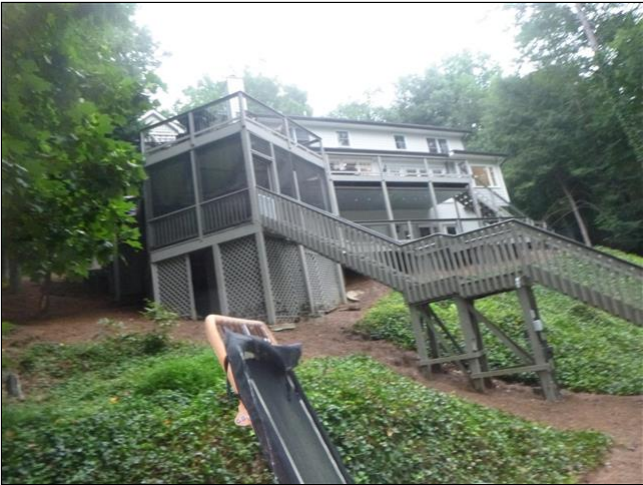
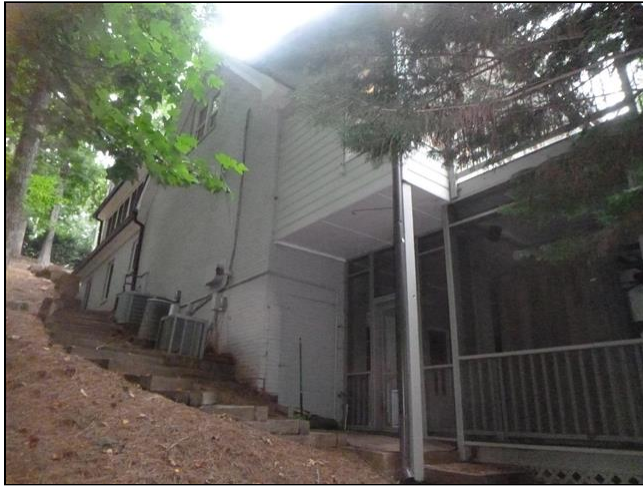
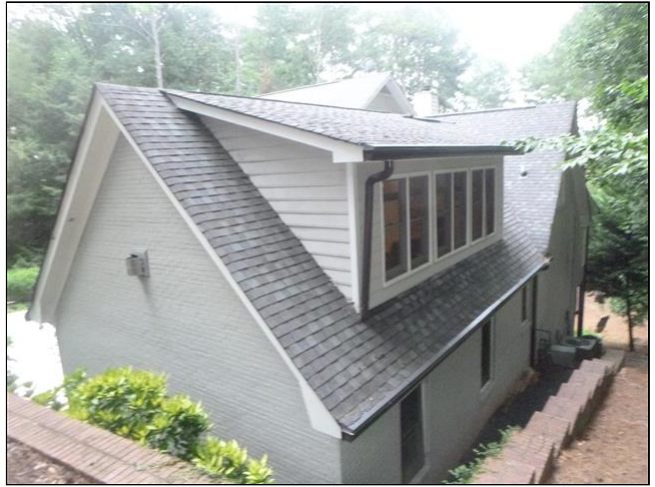
Elevation photos.

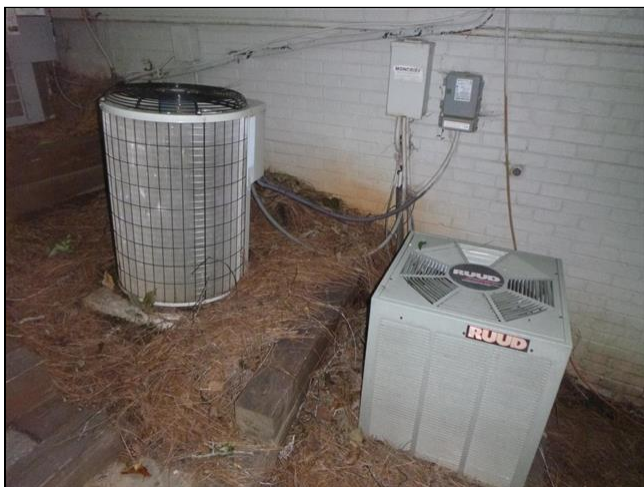
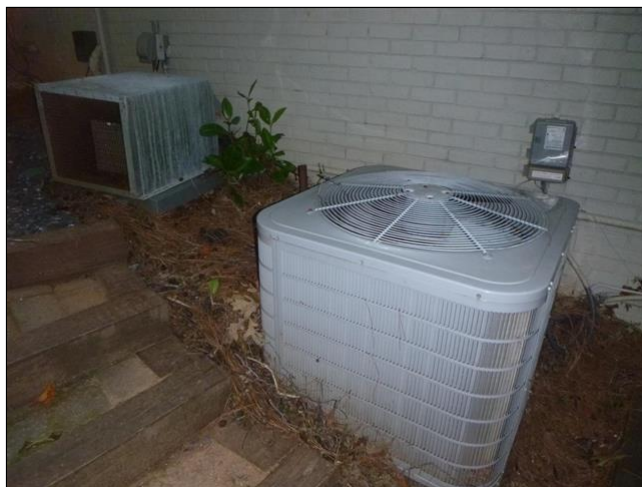
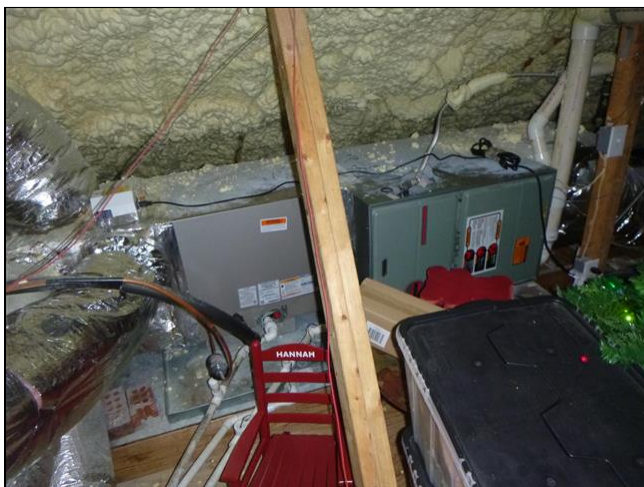
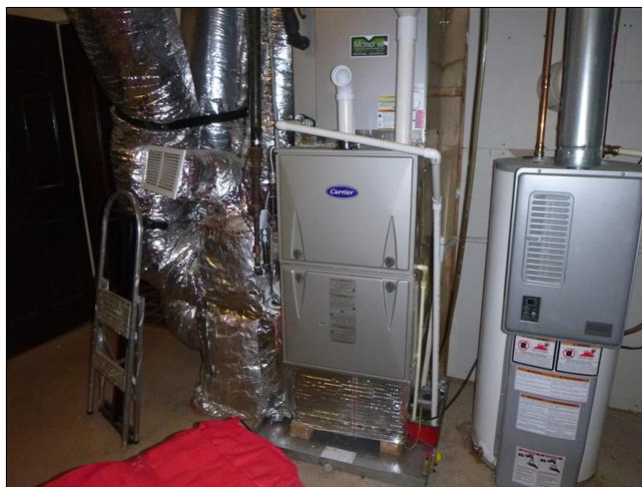
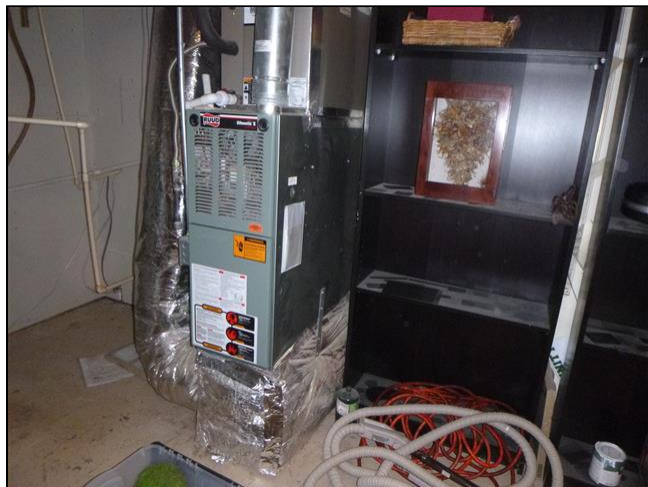
(5) Photo(s) of A/C unit(s).

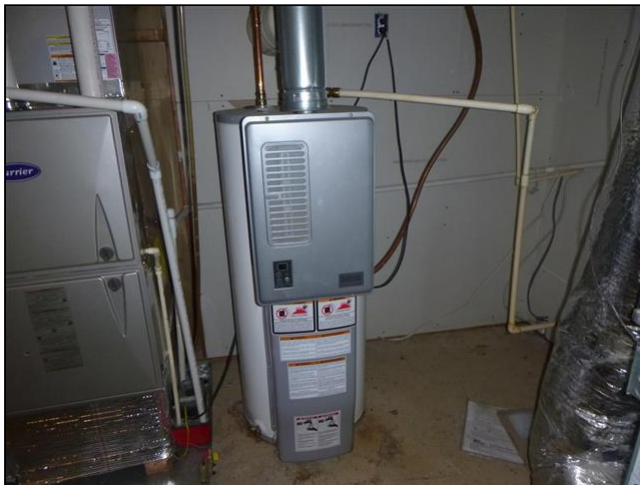
8.3 Item 2(Picture)

(2) The water heater is located in the unfinished basement. This is for your information.

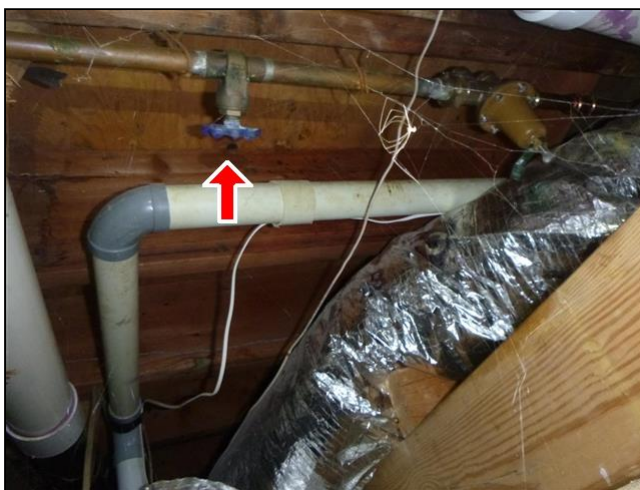
8.4 Item 1(Picture)

The main water shut off is located above the ceiling at the front of the basement.

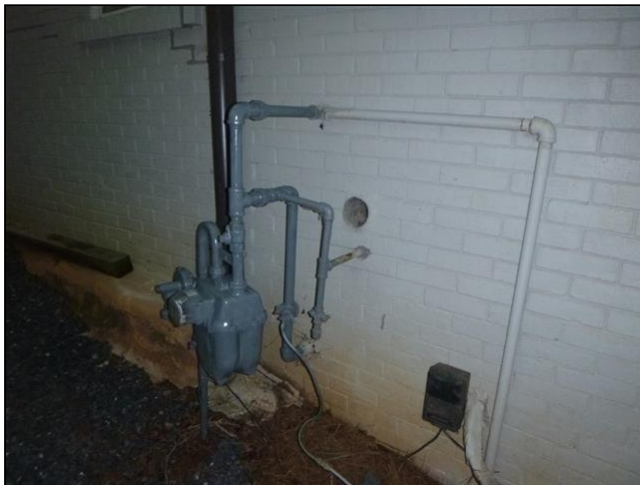
8.5 Item 1(Picture)

The main gas shut off is located on the exterior of the home.
