Trademark Home Inspection Co.

Property Inspection Report

4410 Beckwith Place, Cumming, GA 30041
Inspection prepared for: Tom Berger & Nancy Berger
Date of Inspection: 9/3/2020 Time: 9am
Age of Home: 1999 Size: 4815
Weather: Clear 85 degrees

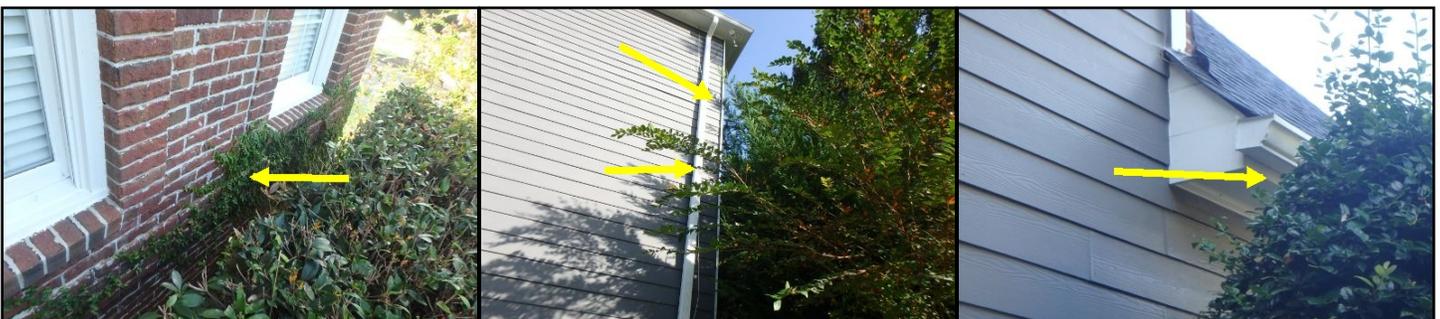
Vines should not grow on structure.*

Tree limbs need cutting back.*

All tree limbs should be cut back at least 10' away from structure to keep squirrels out of attic and extend roof shingle life.*

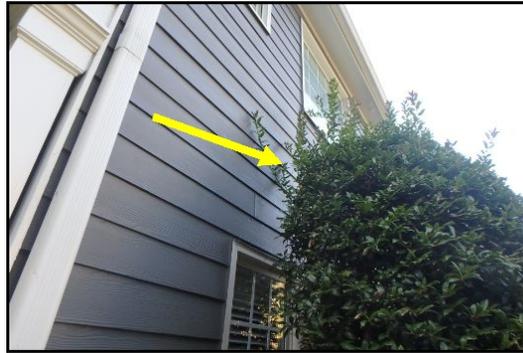
Bushes shouldn't touch structure.*

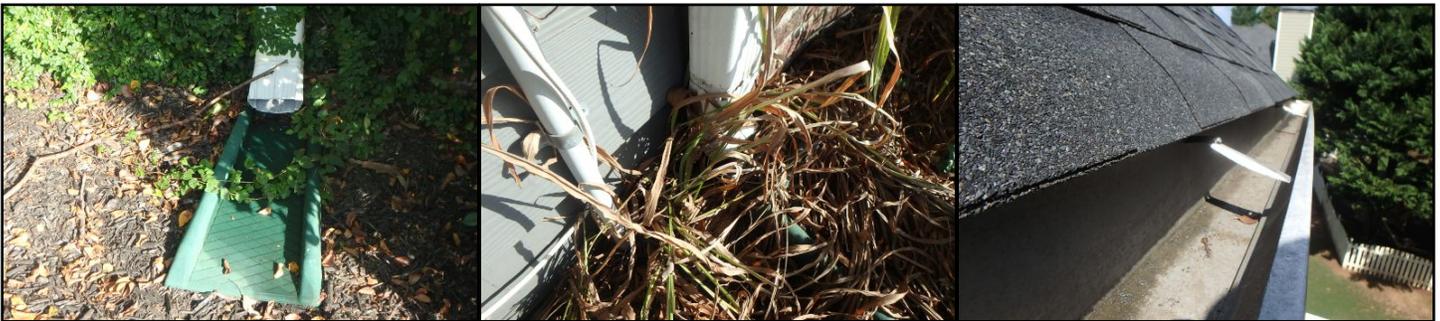
Underground lines should be checked during rains.*

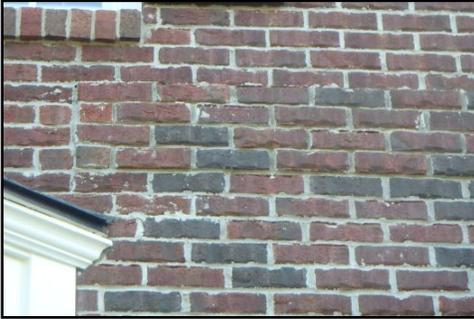
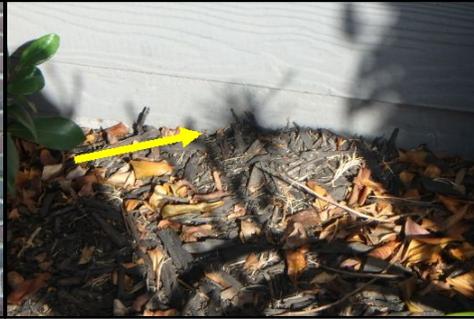
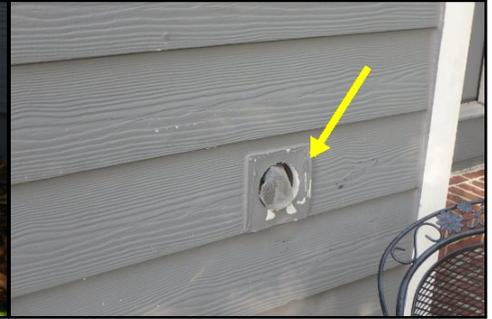
- *Odd brick joint line left of entry, appears to only be cosmetic issue.**
- *Grade is high at siding on right side.**

Grade is high at siding on right side.*

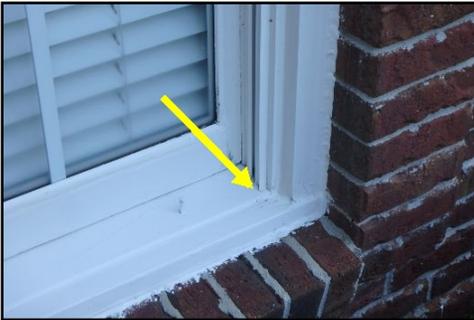
Decay or dry rot, repairs needed.*

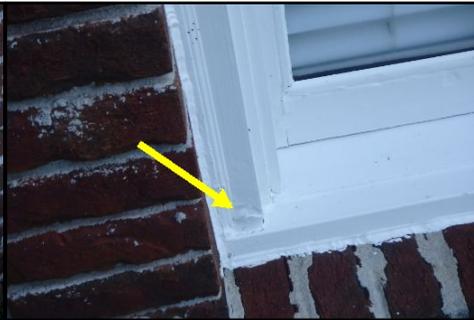
Decay or dry rot, repairs needed.*

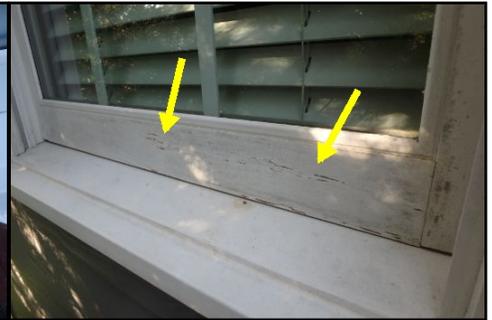
Peeling or missing paint, maintenance needed.*

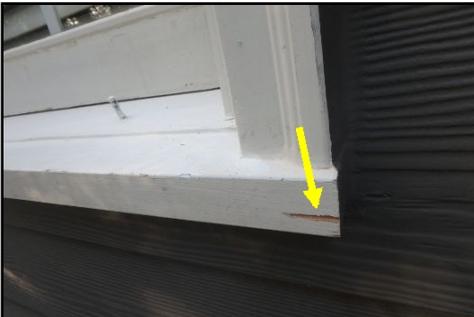
Peeling or missing paint, maintenance needed.*

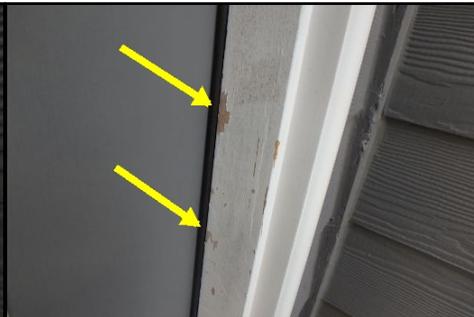
Peeling or missing paint, maintenance needed.*

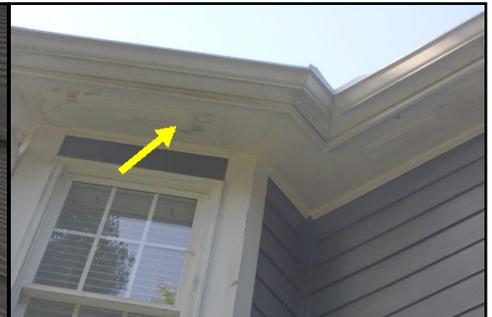
pressure washing needed.*

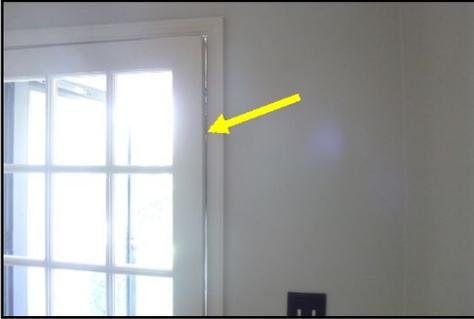
entry door sticks*

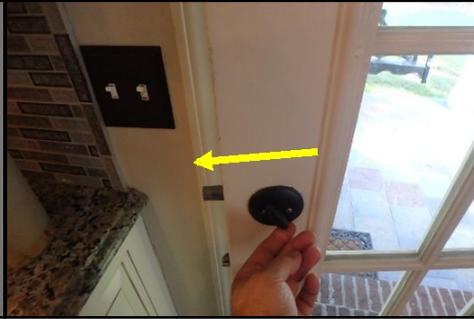
Dead bolt needs deeper hole to close properly at entry.*

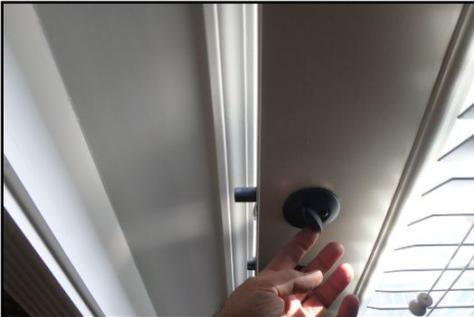
Dead bolt needs deeper hole to close properly at patio.*

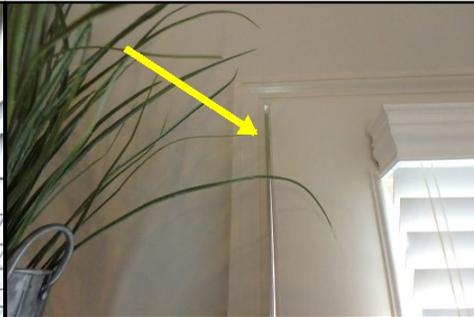
Some doors stick and need adjustments or repairs to close properly at patio.*

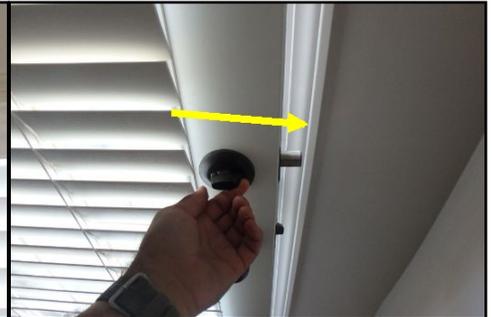
Dead bolt needs deeper hole to close properly at master.*

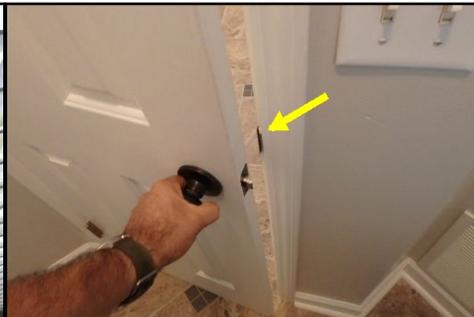
Door not latching, needs adjustment at master toilet door: *

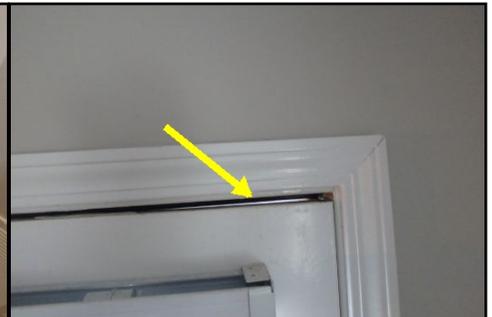
some exterior doors need weatherstrip, not lsealing.*

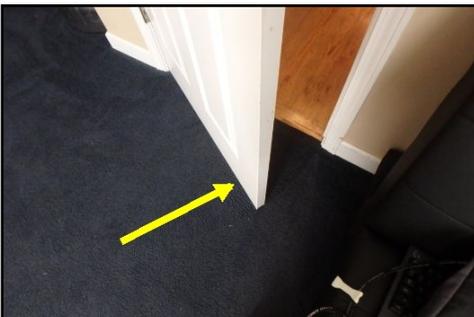
door rubs carpet in blue carpet room.*

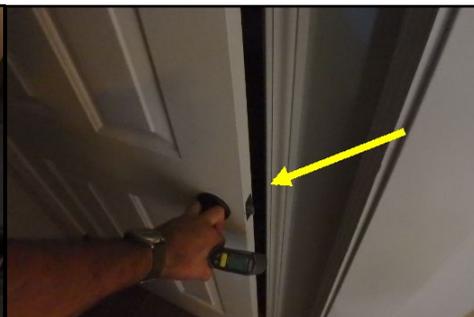
Door not latching, needs adjustment at coat closet .*

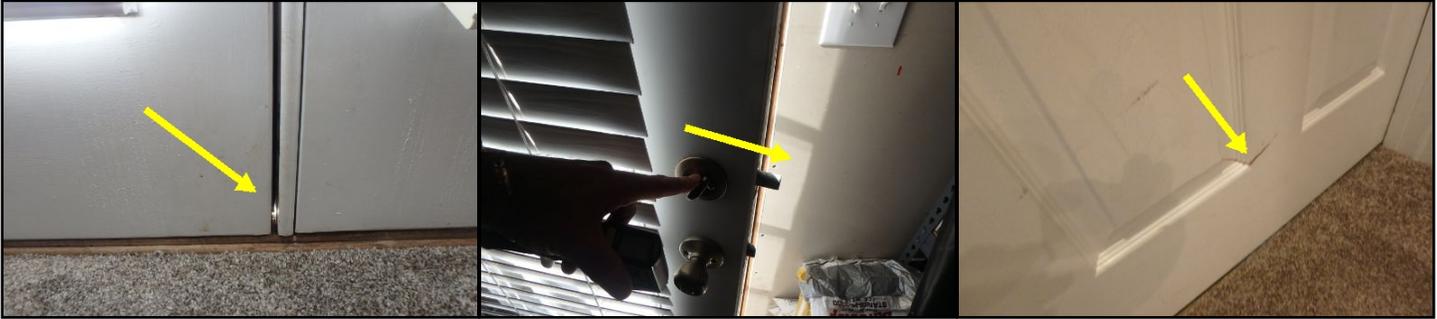
basement exterior doors not sealing well.*

Dead bolt needs deeper hole to close properly in basement.*

minor damage on basement door.*

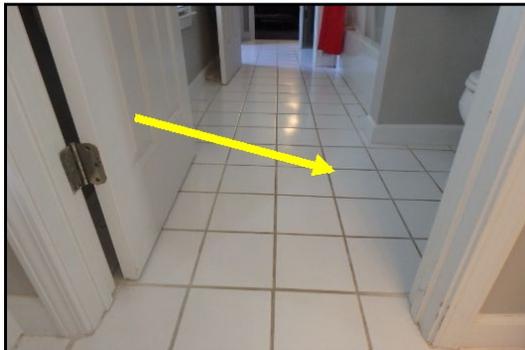
Floor is out of level in J&J bath.*

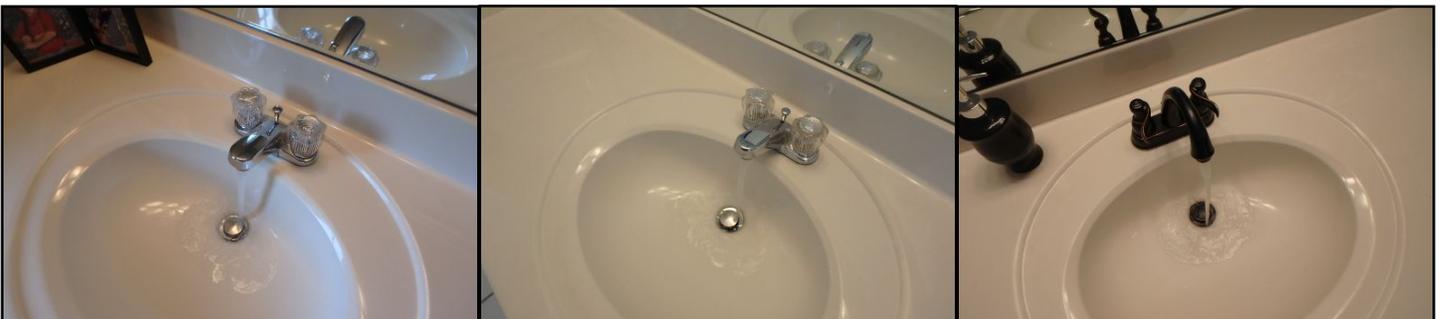
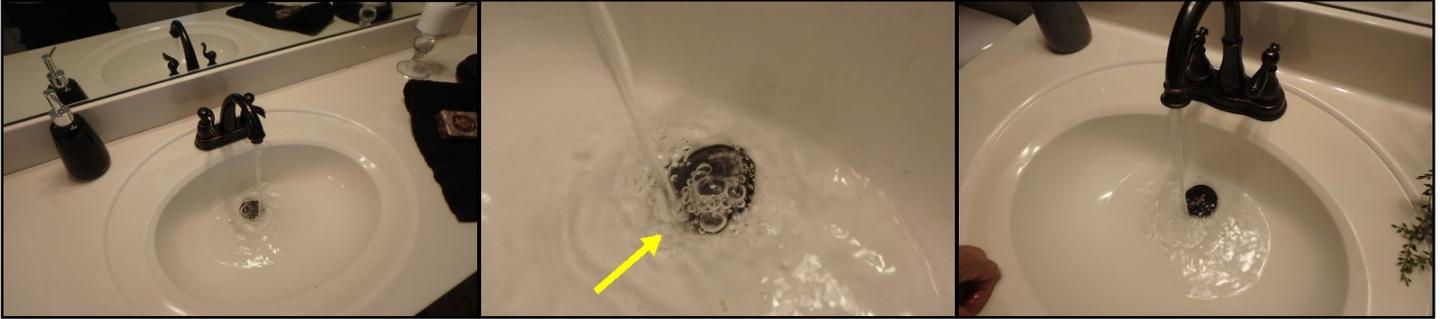
- *Right master sink drain is a little slow.**
- *Slow drain in main floor bath sink.**

Right master sink drain is a little slow.*

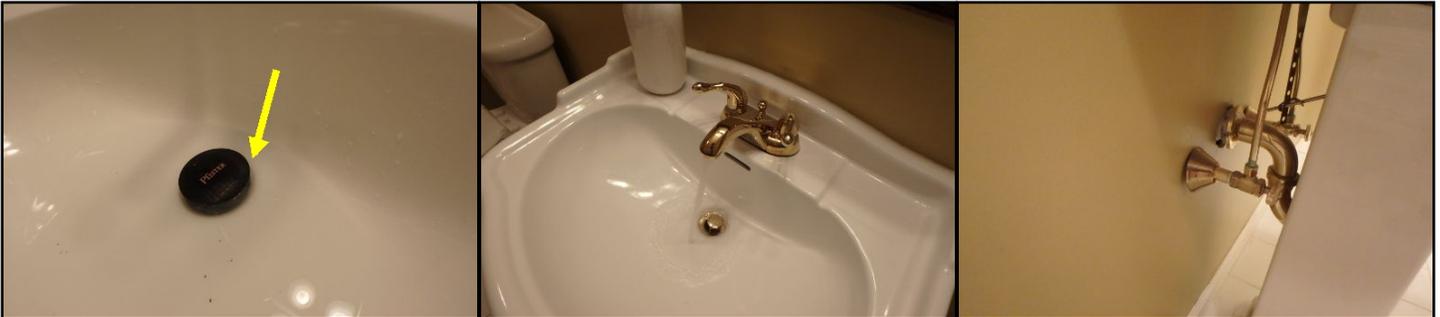
Slow drain in main floor bath sink.*

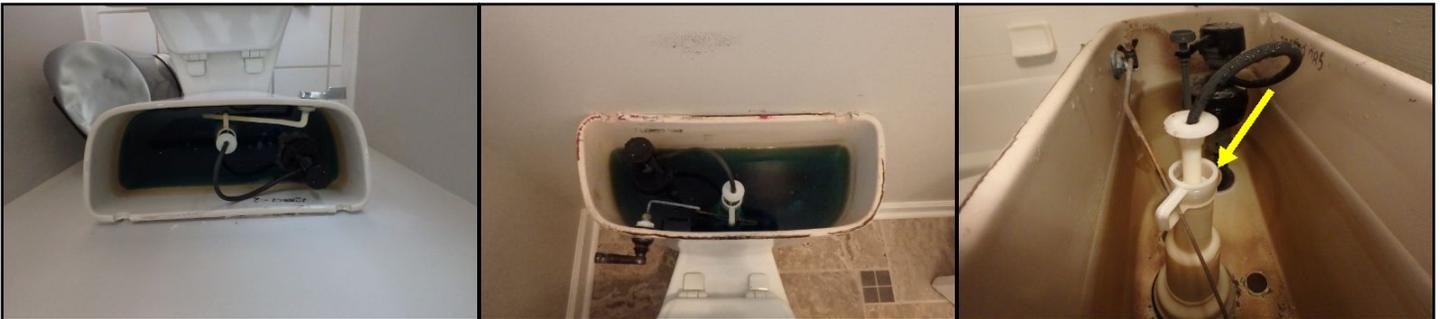
- Tank fill level too high, needs adjusting or may begin to run constantly soon; see photos.*

Tank fill level is high, needs adjustment in main floor bath.*

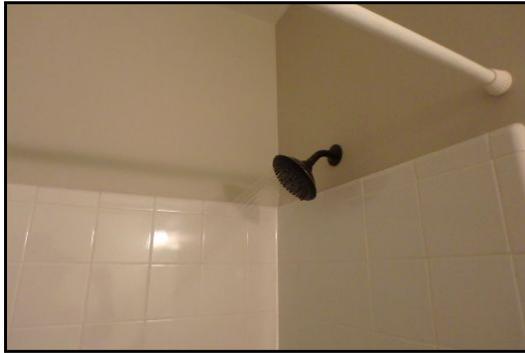
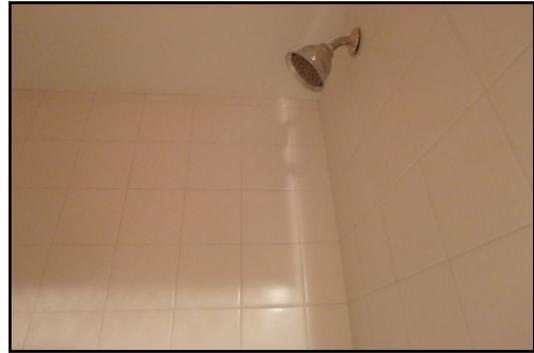
*Low water pressure noted in master shower or when multiple units running.**

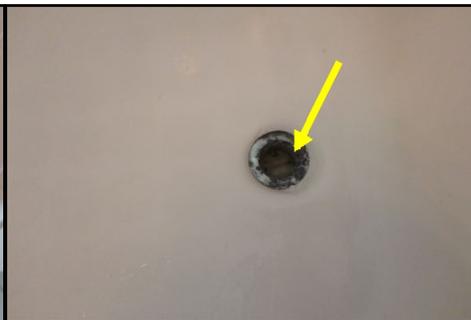
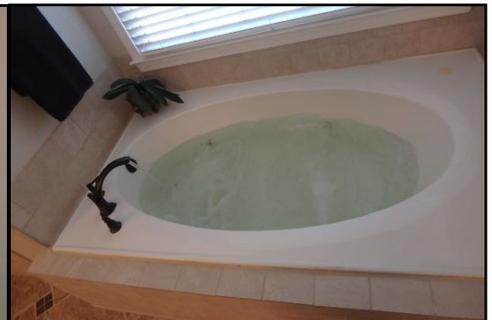
- *Tub drain is damaged in J&J bath, lacks screw for stopper.**

*Tub drain is damaged in J&J bath, lacks screw for stopper.**

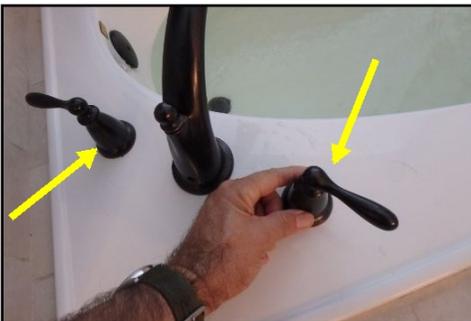
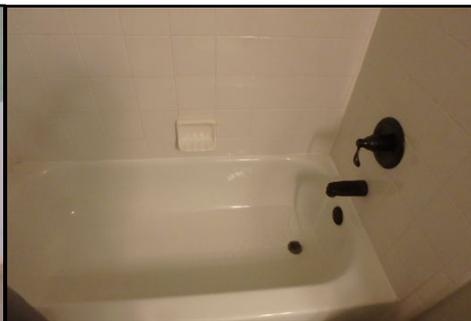
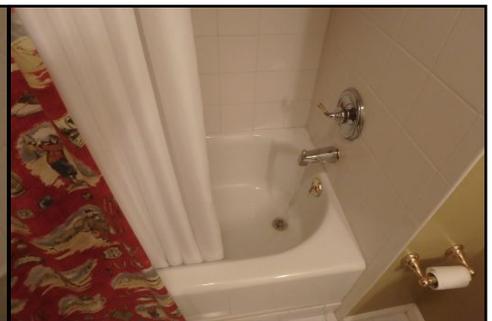
*master tub faucet not well secured.**

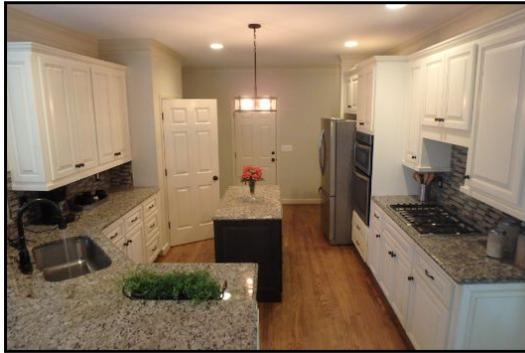
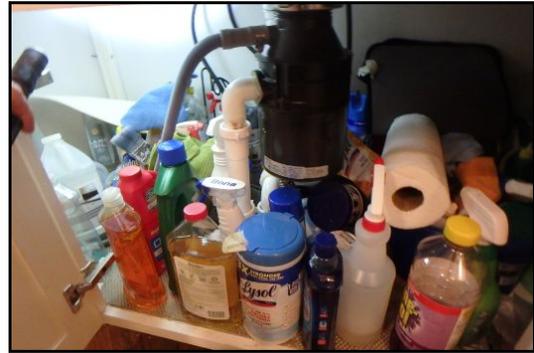
- *Countertop needs grinding down at stove to slide forward a little.**

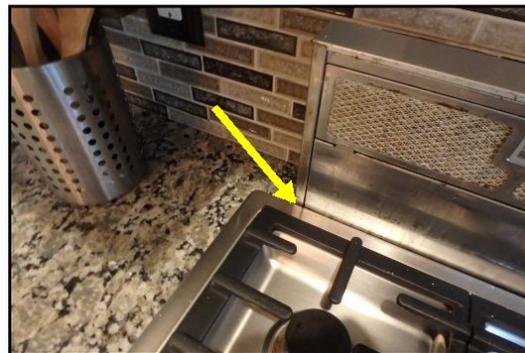
- *Down draft hits stove when rising.**

*Down draft hits stove when rising.**

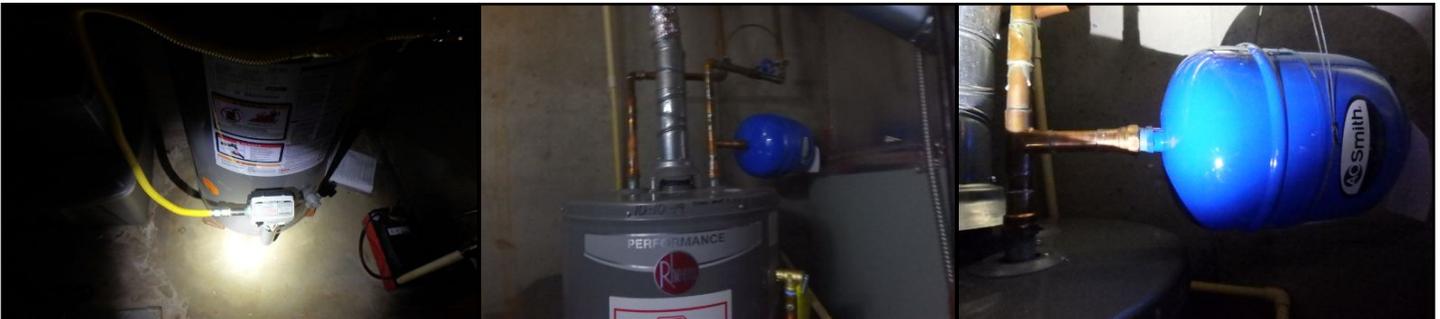
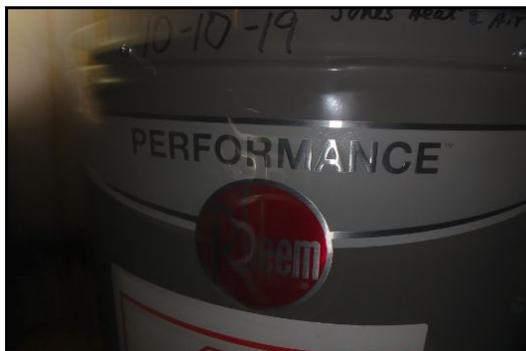
50 gallon 2019 model

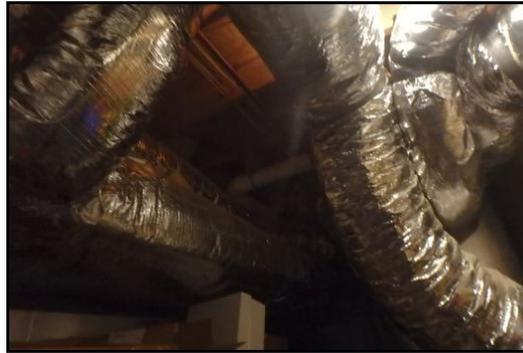
Basement units lack proper exterior combustion supply, needs to be added.*

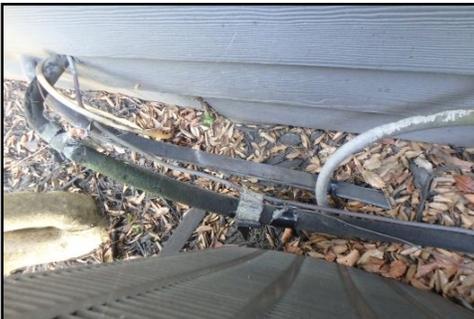
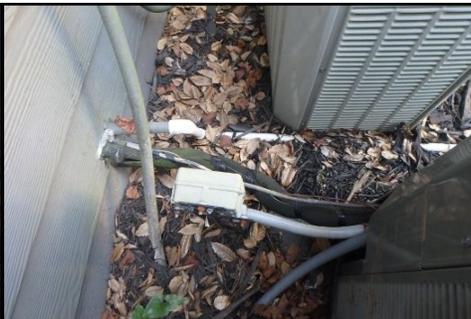
Condensation line appears to be covered or blocked, end needs to be open to drain.*

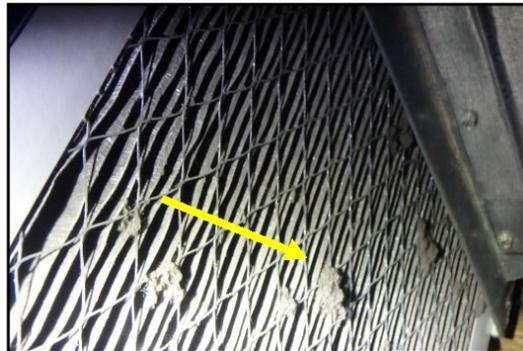
Filter needs to be replaced.*

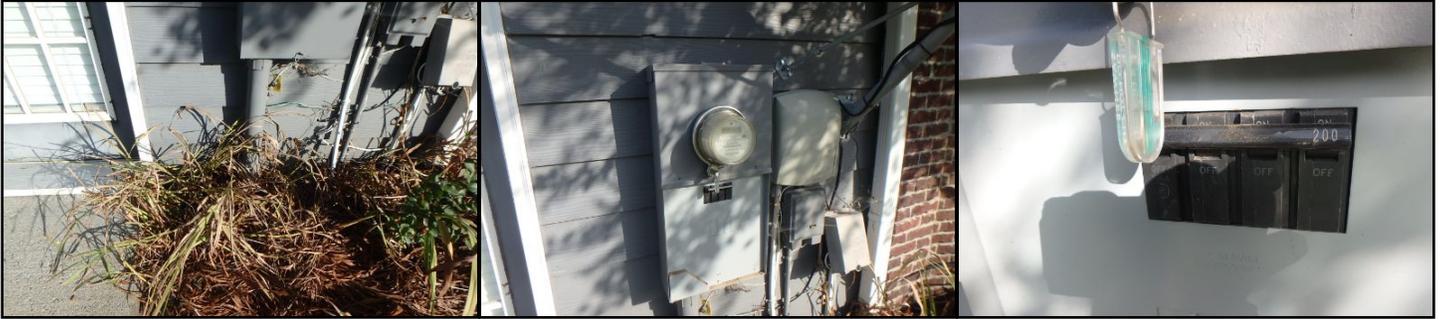
200 amp service, disconnect on right side

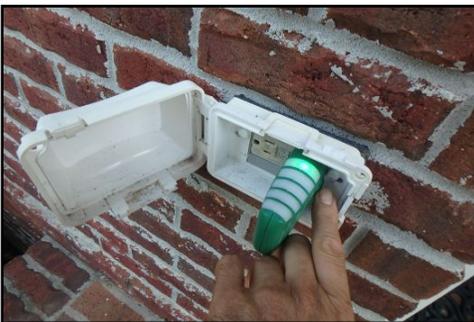
Most exterior GFCI outlets not tripping or not wired correctly.*

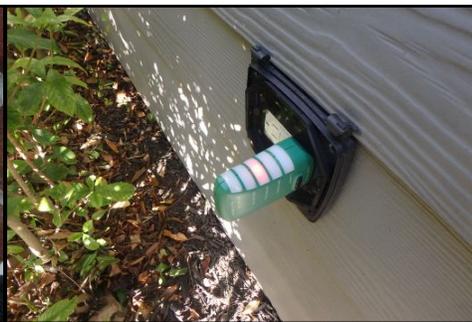
open ground on side exterior GFCI.*

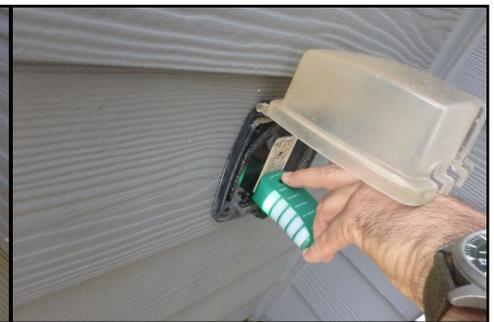
Most exterior GFCI outlets not tripping or not wired correctly.*

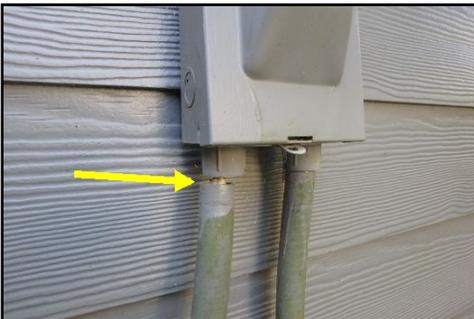
Loose conduit at AC unit needs securing.*

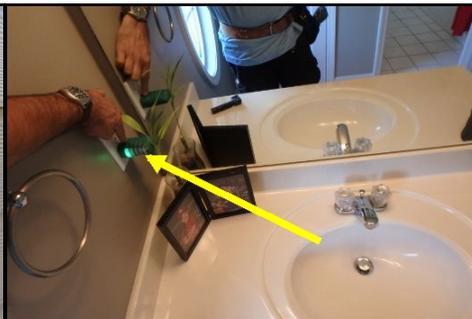
Recommend GFCI protection for bath outlets, missing in J&J bath.*

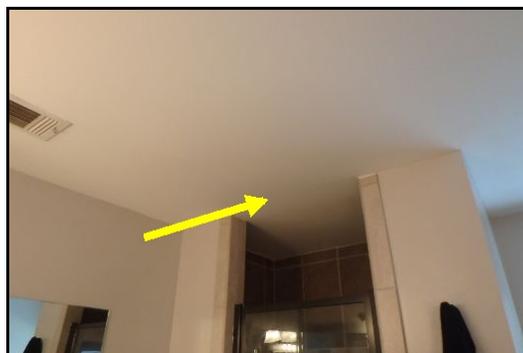
no light or exhaust fan in master shower.*

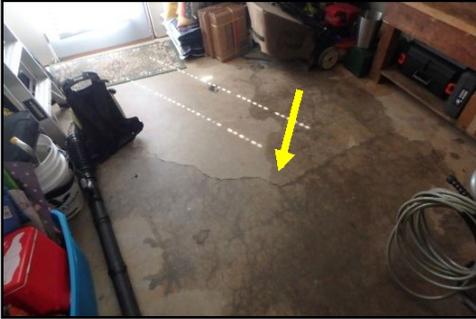
- *Common hairline cracks present but within acceptable tolerance.**

Common crack, not a concern

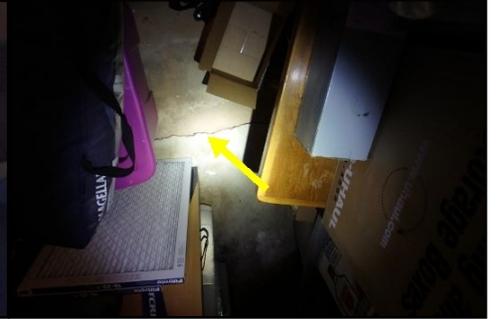
cracks in slab
