Inspection Report

Property Address:
881 Little Lost Landing NW
Suwanee GA 30024

Date: 9/1/2020	Time: 09:00:00 AM	Report ID: 090120MG1042
Property: 881 Little Lost Landing NW Suwanee GA 30024	Customer: Suzanne Lim	Real Estate Professional: Allison Kloster Harry Norman - 7855 North Point Parkway

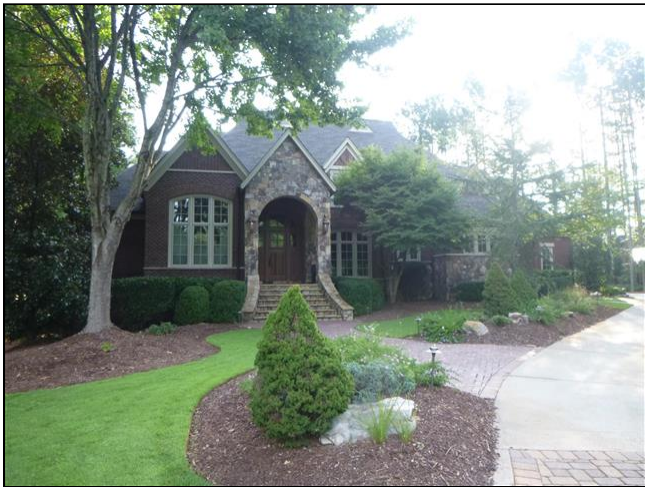
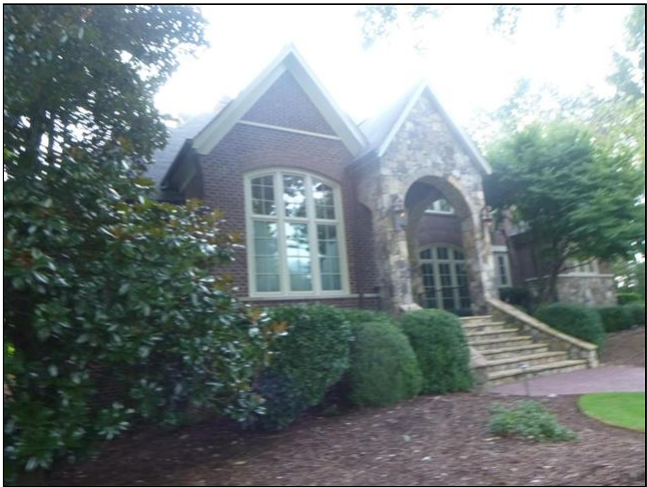
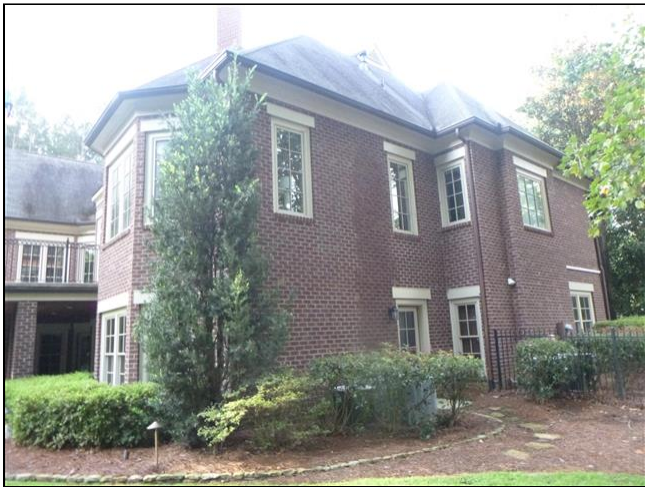
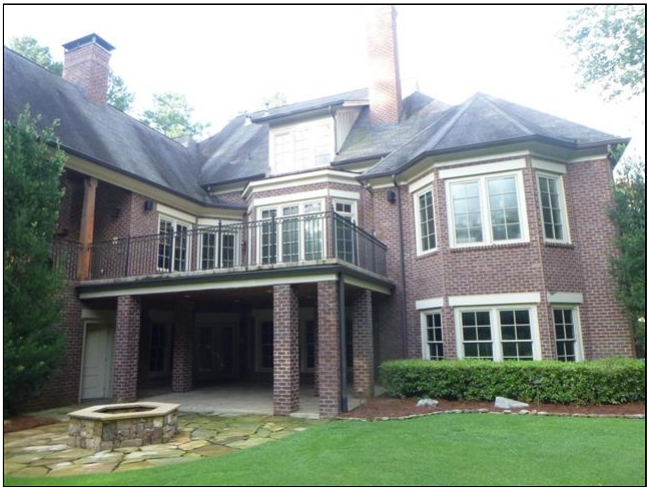
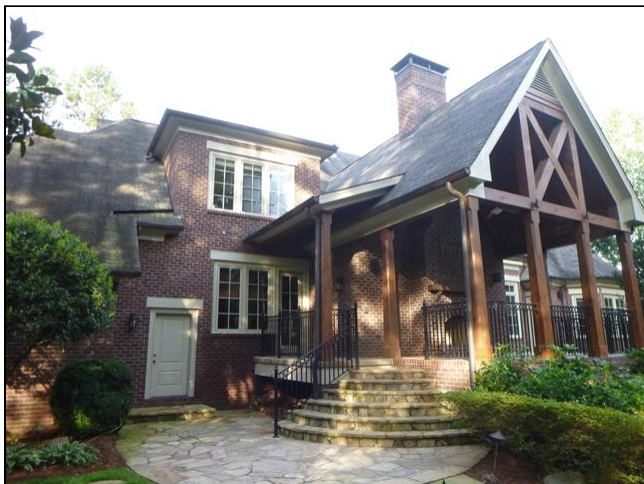
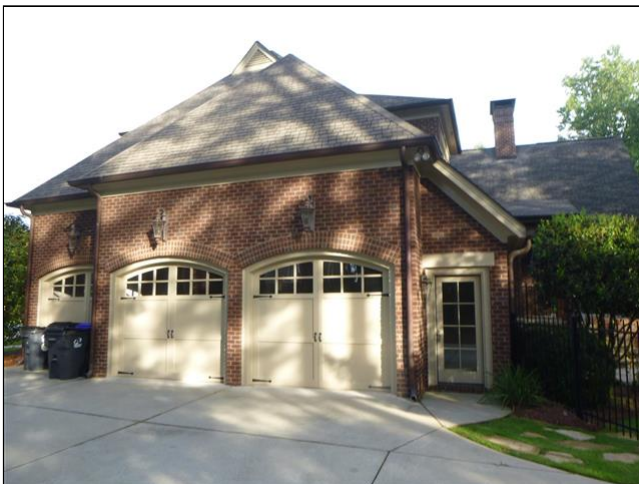
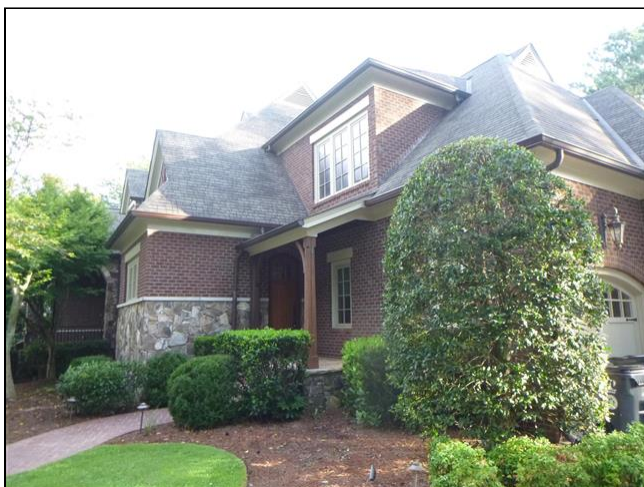
Elevation photos.

🔧 (2) The tree limbs that are in contact with roof or hanging near roof at the front of home and should be trimmed away. This will help prevent against rodent entry into the attic. See elevation photos for location.

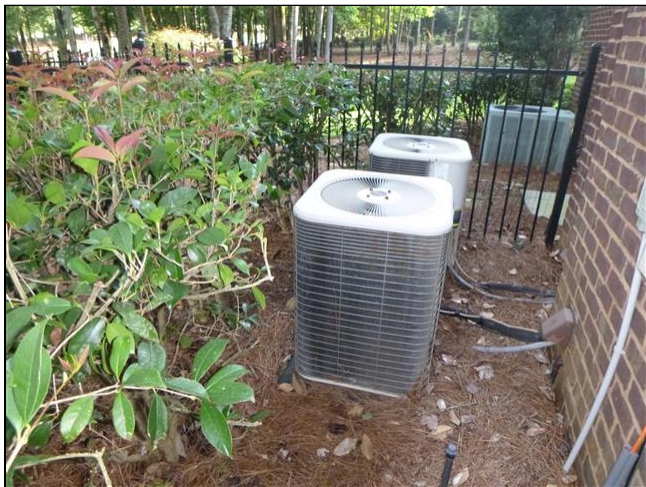
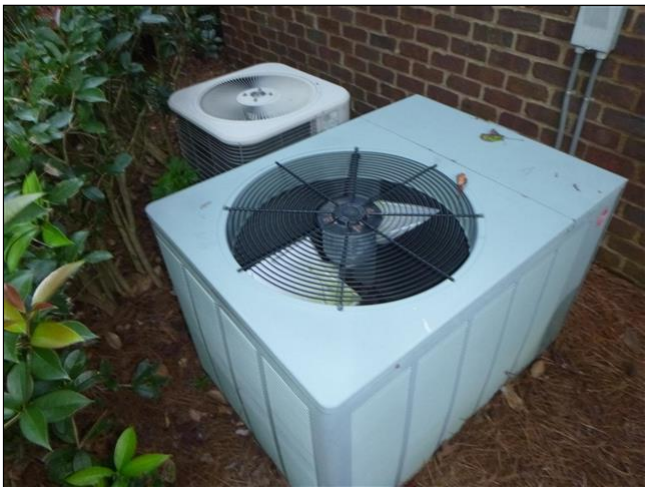
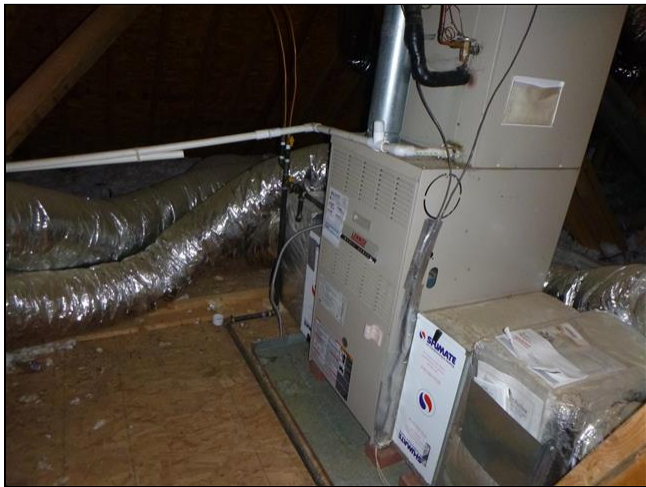
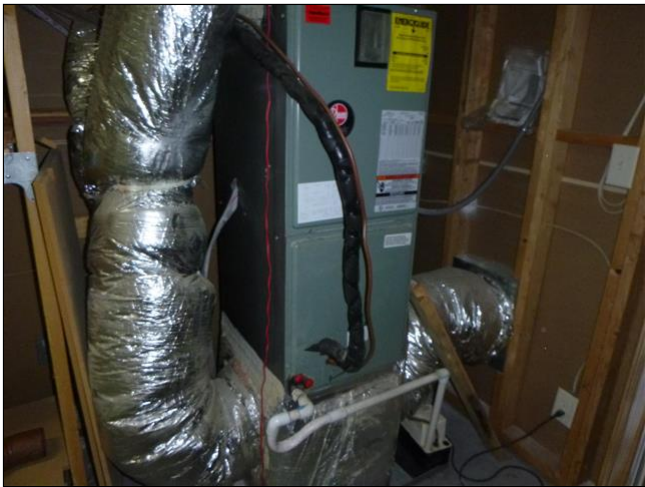
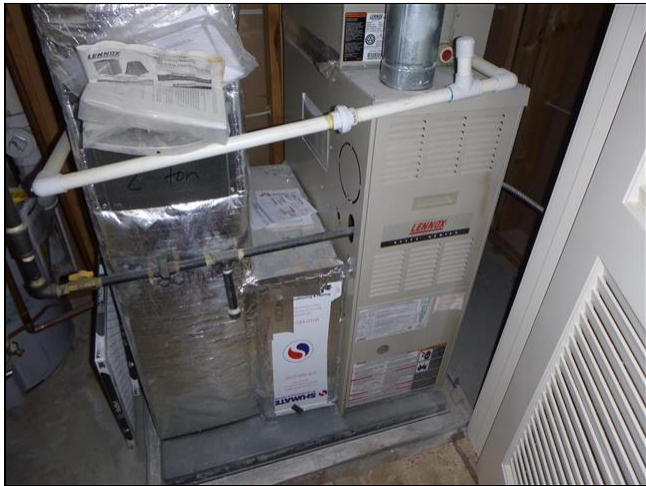
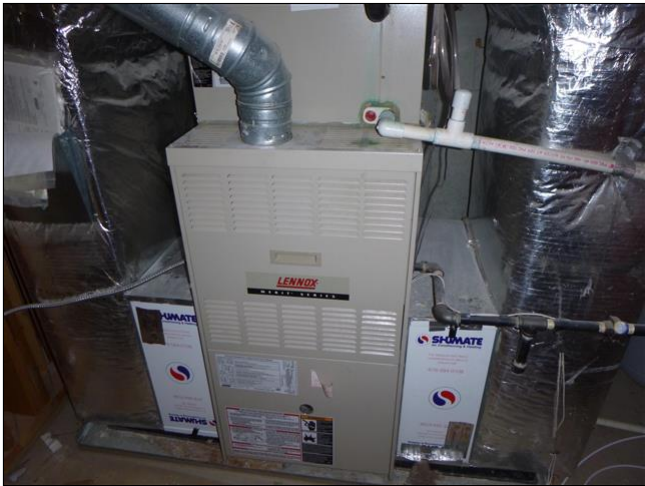
(5) Photo(s) of A/C unit(s).

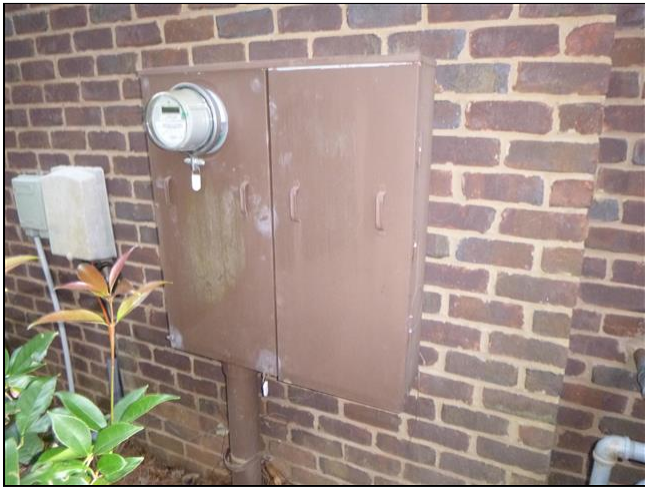
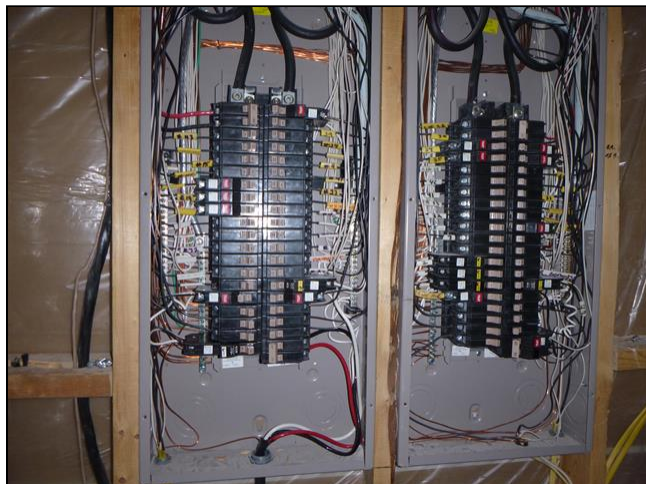
The main panel box is located at the basement. However, the main disconnect (shut-off) is outside at meter base panel (for your information). Panel was inspected for function (not code compliance) and building codes and standards have changed over the years.

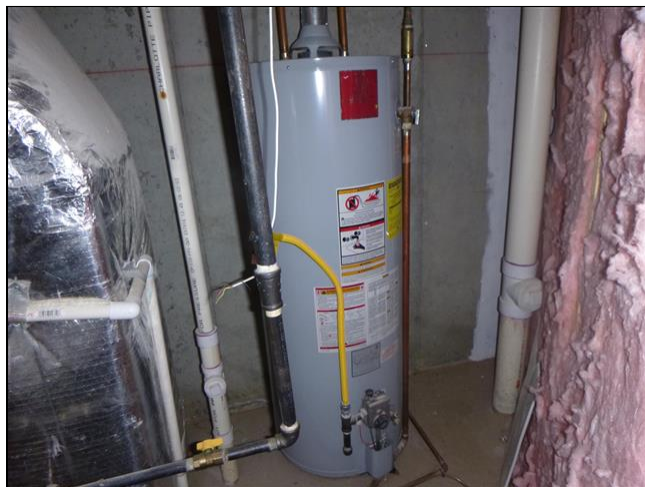
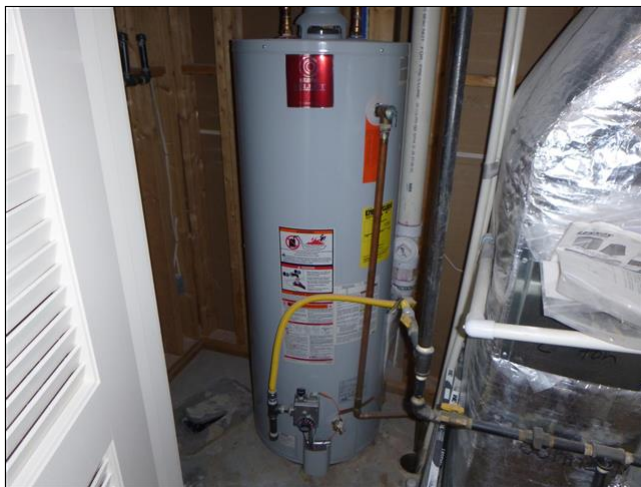
- 🔧 (5) The water heater is located in the basement. This is for your information.

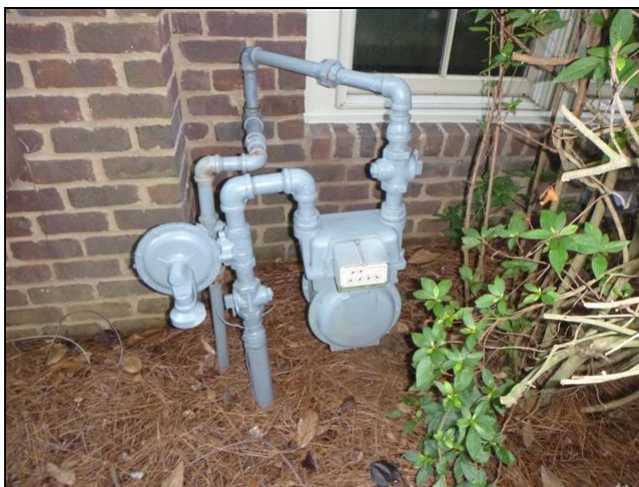
8.5 Item 1(Picture)

The main gas shut off is located on the exterior of the home.
