Inspection Report

Property Address:
3336 Grand Villas Loop
Gainesville GA 30506

Dana Inspection Services, Inc.

Date: 8/11/2020		
Property: 3336 Grand Villas Loop Gainesville GA 30506	Customer: Carol Lowenthal	Real Estate Professional: Andrea Kenny Ansley Atlanta Real Estate

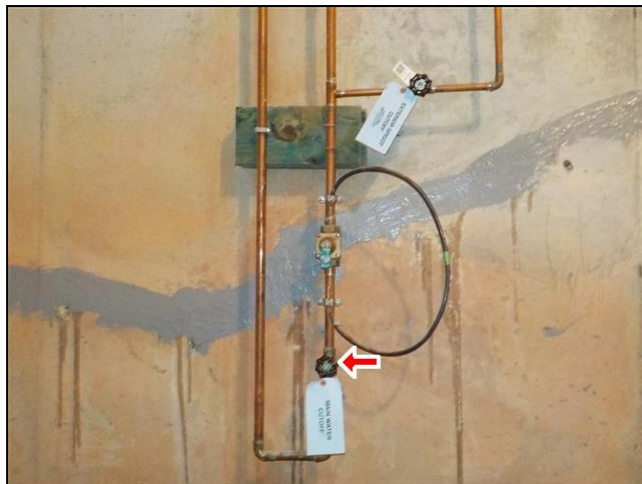
Basement front unfinished area.

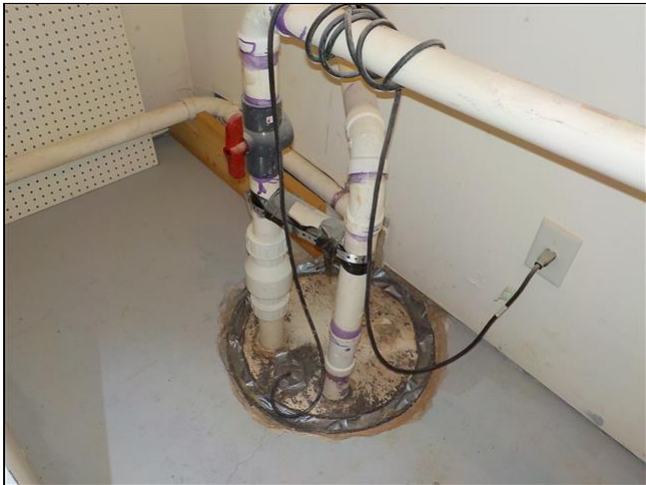
The sewer ejection pump in the basement is working as expected.

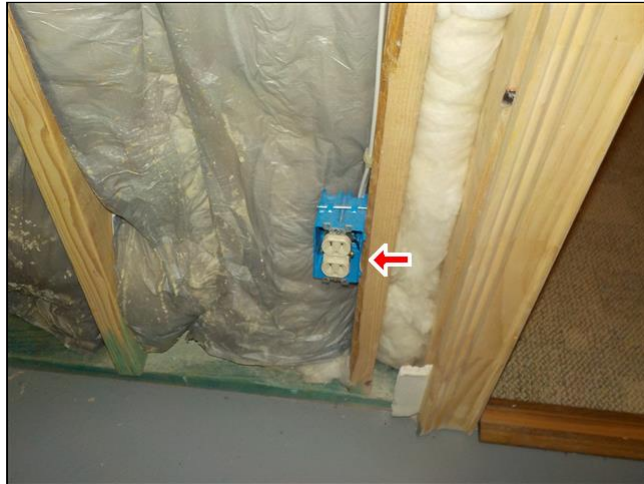
(3) Some of the outlets in the unfinished areas of the basement have outlets without covers.

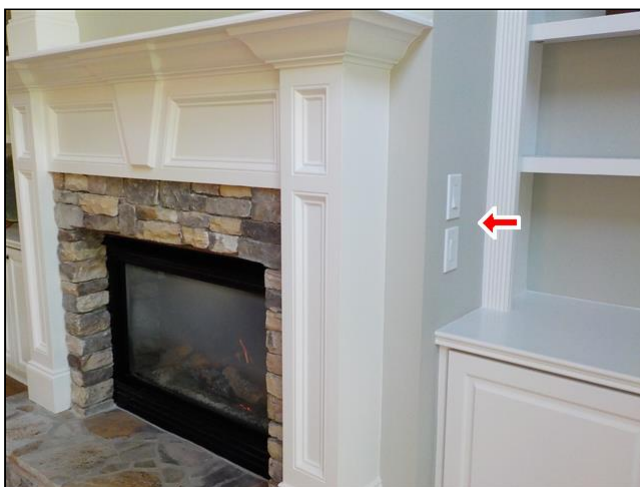
(3) There are two switches for the fireplace. One operates the fireplace and I am unsure of what the 2nd one operates. Contact the seller for more info.
