Arena Home Inspections

Home Inspection Report

Property address: **1508 Walker Ridge Dr SW
Marietta GA 30064-4168**

Inspection date: **Tuesday, August 25, 2020**

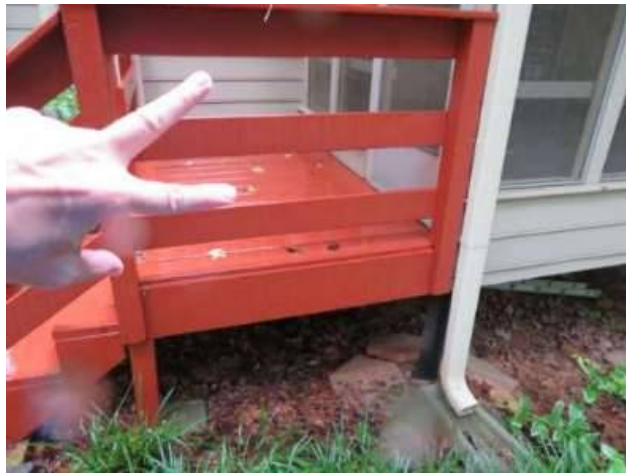
Gaps larger than 4" were found in one or more guardrails. This is a safety hazard, especially for small children. Recommend that a qualified contractor make modifications as necessary, such as installing additional balusters, so gaps in guardrails don't exceed 4".

Photo 2-2 Rear Deck Guardrail - excessive gap(s) (more than 4")

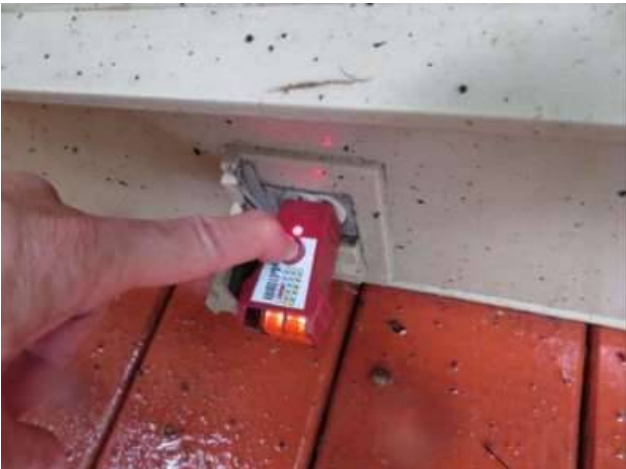
One or more exterior receptacles aren't waterproof or rated for use in wet areas. This is a safety hazard and poses a risk of both fire and shock.

Photo 3-2 Rear Electrical Outlet Box - should be GFCI

Recommend having a qualified, licensed electrician make repairs as necessary. For example, install waterproof covers, replace interior rated receptacle boxes, etc., so all exterior receptacles are waterproof as per standard building practices.

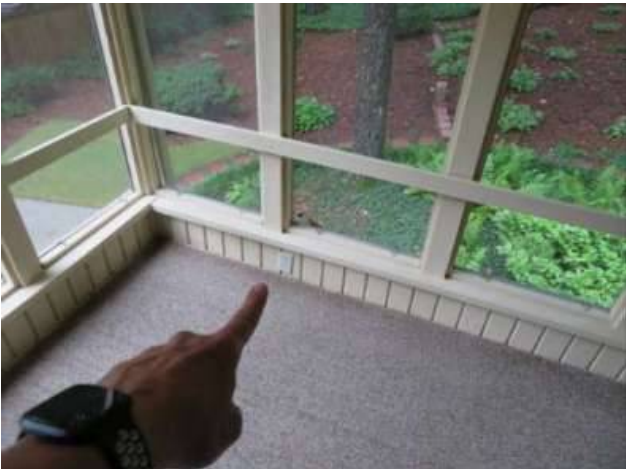
Photo 3-4 Rear Covered Deck - outlet(s) are not waterproof & should be GFCI

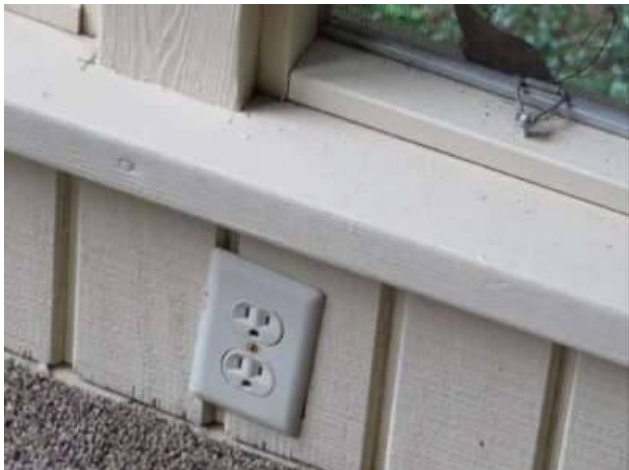
Photo 3-5 Rear Covered Deck - outlet(s) are not waterproof & should be GFCI (zoom view)

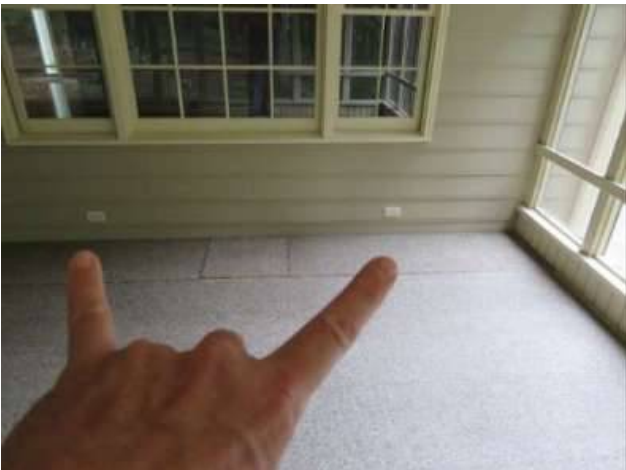
Photo 3-6 Rear Covered Deck - outlet(s) are not waterproof & should be GFCI

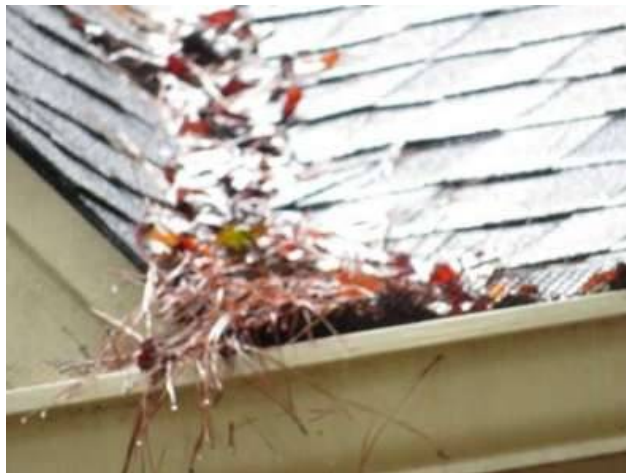
6) 🧰 Significant amounts of debris have accumulated in one or more gutters. Recommend cleaning gutters now and as necessary in the future.

Photo 6-2 Gutter(s) - excess organic debris

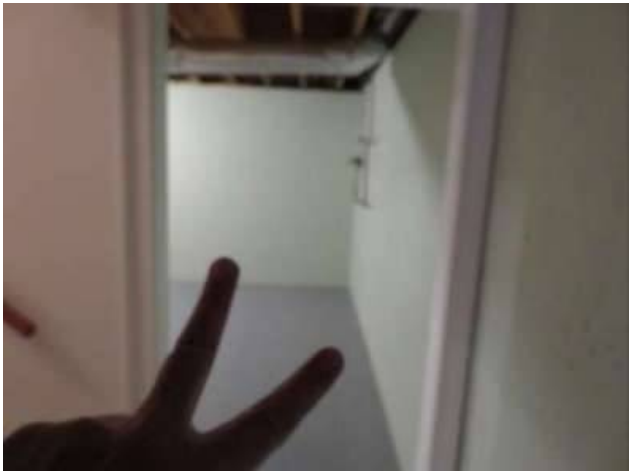
7) 🛠️ Garage/Basement House Door(s) - should be installed

Photo 7-4 Garage/Basement - should have one-hour fire proof door(s) & should be properly weatherstripped

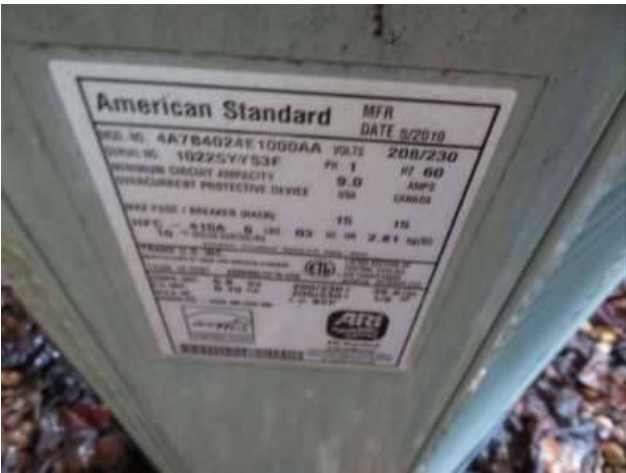
13) The estimated useful life for exterior air conditioning and/or heat pump compressors is 10 to 15 years. Both units are at this age range and may need replacing at any time.

Photo 13-2 A/C Unit #2 info (2010)

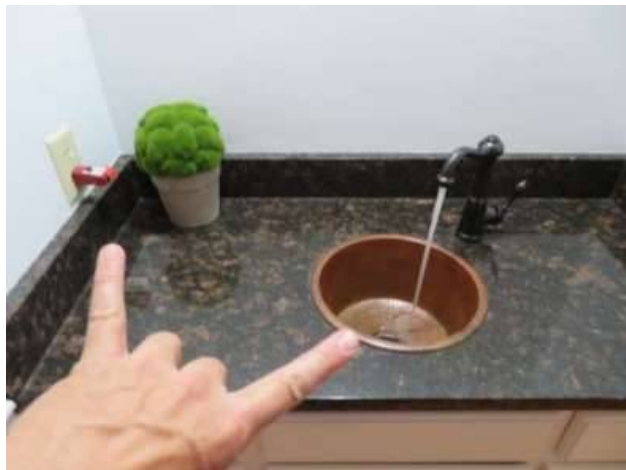
Photo 15-2 Wet Bar - outlet box should be GFCI

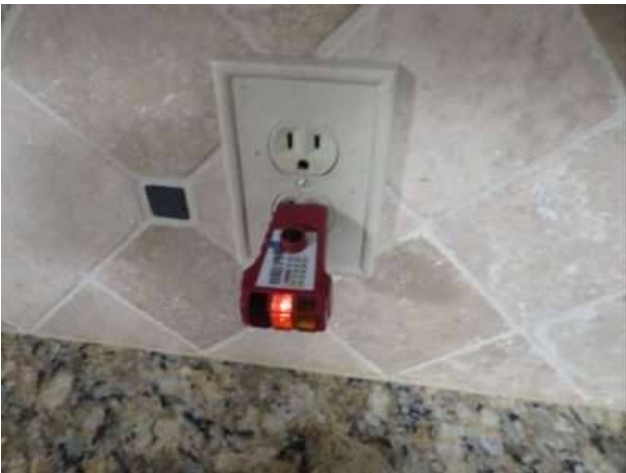
Photo 15-6 Kitchen - counter-top outlet(s) should be GFCI & some have open ground(s) (zoom view)

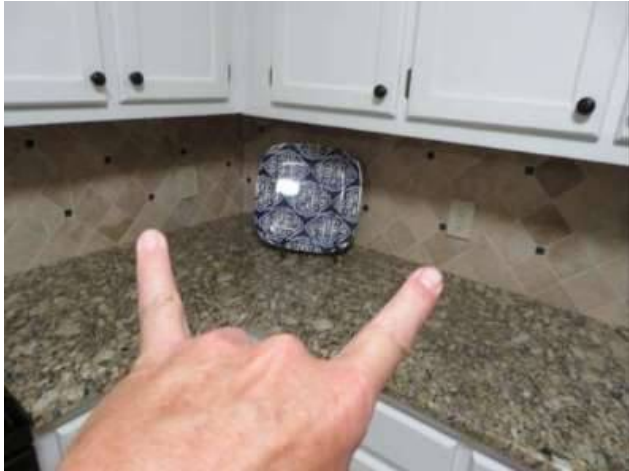
Photo 15-7 Kitchen - counter-top outlet(s) should be GFCI

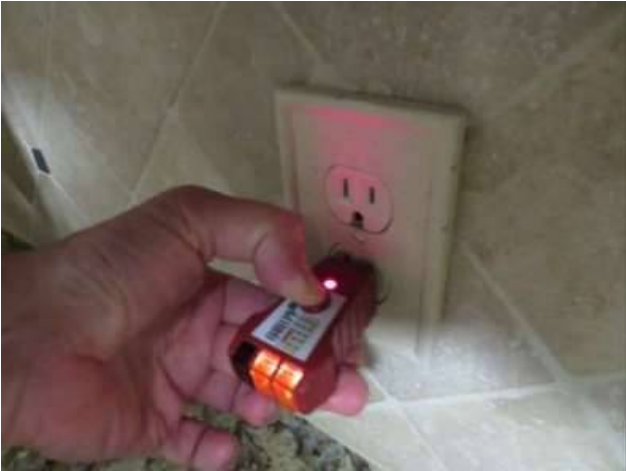
Photo 15-8 Kitchen - counter-top outlet(s) should be GFCI (zoom view)

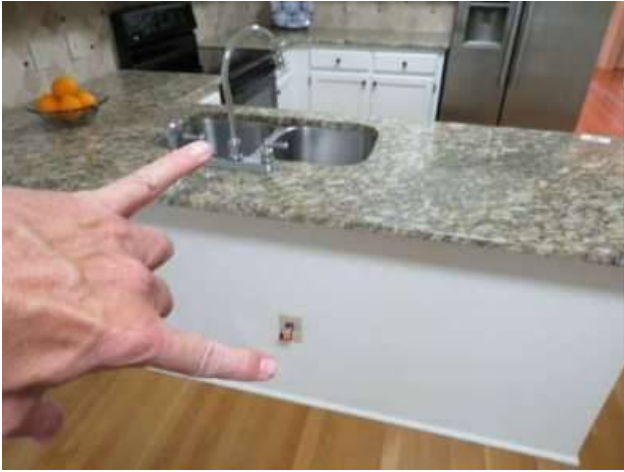
Photo 15-9 Kitchen - outlet(s) within 6' of sink should be GFCI

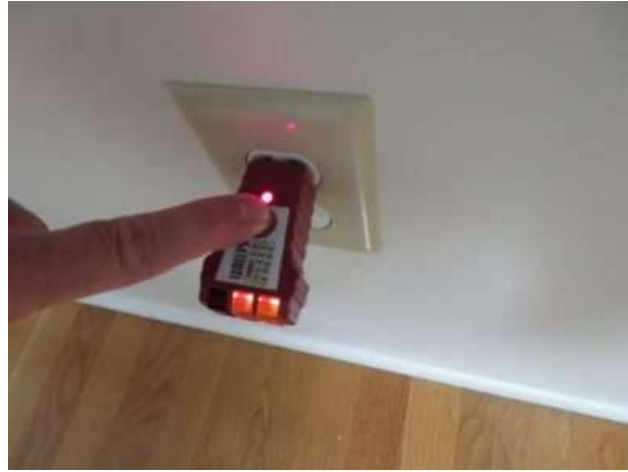
Photo 15-10 Kitchen - outlet(s) within 6' of sink should be GFCI (zoom view)

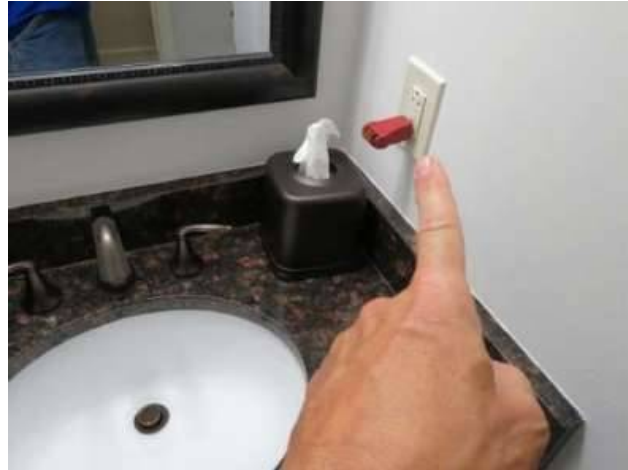
One or more ground fault circuit interrupter (GFCI) receptacles are tripped and won't reset. This is a safety hazard and may pose a risk of fire and/or shock. Recommend having a qualified, licensed electrician evaluate and make repairs as necessary.

Photo 16-2 Powder Room GFCI Outlet Box - tripped & won't reset

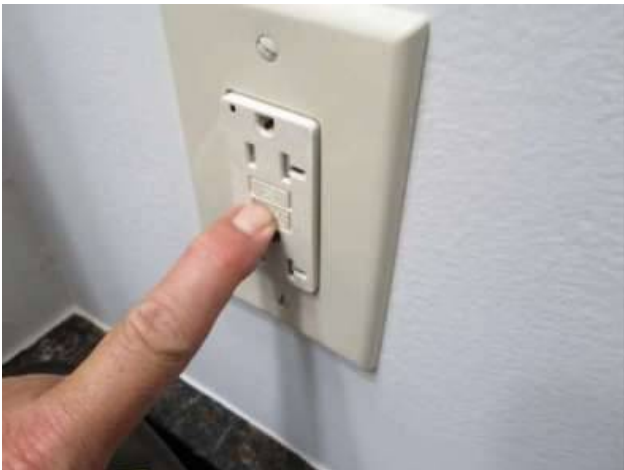
Photo 16-3 Powder Room GFCI Outlet Box - tripped & won't reset (zoom view)

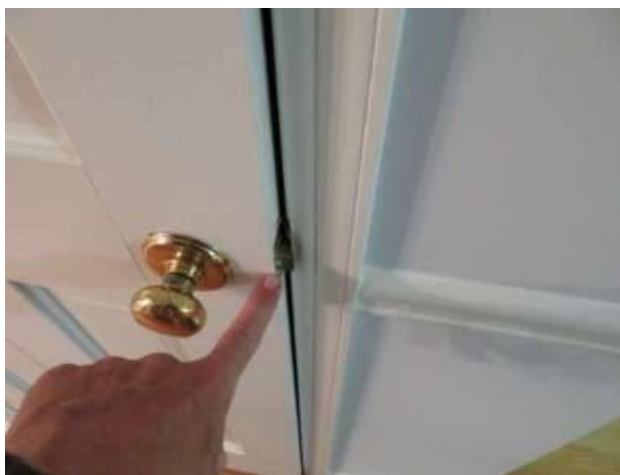
Photo 19-4 Kitchen Pantry Entrance - door binds at latch

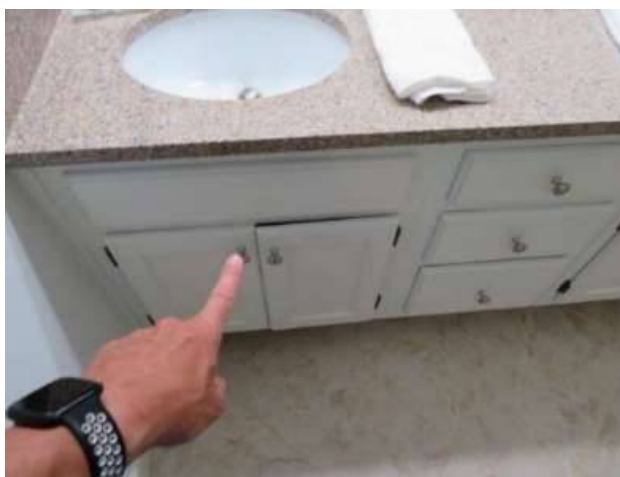
Photo 19-6 Master Bathroom Cabinet(s) - bind at adjacent door(s)

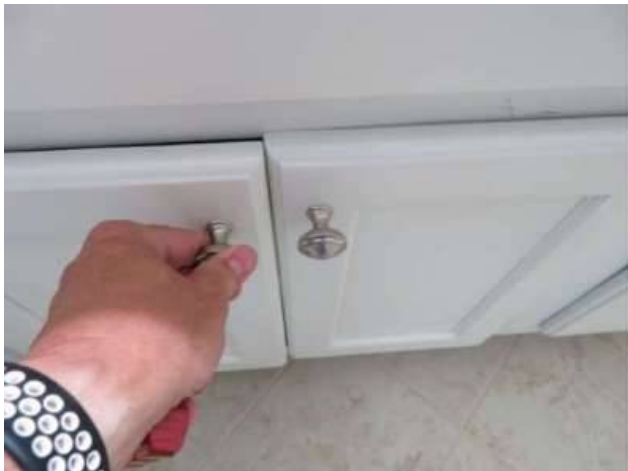
Photo 19-7 Master Bathroom Cabinet(s) - bind at adjacent door(s) (zoom view)
