Inspection Report

**339 South Esplanade
Alpharetta, Georgia 30009**

Inspection Date September 10, 2020
Inspector Jay Cao
www.HouseChecked.com
jc@housechecked.com
(678) 557-8958
interNACHI Certified Inspector, GA Registered Professional Engineer

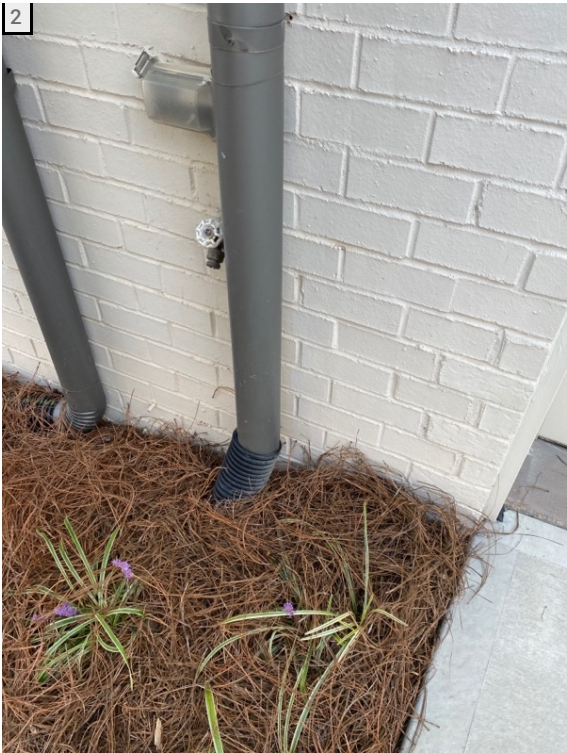
3. Downspout(Exterior: Ground View): Elbow(s) are not properly connected

all the downspout extenders going into the grade should be checked for clogging, clean as need

Location	Exterior: Ground View
Impact	Improper connections prevent water drainage is not optimally contained
Suggested Action	Secure or replace the elbow connector
Other Information	The elbow connector should be securely fastened to prevent the elbow from coming loose and assure a leak-free elbow

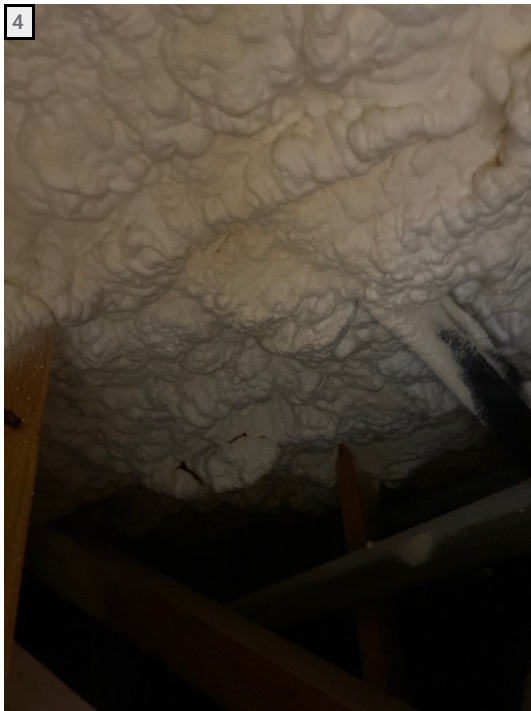
Location Attic

Roof Sheathing

Possible Concern

covered by foam insulation

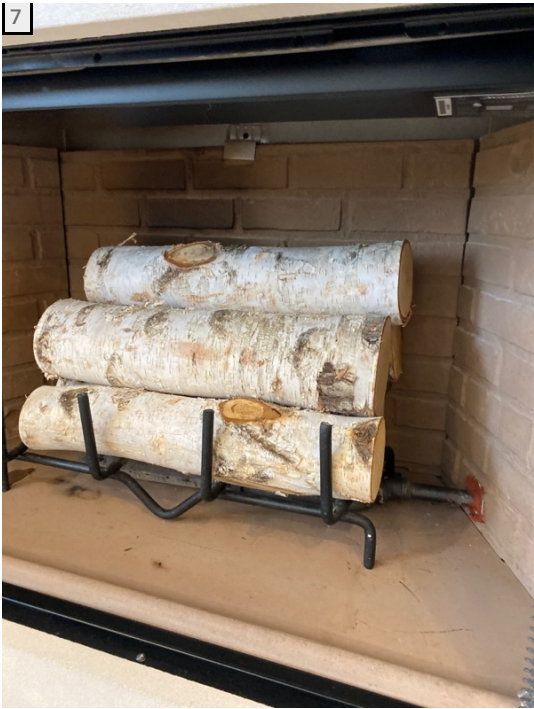
In Working Order
due to limited access of the chimney, only about 20% of the system can be visually checked, for the whole system condition assessment, qualified contractor should be hired.
Location Living Room

In Working Order
working condition
Location Living Room

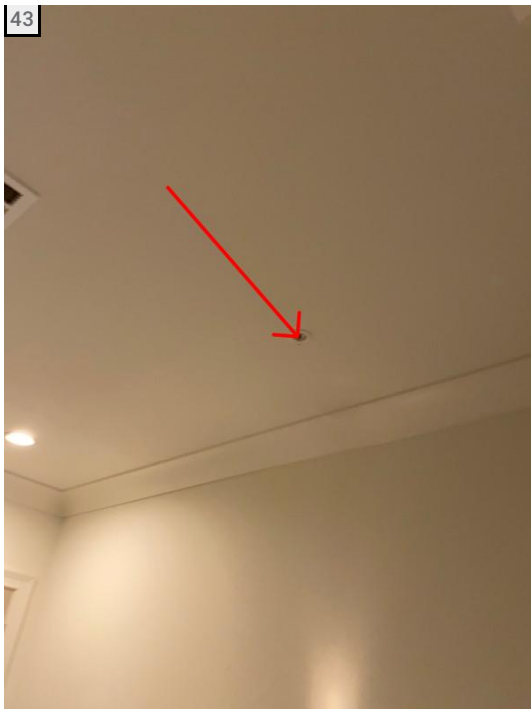
Location Hallway and Stairs

all the smoke alarms and CO alarms throughout the house shall be tested at the time of moving in, current code requires each bedroom shall have smoke detector, older house without major renovation doesn't need to meet this requirement but it is strongly recommended

centralized fire alarm system noted

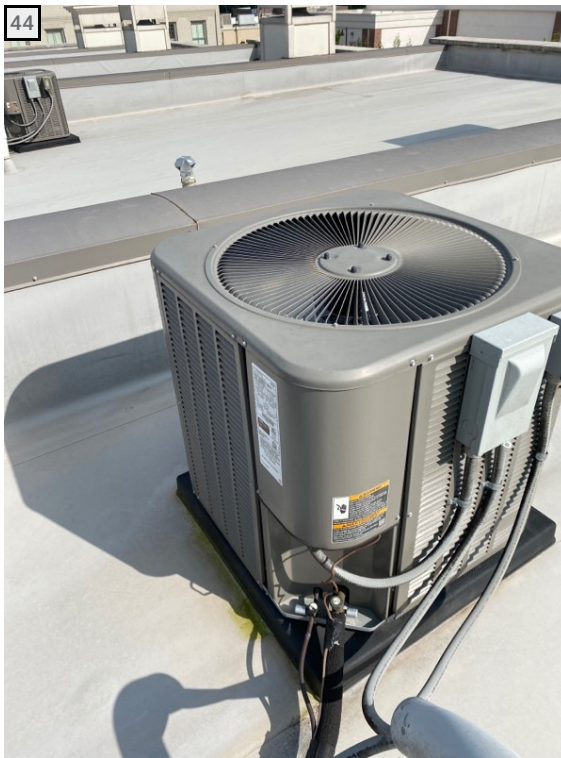
Location Exterior: Roof View

ac cooling appear working at the time of inspection, it did have sufficient cooling, photos were taken at 60F set point

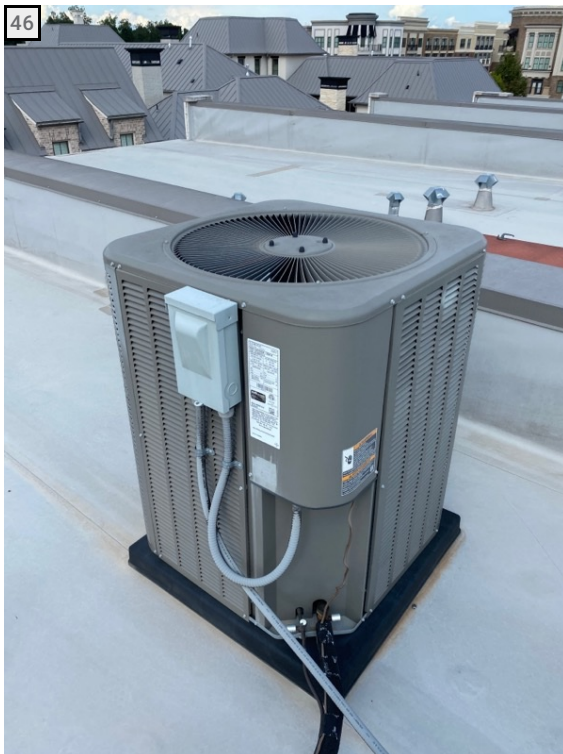
Location Exterior: Roof View

ac cooling appear working at the time of inspection, it did have sufficient cooling, photos were taken at 60F set point

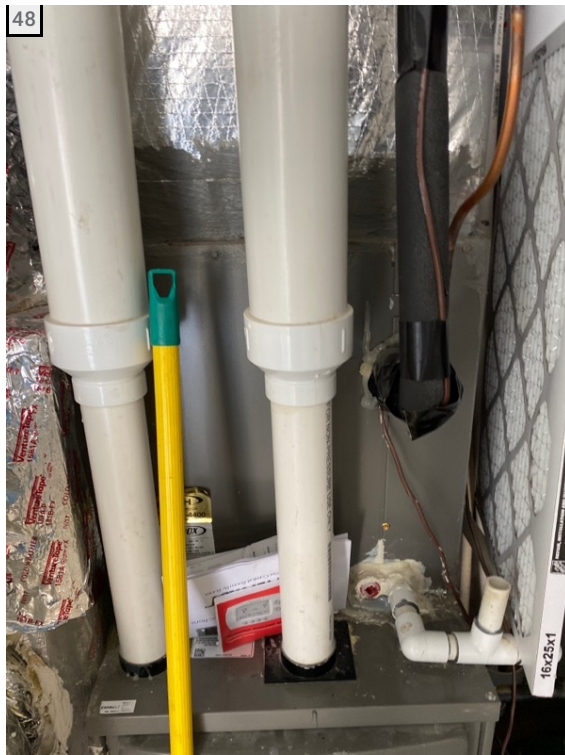
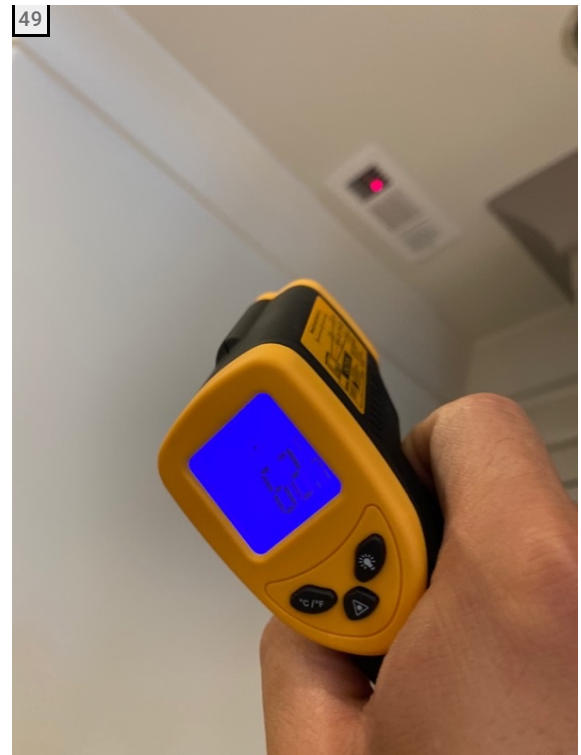
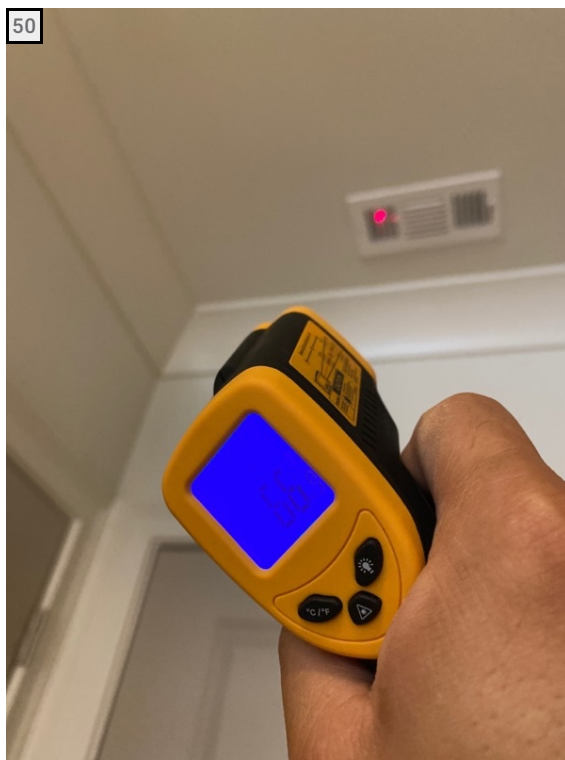
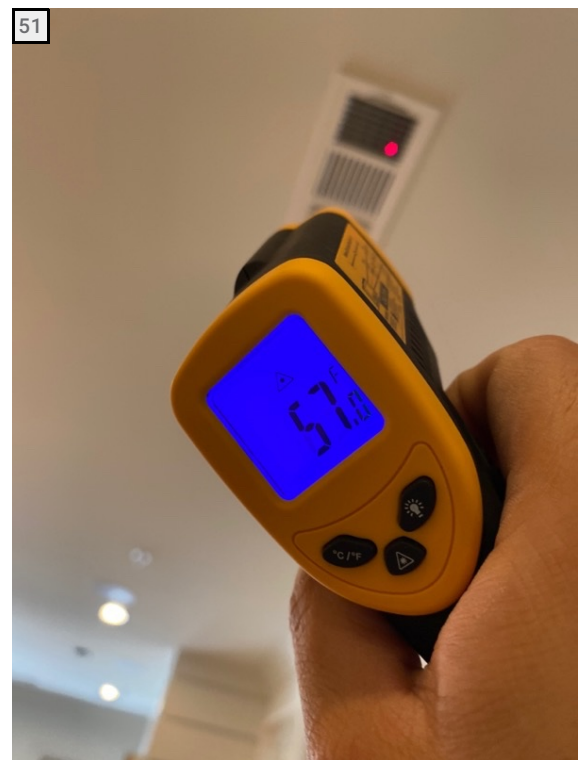
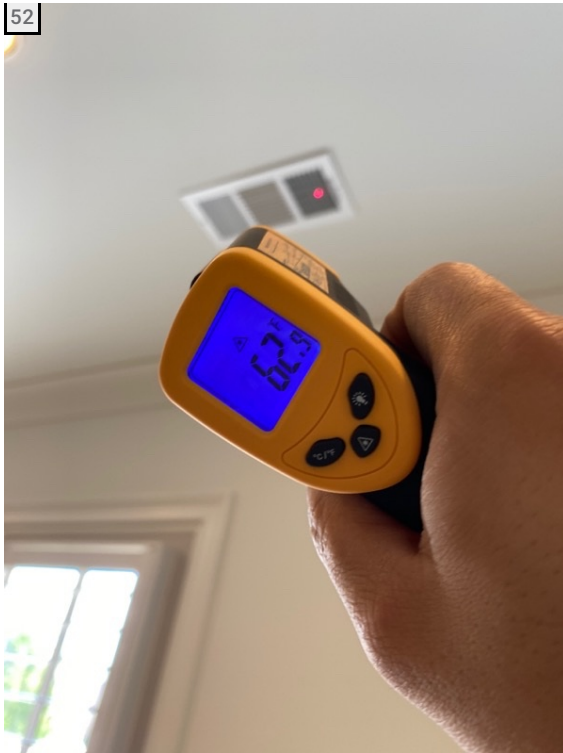
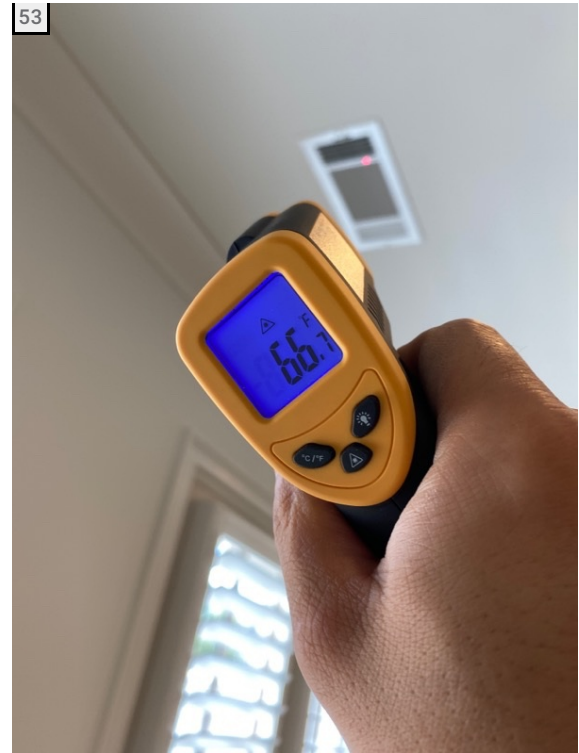
**✓ AC-Evaporator Coil 1****In Working Order****AC cooling was turn on, AC appeared in working condition. set point was 60F****Location** Attached Garage

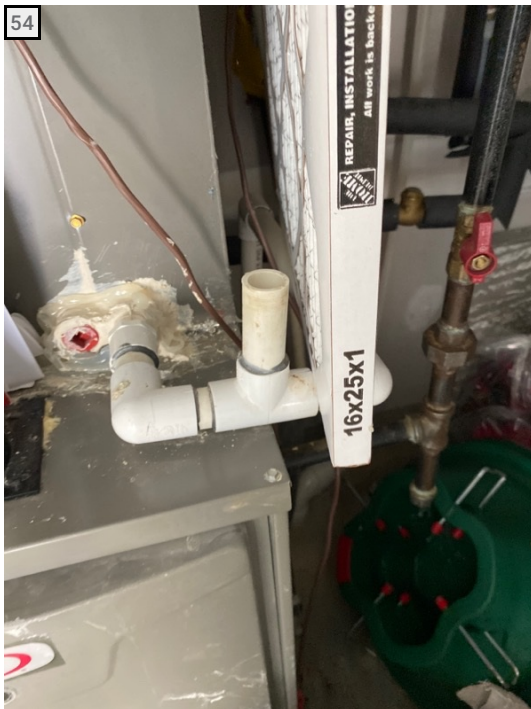
Location Attached Garage

condensate line has a good slope

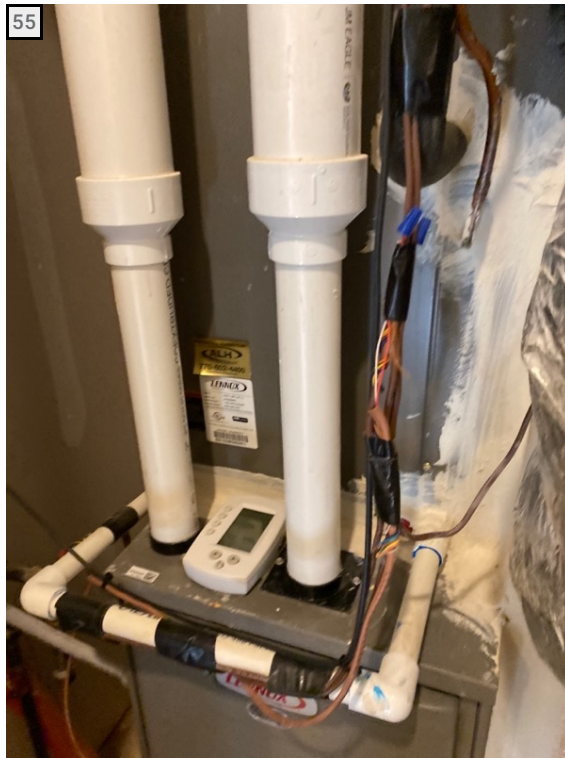
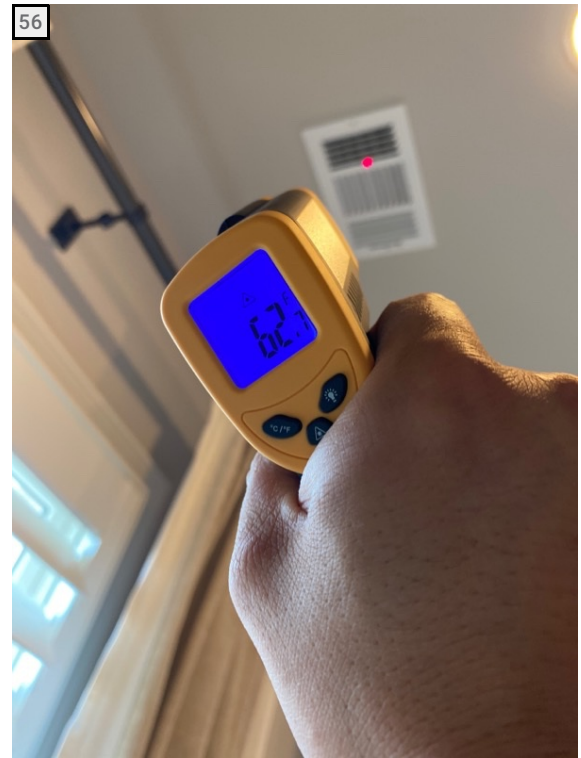
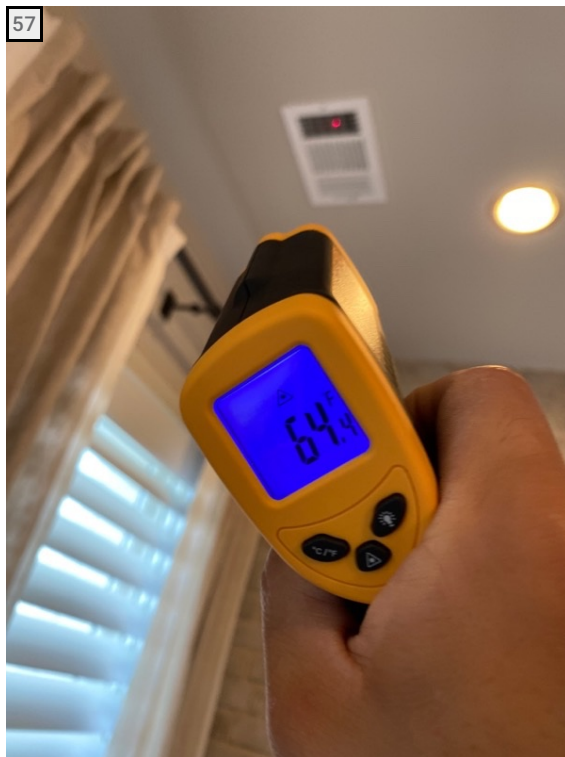
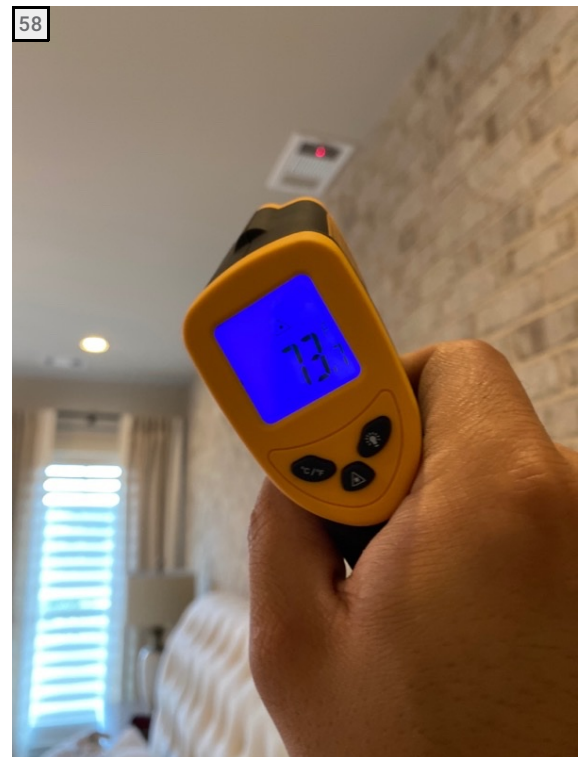
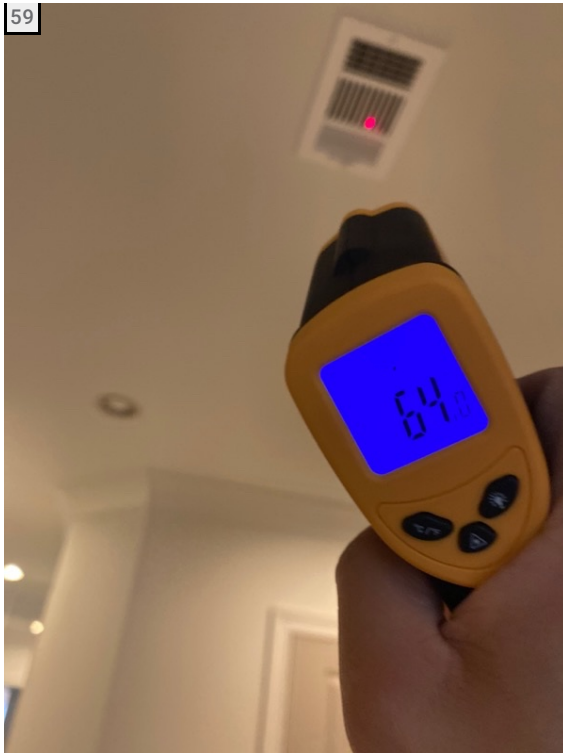
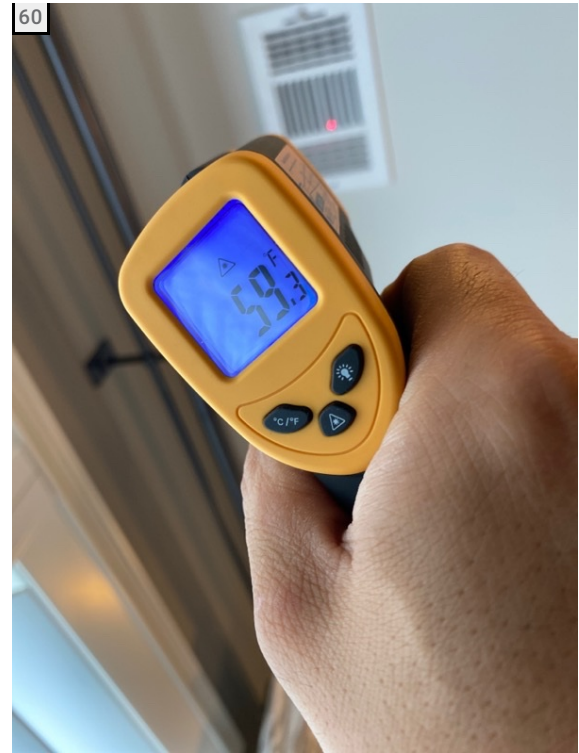
Location Utility Room

✓ **AC-Evaporator Coil 2**

AC cooling was turn on, AC appeared in working condition. set point was 60F

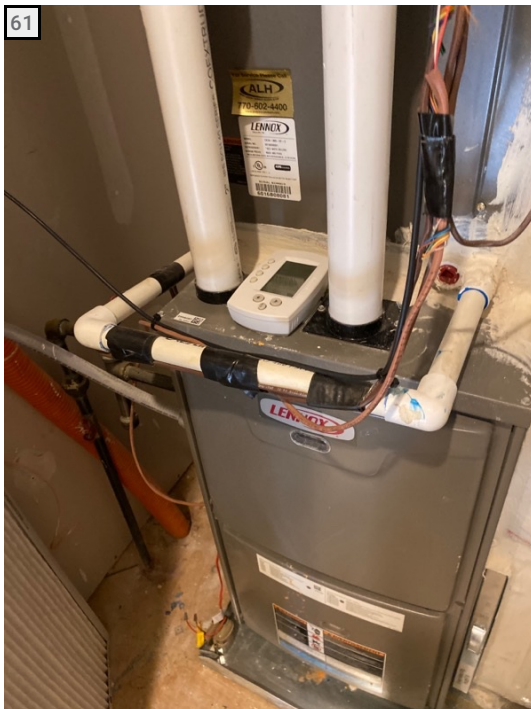
Location Utility Room

condensate line has a good slope

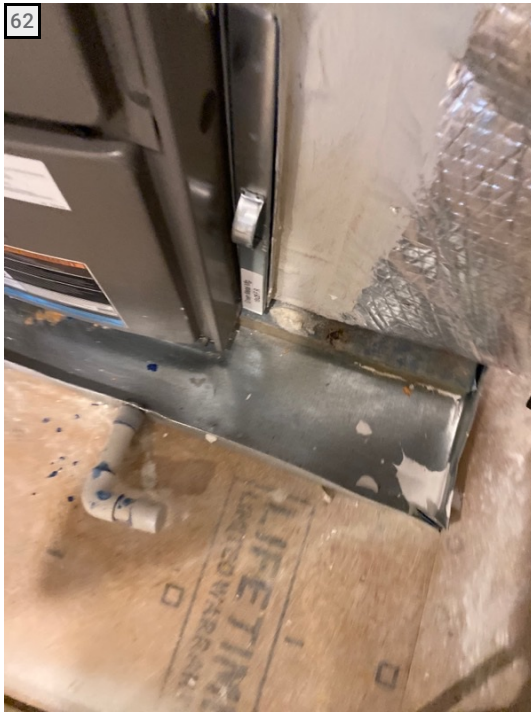
Location Utility Room

wet pan is clean, no water signs

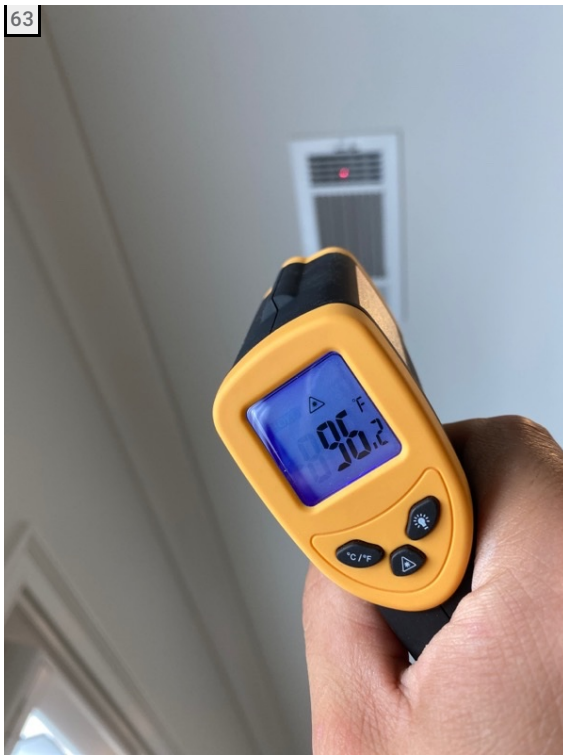
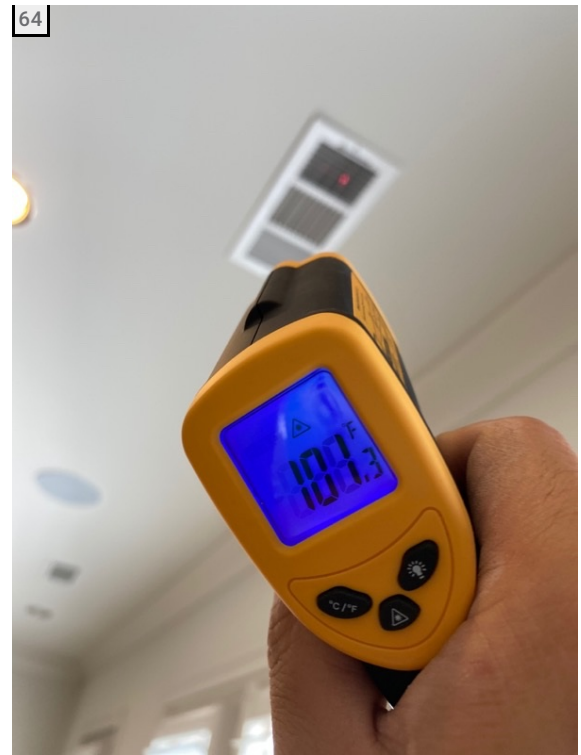
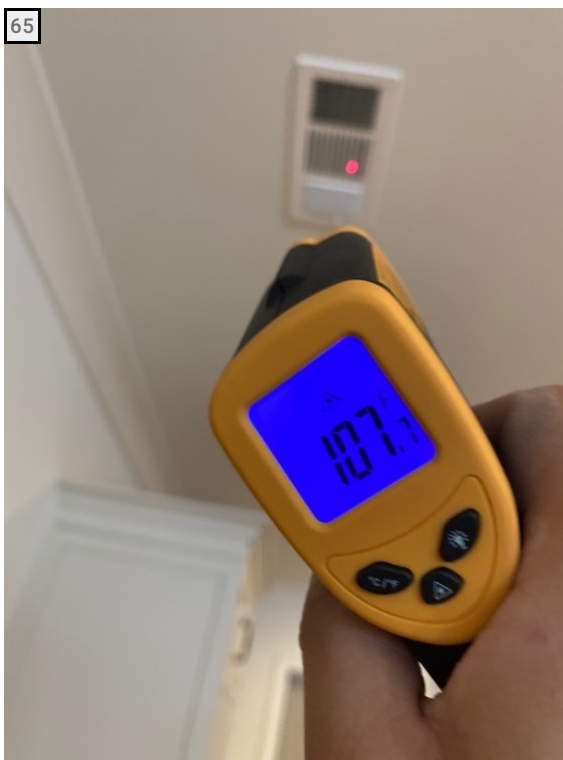
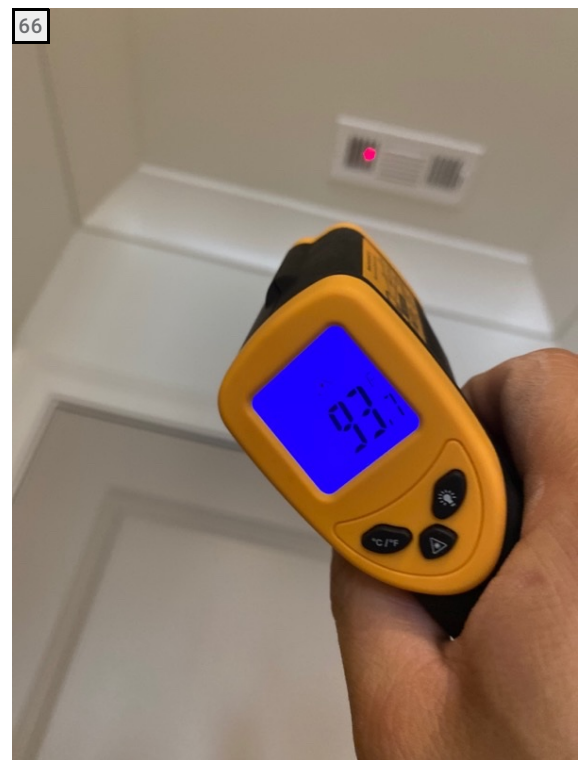
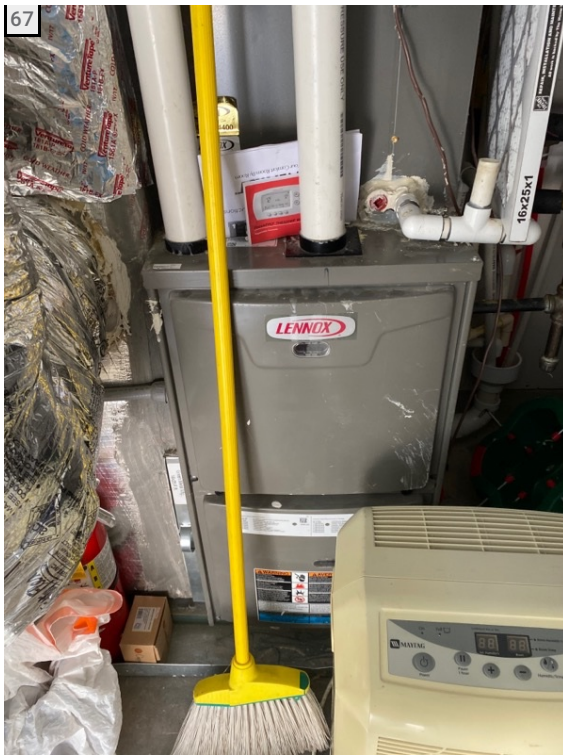
Location Attached Garage

Unit was in working condition at the time of inspection set point was 80F

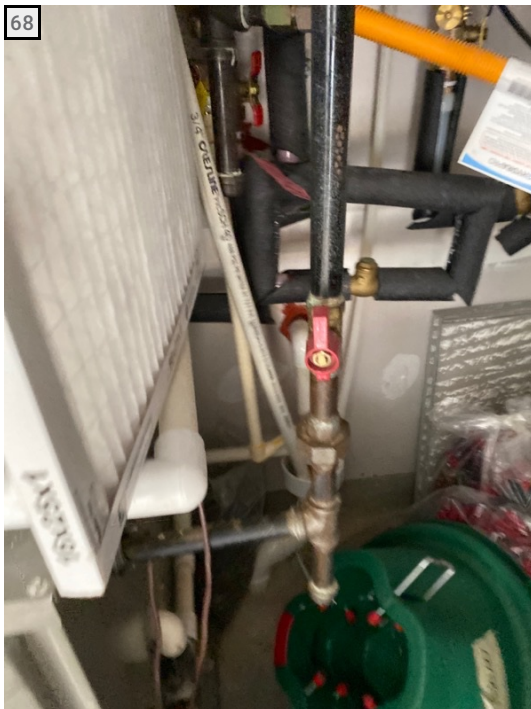
Location Attached Garage

furnace main gas shut-off valves noted

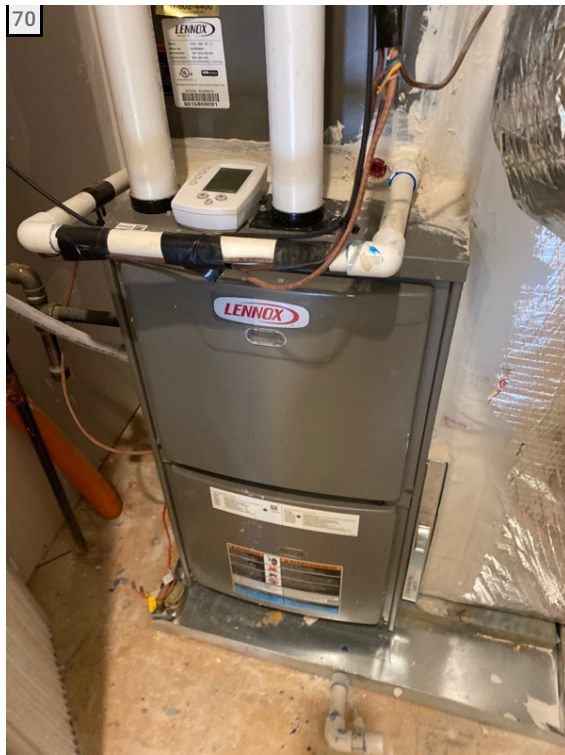
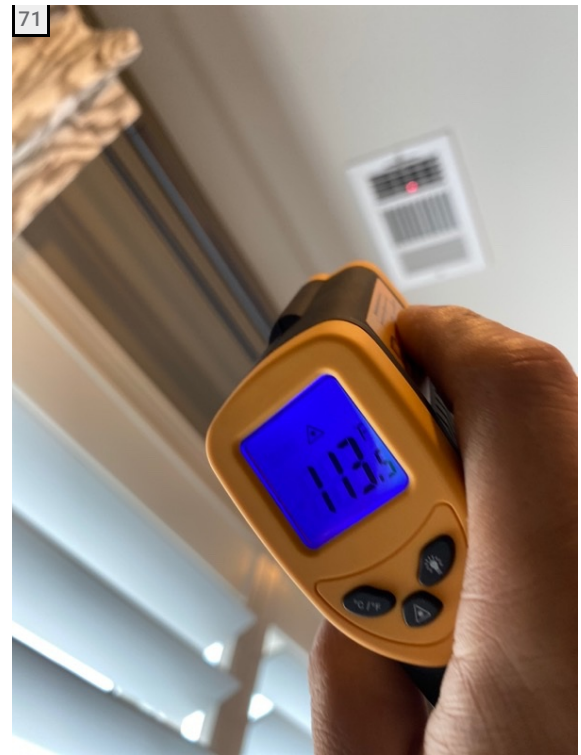
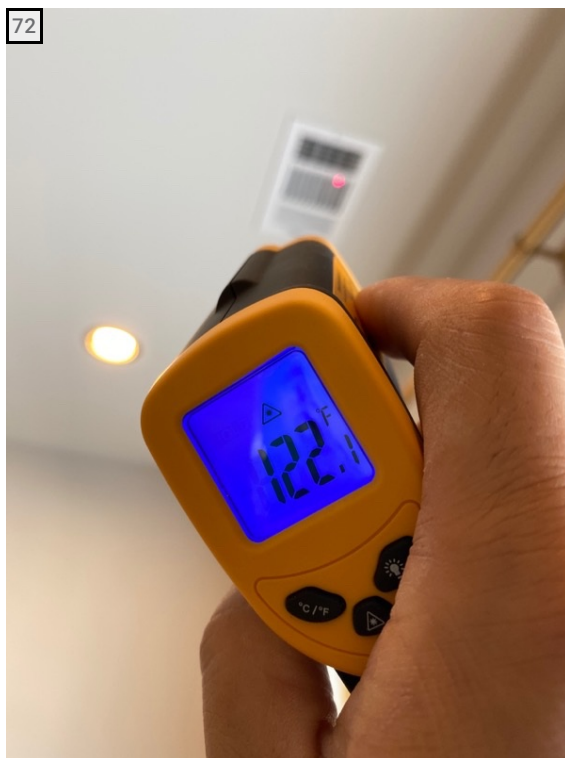
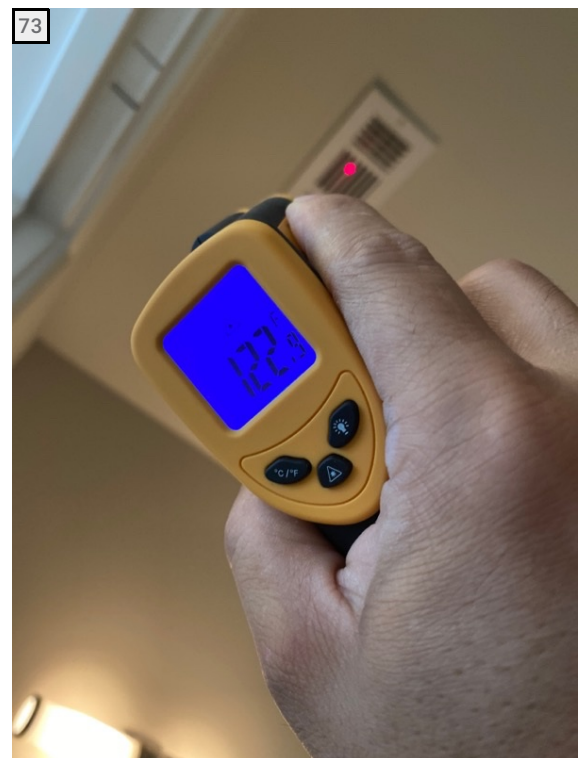
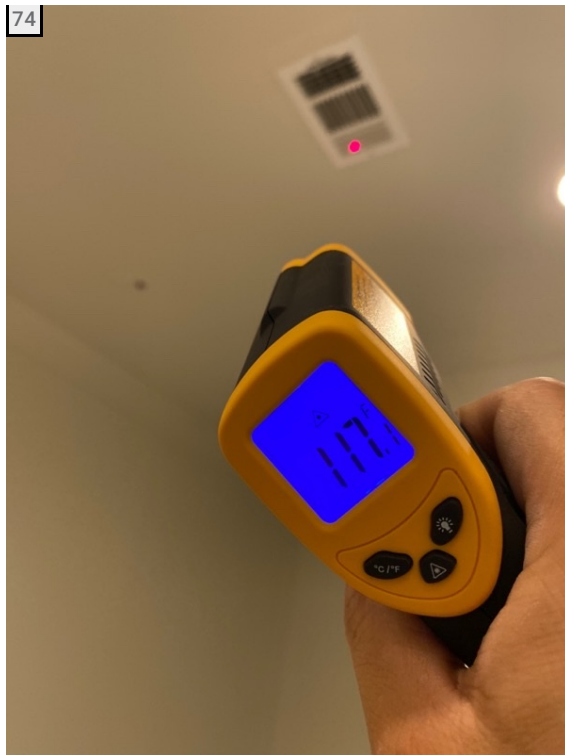
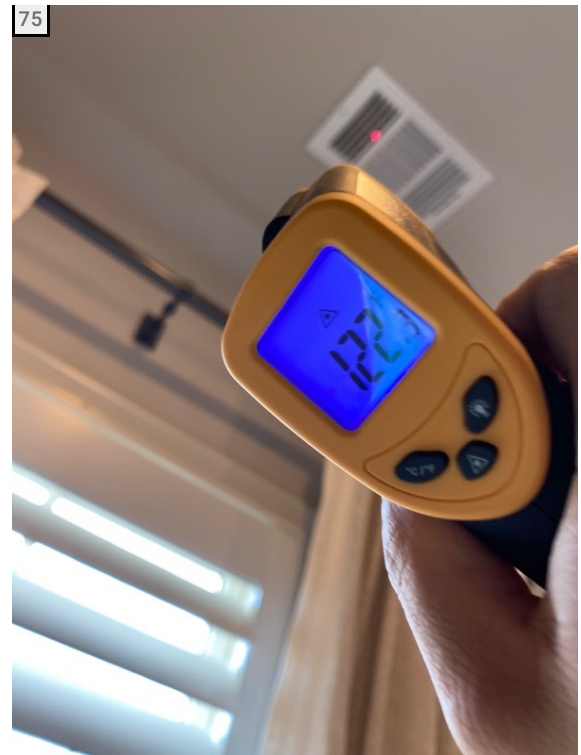
Location Utility Room

disconnect switch is missing

Unit was in working condition at the time of inspection set point was 80F

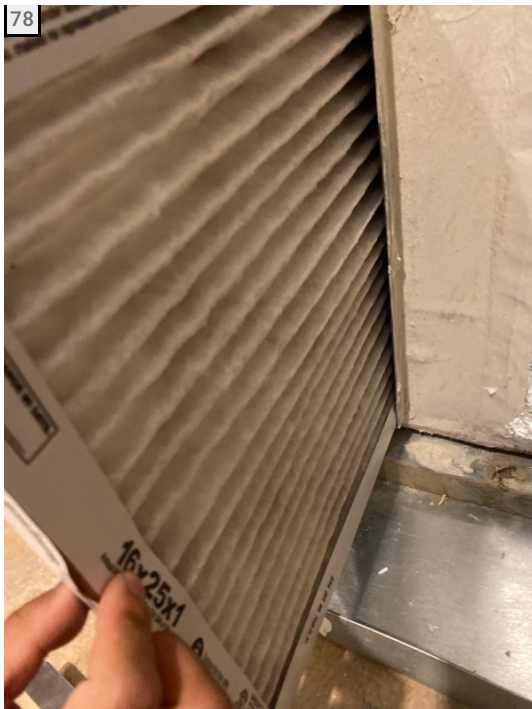
Location Utility Room

air filter appeared clean

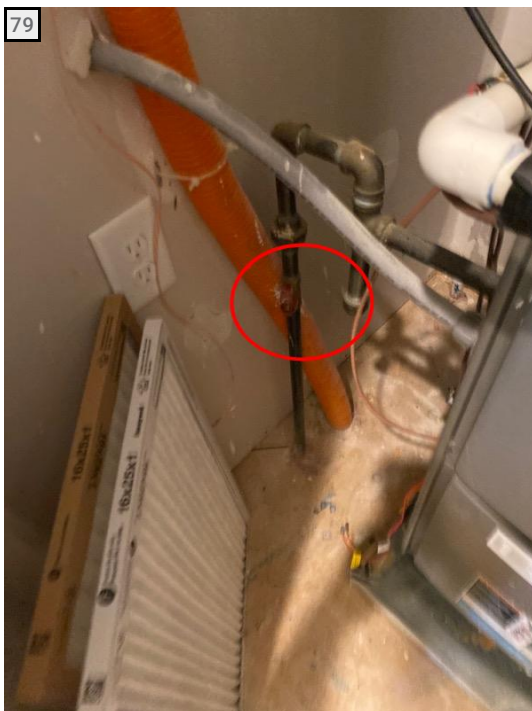
Location Utility Room

furnace main gas shut-off valves noted

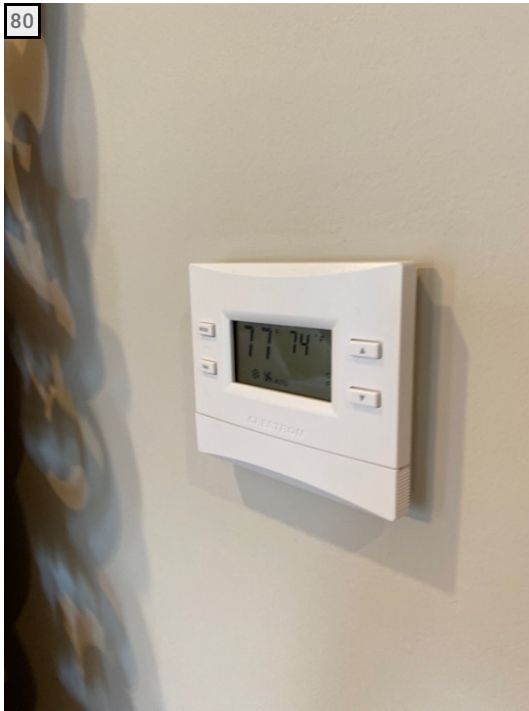
In Working Order**working condition****Location** Master Bedroom

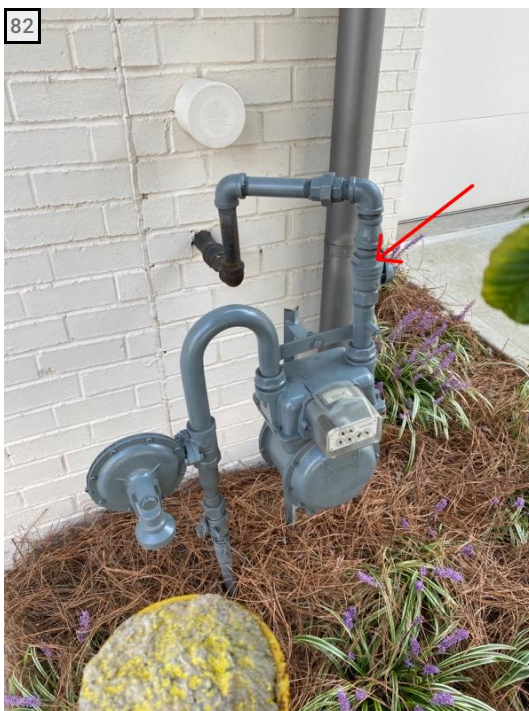
Location Exterior: Ground View

main gas cutoff valve noted

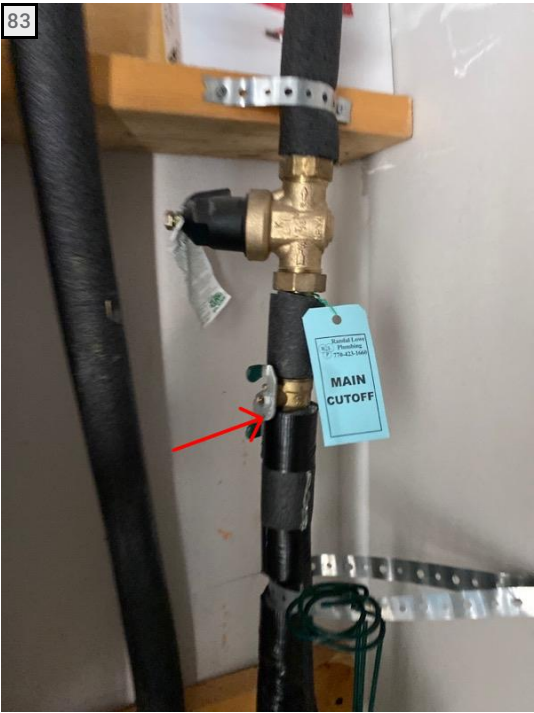
Location Attached Garage

main water cut valve noted

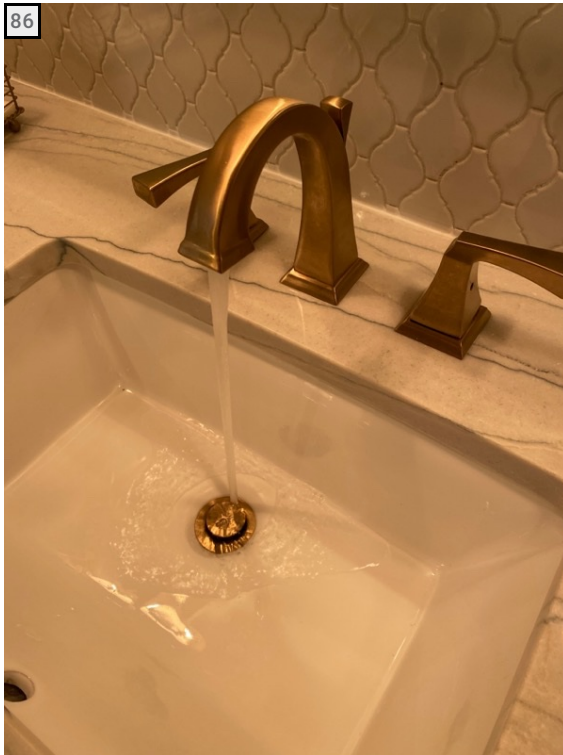
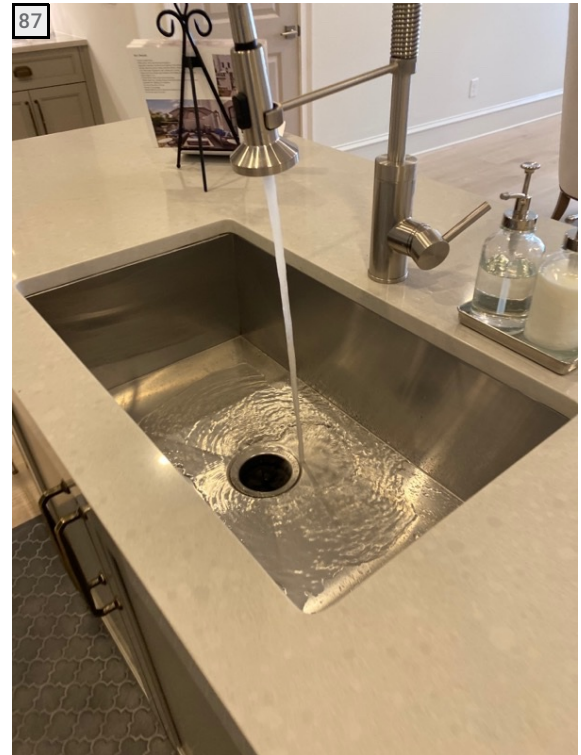
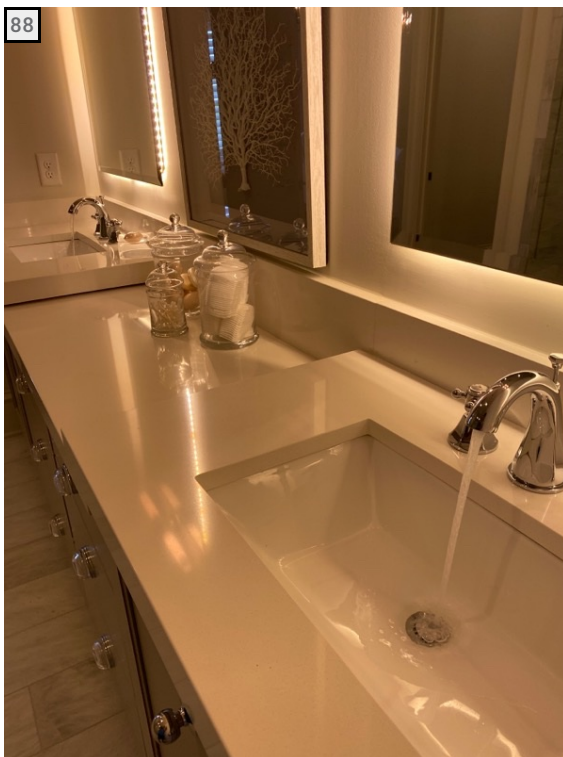
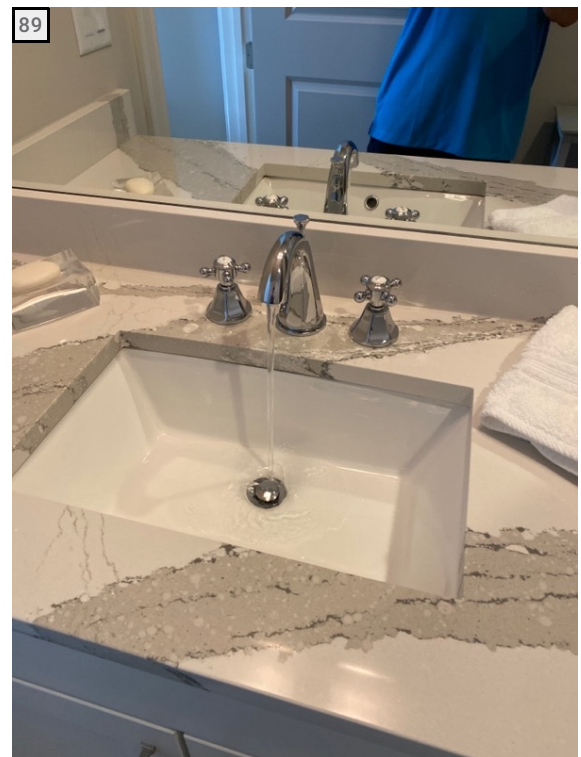
In Working Order**working condition****Location** Master Bathroom, Kitchen, Partial Bathroom, 3rd Bathroom

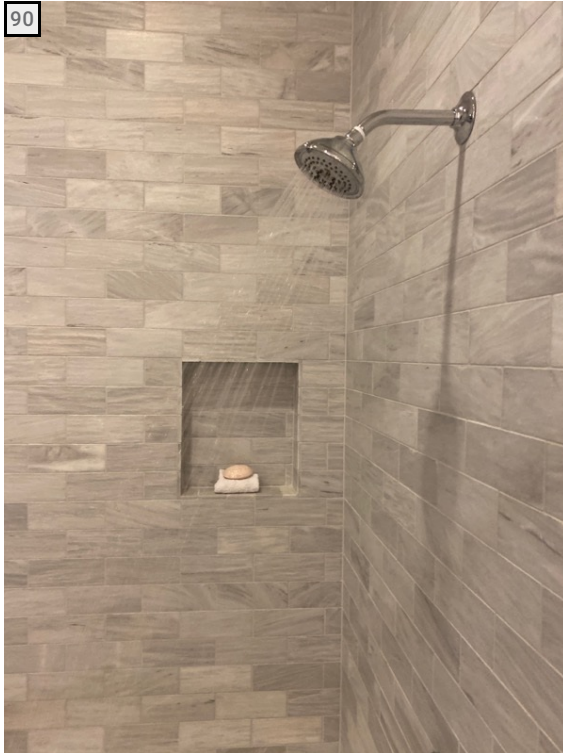
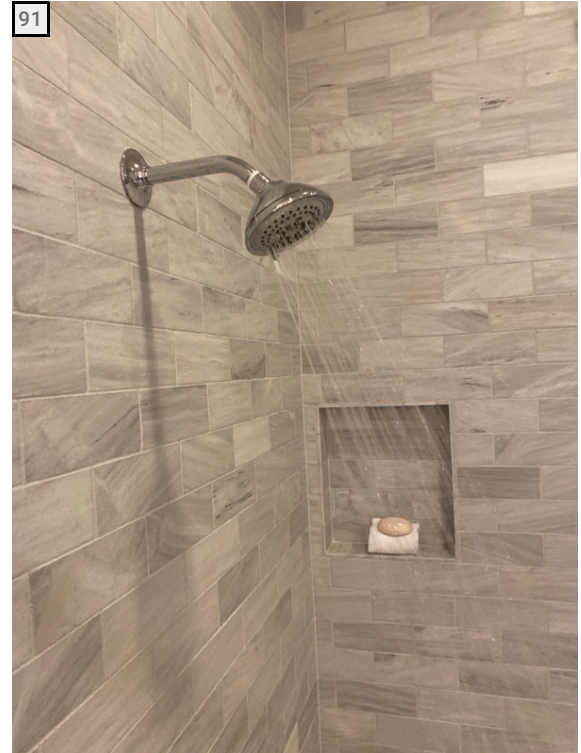
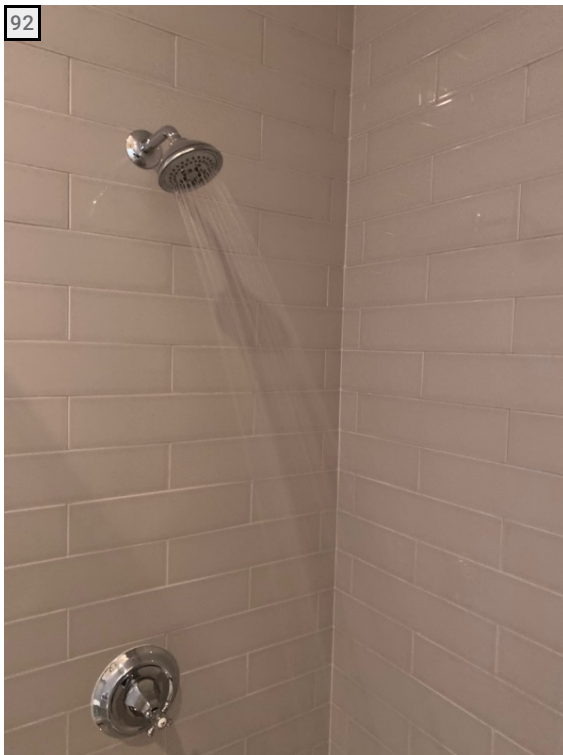
**✓ Stand-alone Shower**

In Working Order**working order****Location** Master Bathroom, 2nd Bathroom

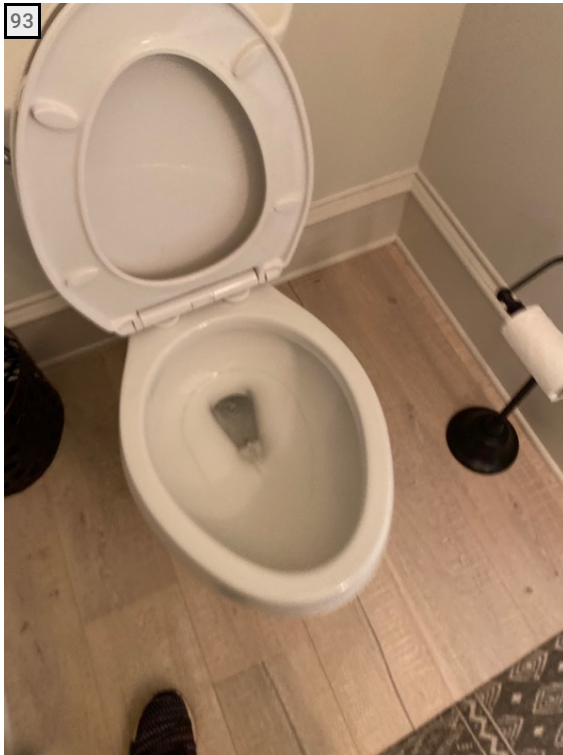
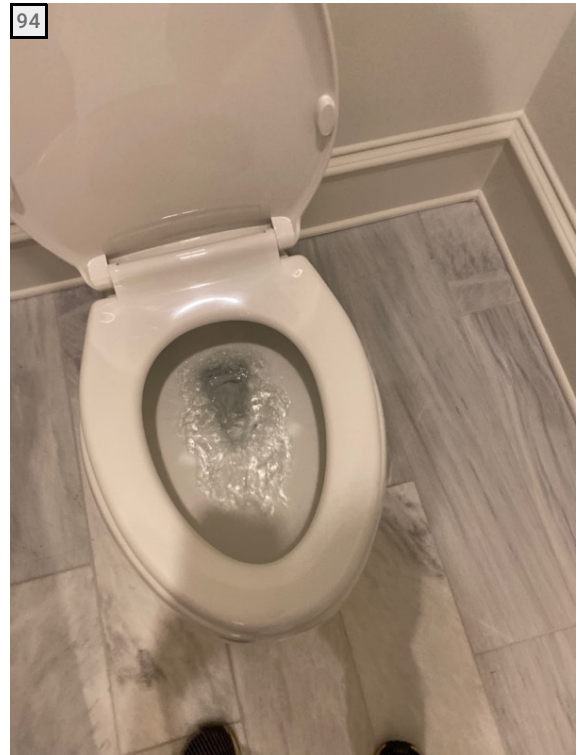
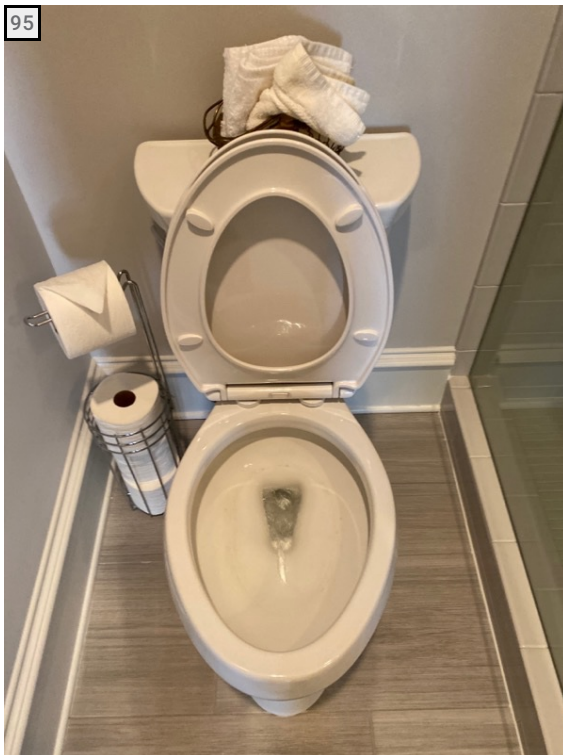
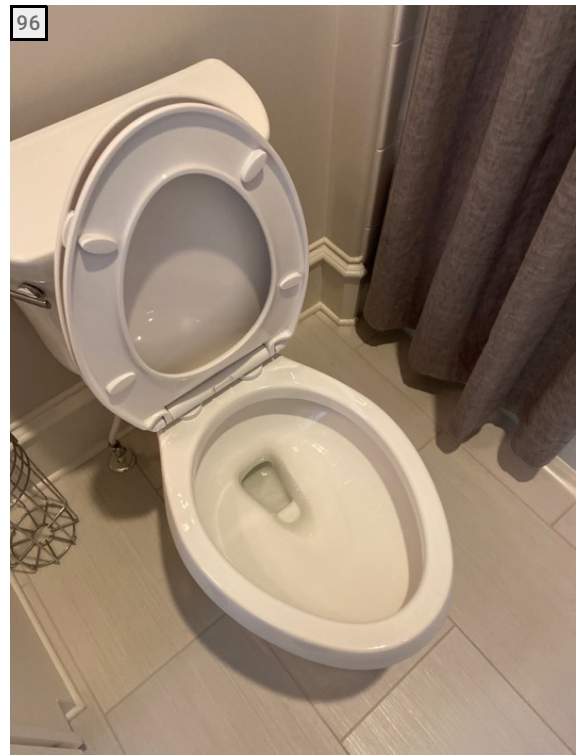
**Toilet**

In Working Order**working order****Location** Master Bathroom, Partial Bathroom, 2nd Bathroom, 3rd Bathroom

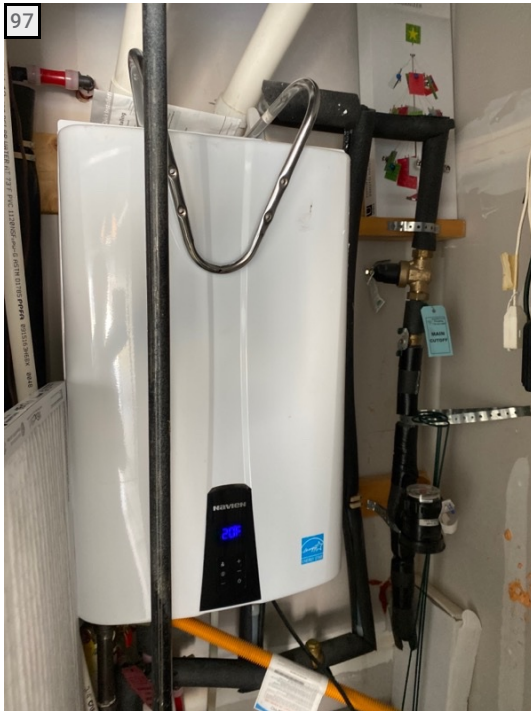
**✓ Water Heater**

In Working Order

appear working at the time of inspection

Location Attached Garage

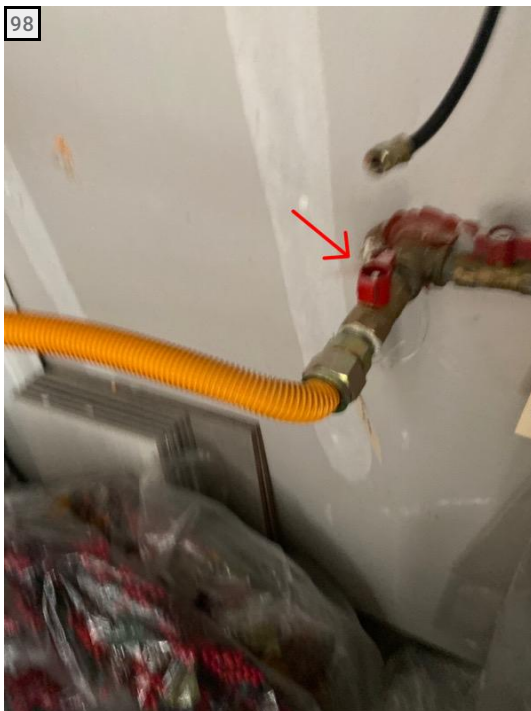
In Working Order

gas shut valve noted

Location Attached Garage

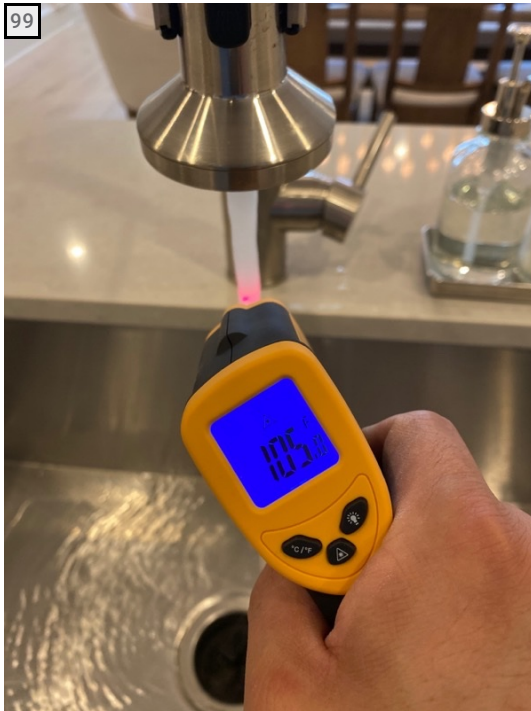
In Working Order

temperature is in normal range

Location Attached Garage
