# **Trademark Home Inspections**

Property Inspection Report

**162 Highgrove Dr, Suwanee, GA 30024**

**Date of Inspection: 10/2/2020 Time: 9:00 AM**

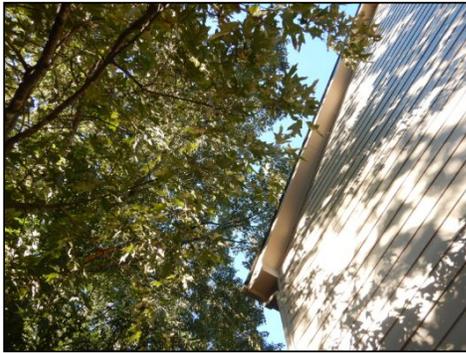
Tree limbs within 10 feet of roof should be trimmed away to provide air and sunlight to roof, while minimizing debris & dampness. Also helps rodent gaining access to roof structure.

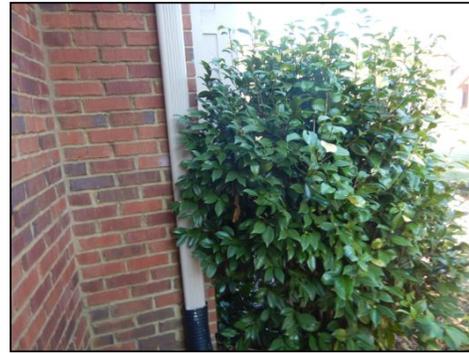
Prune vegetation back a minimum of 18 inches away from the structure.

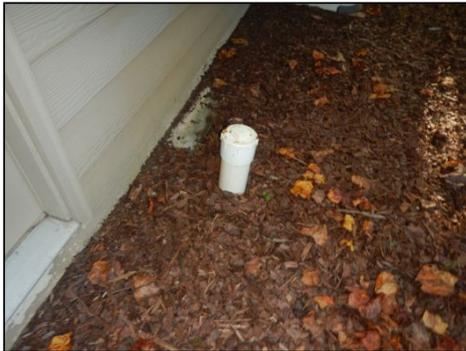
Waste line clean out noted.

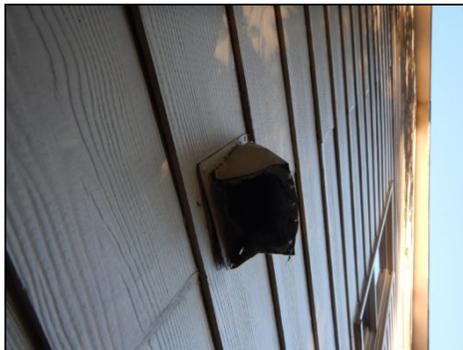
Vent flapper stuck open or missing noted. This may invite insect activity such as bees nest. This also can be a potential fire hazard. In the interest of safety, Recommend repair or replacement by qualified contractor.

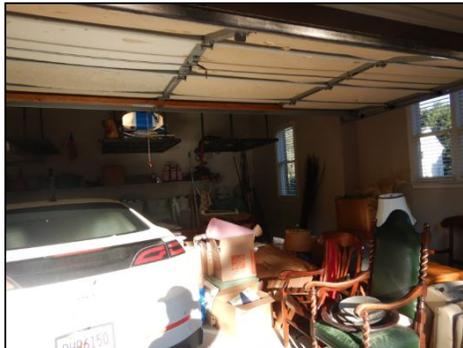
Visible areas observed were functional. Entire area not visible at time of inspection.

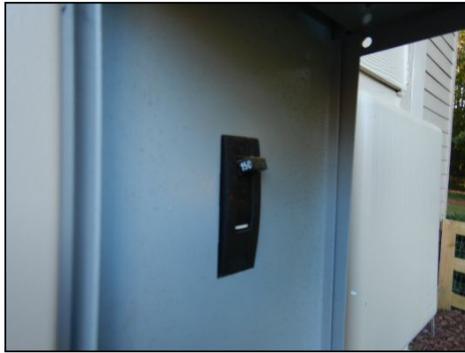
150 amp main breaker noted on exterior side of home.

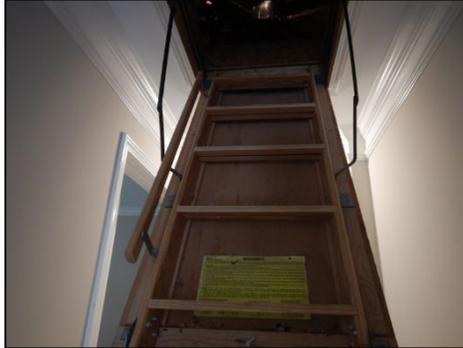
Attic access not insulated and should be addressed for energy efficiency.

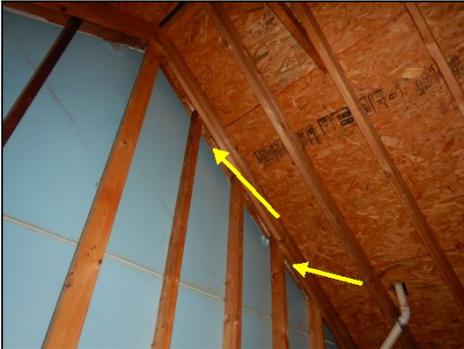
Construction gap observed. Recommend sealing to prevent moisture intrusion and wildlife entry. Recommend review and repair by qualified contractor.

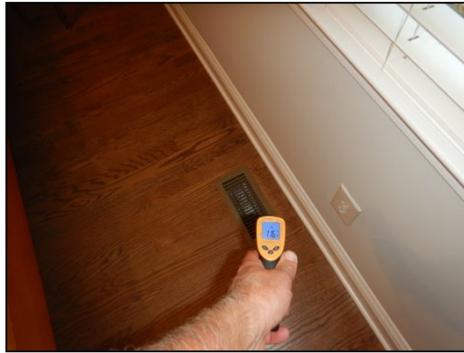
Acceptable heat reading noted at time of inspection. main

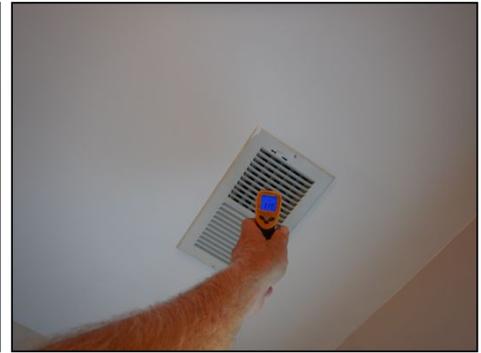
Acceptable heat reading noted at time of inspection. upstairs

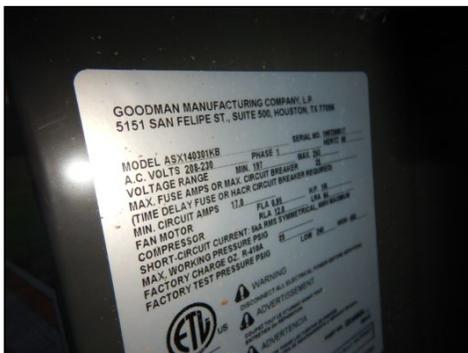
Compressor unit is a 2.5 ton system manufactured in 2019.

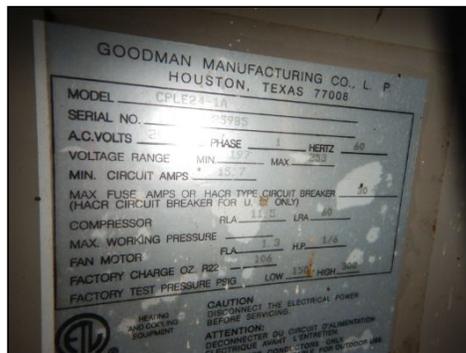
Compressor unit is a 2 ton system manufactured in 2002.

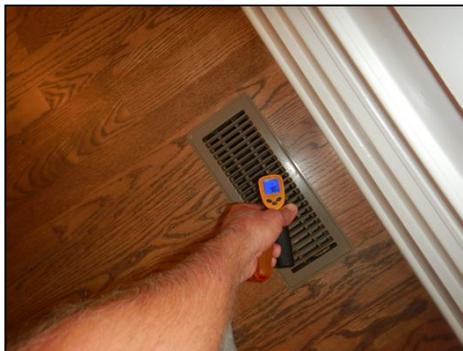
Acceptable AC reading noted. The temp differential should be 14-16 degrees from the return to the register based on industry guidelines which they are. main

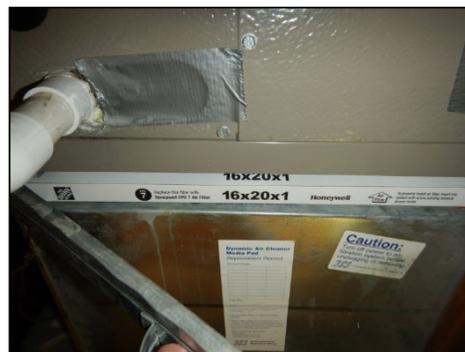
Filter functional at time of inspection.

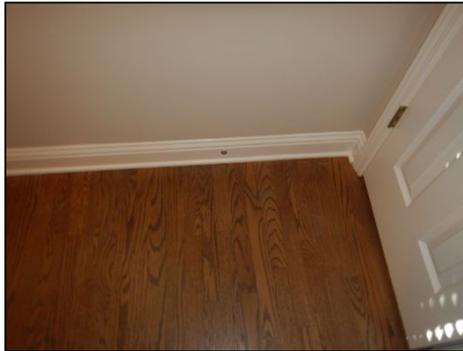
Door stop missing on several doors in the home. Recommend installing door stop to prevent damage to wall.

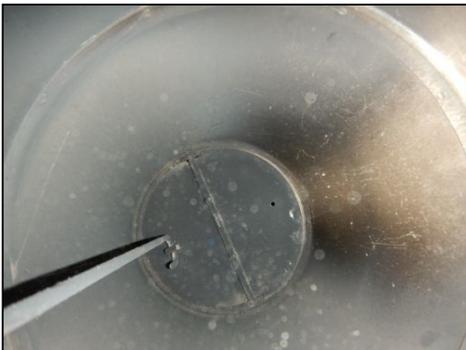
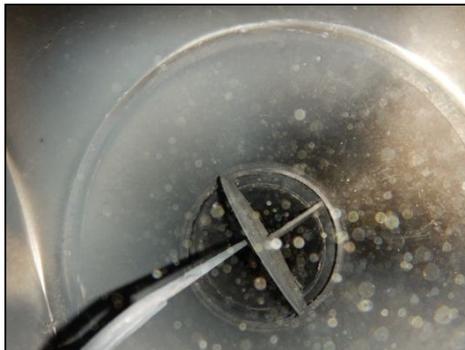
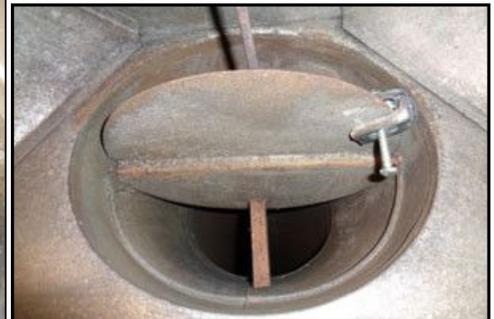
Damper worked properly at time of inspection, but missing damper clamp. This device is used when gas fireplace is in use. It prevents carbon monoxide from entering the home. Recommend installing by a qualified contractor.

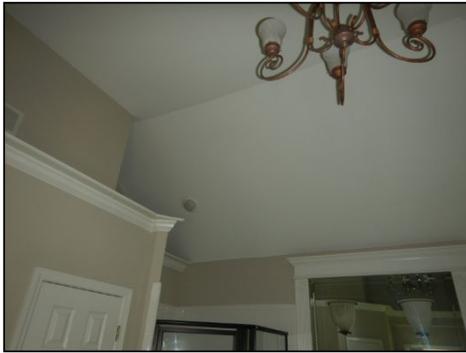
No exhaust vent noted. Due to the age of the home, windows are acceptable means of bathroom ventilation. master

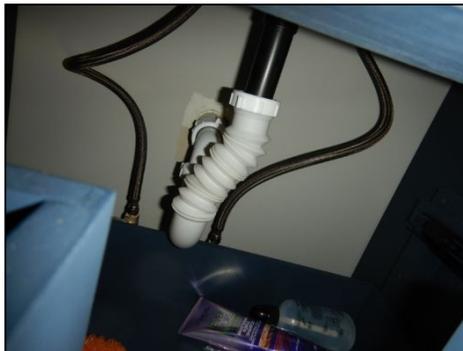
Corrugated drain pipe noted. Recommend replacement to prevent clogging of drain pipe by qualified plumbing contractor. right upstairs bath

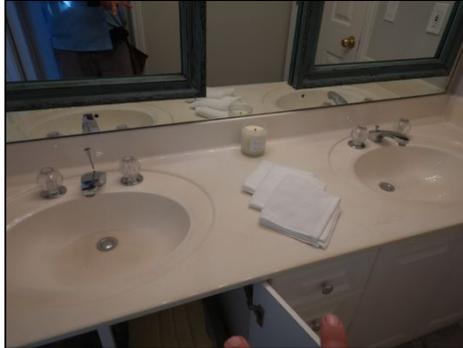
Faucet functioned properly but drain stopper missing or not operational. Could not test overflow at time of inspection. JJ bath

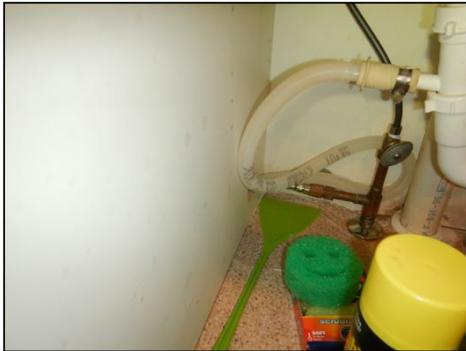
No visible air gap/high loop at dishwasher drain line, it is to keep sewer gases from entering the dishwasher. recommend repair by a qualified contractor.

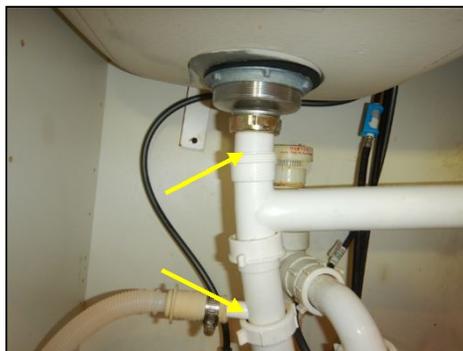
Page 29 Item: 6	Plumbing	<ul style="list-style-type: none"><li>• Drain line not installed properly. Possible water leak. Recommend repair by a qualified contractor.</li></ul>
Page 30 Item: 9	GFCI	<ul style="list-style-type: none"><li>• Outlet is not GFCI protected. In the interest of safety, locations such as garages, unfinished basements, kitchens, laundry rooms, outside area and all plumbing fixtures within 6 feet should be GFCI protected. Recommend review by qualified electrical contractor.</li></ul>

Drain line not installed properly. Possible water leak. Recommend repair by a qualified contractor.

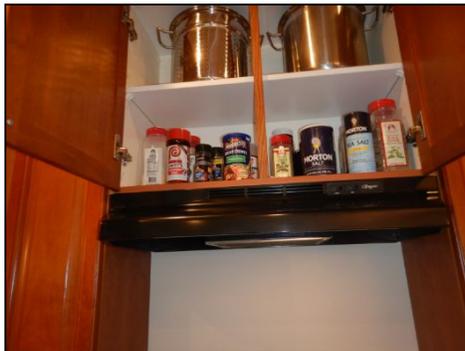
Exterior vented fan is recommended where gas appliances are in place.

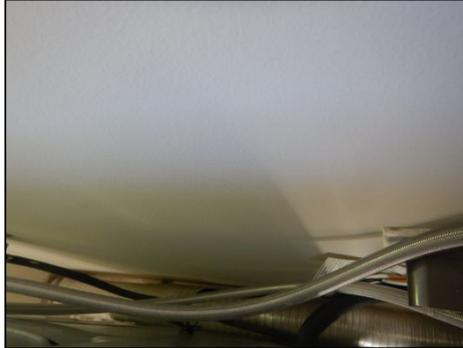
Limited view but recommend cleaning regularly to prevent potential fire hazard.

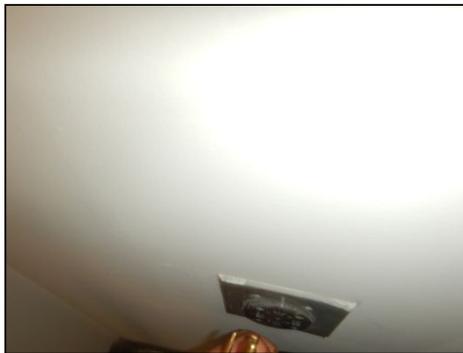
4 prong dryer outlet noted.

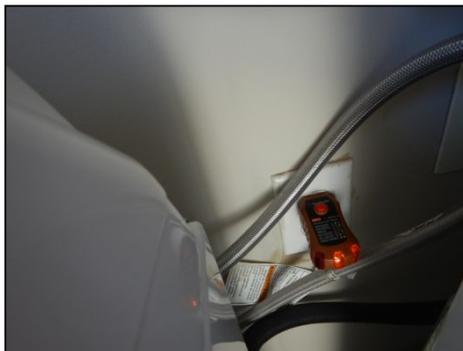
- *Outlet is not GFCI protected. In the interest of safety, locations such as garages, unfinished basements, kitchens, laundry rooms, outside area and all plumbing fixtures within 6 feet should be GFCI protected. Recommend review by qualified electrical contractor.*

Outlet is not GFCI protected. In the interest of safety, locations such as garages, unfinished basements, kitchens, laundry rooms, outside area and all plumbing fixtures within 6 feet should be GFCI protected. Recommend review by qualified electrical contractor.
