Trademark Home Inspections

Property Inspection Report

112 Newcastle Walk, Woodstock, GA 30188

Date of Inspection: 12/29/2019 Time: 9:00 AM

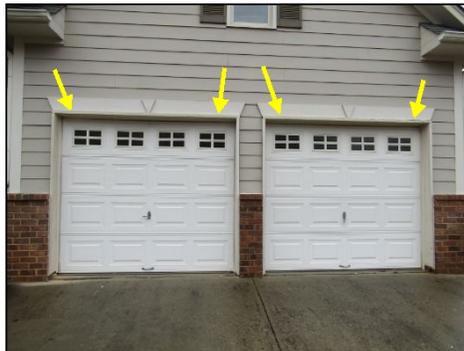
Flashing does not completely cover the trim at garage doors. This is a moisture concern. Recommend review/repair by a qualified contractor.

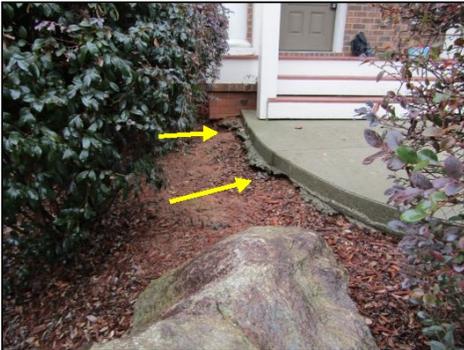
Erosion noted in some areas. Recommend review by a qualified contractor to prevent erosion and cracking of slabs or deck footings.

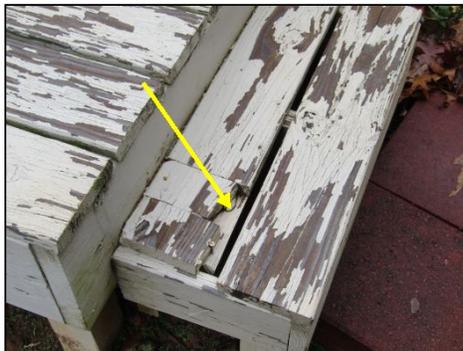
Step tread is loose/damaged. Safety concern. Recommend review for repair by a qualified contractor.

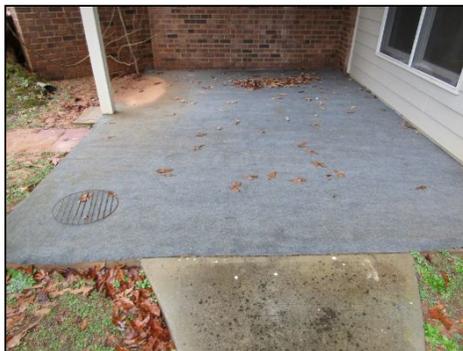
Carpet installed at back patio. Unable to visually inspect the slab.

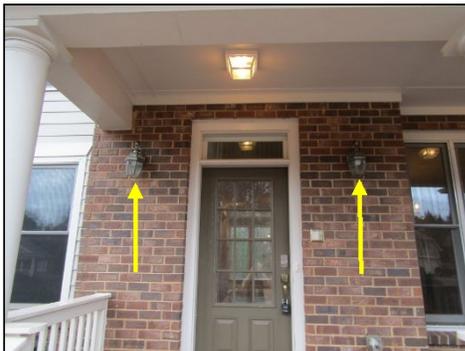
Light switch damaged or bulb inoperable. Recommend replacing bulbs and reviewing with seller prior to close to ensure it will not require professional repairs.

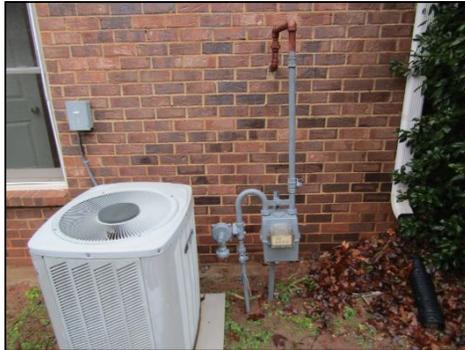
Main gas meter and valve visually functional at time of inspection.

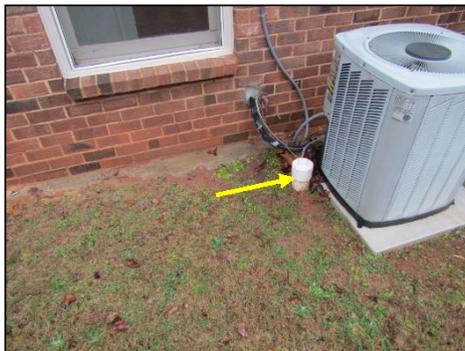
Waste line clean out noted on left side of home.

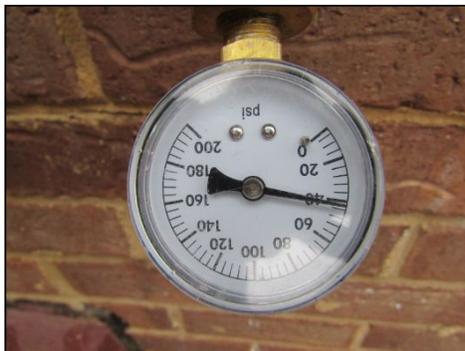
Water pressure noted as good at the time of inspection.

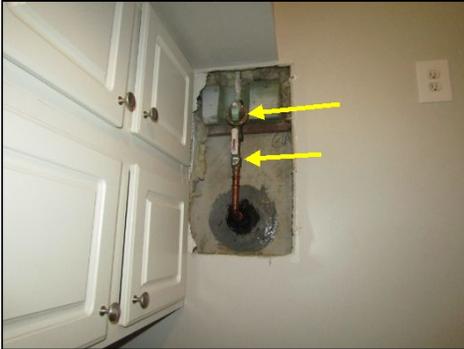
Pressure regulator and main water shut off located in cutout at front of home in basement wall.

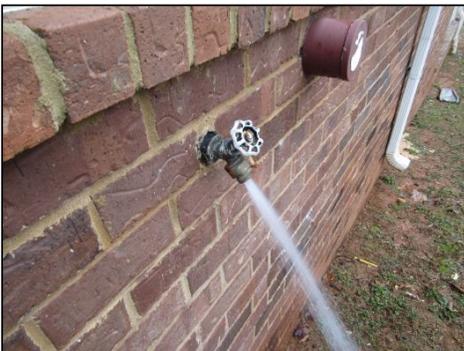
*Faucets tested and functional at time of inspection.

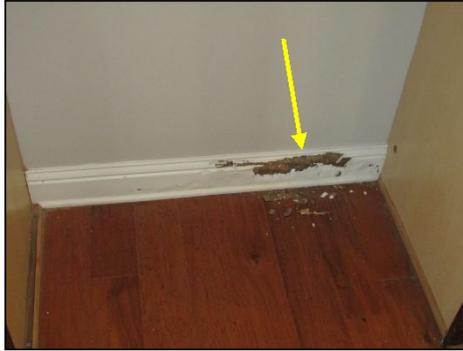
Termite activity noted in the kitchen. Recommend review by a qualified termite and pest control contactor.

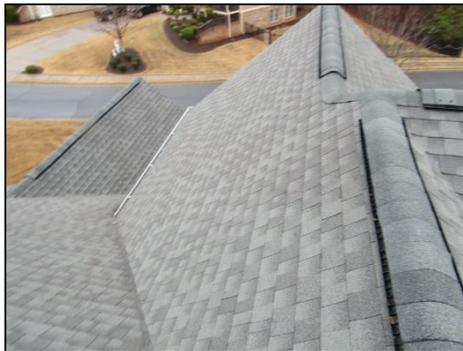
Roof in overall good condition at time of inspection recommend review by a qualified contractor for noted areas of concern.

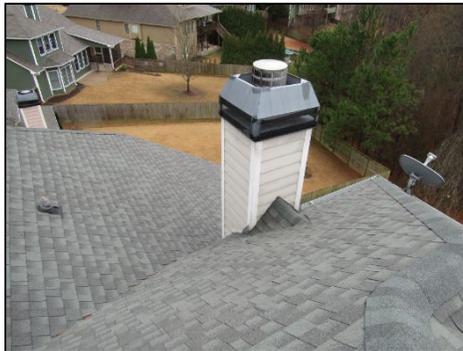
Chimney visually functional with no deficiencies noted at time of inspection.

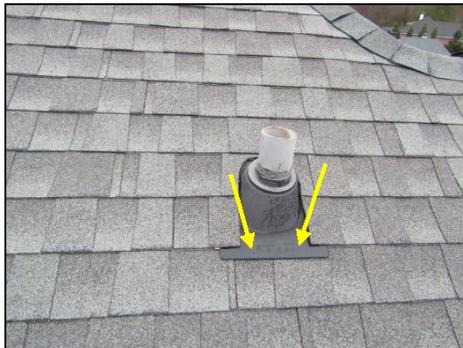
Missing nails at vent cap. Nails are needed for proper fastening. Recommend review by a qualified contractor.

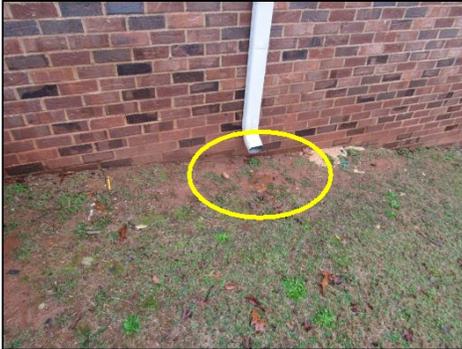
Extensions / Splash blocks missing or insufficient: Install to divert water away from the foundation.

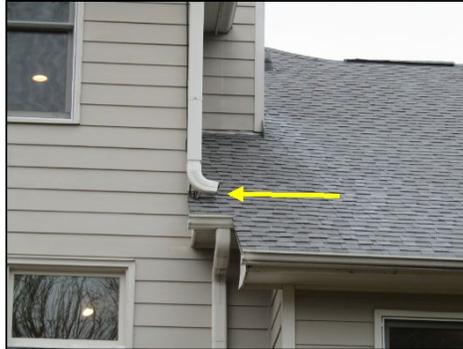
Downspouts terminate perpendicular to the roof shingles. This can allow water to flow under the shingles and lead to roof leaks. Recommend repair by a qualified gutter contractor.

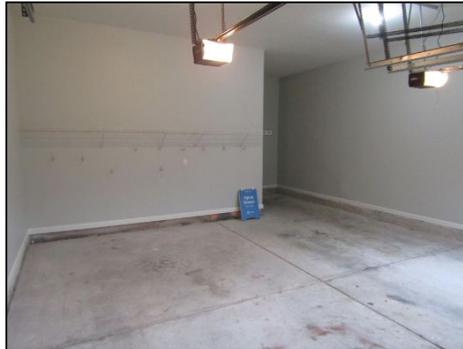
Visible areas observed were functional at time of inspection.

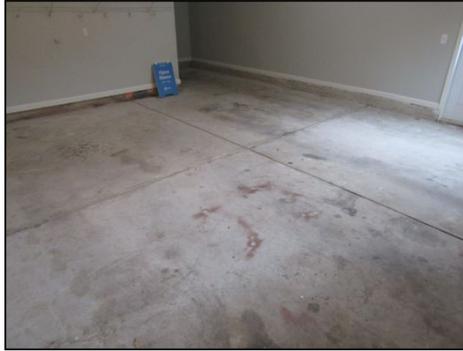
Visible areas observed were functional at time of inspection.

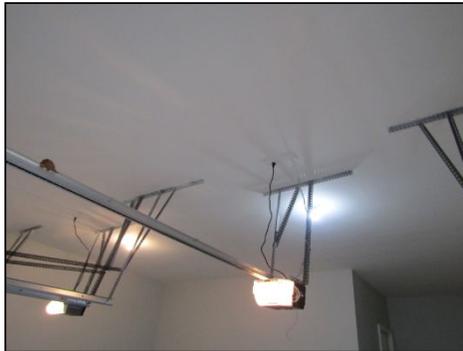
Ceiling functional at time of inspection.

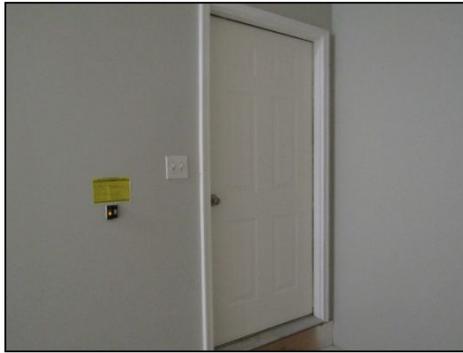
Visually functional at time of inspection.

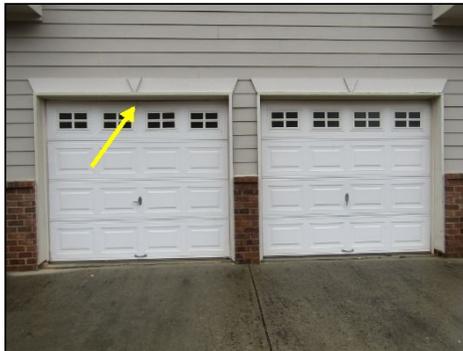
Damage noted at the top of the left side garage door. Recommend review or repair by qualified garage door contractor for proper functionality.

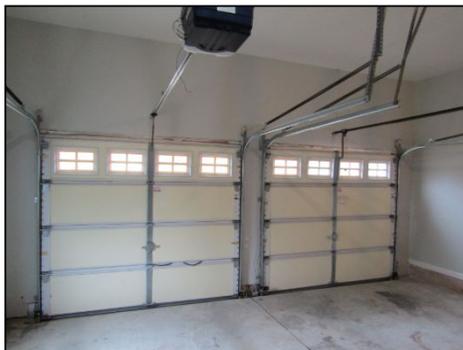
All components and parts functional at time of inspection.

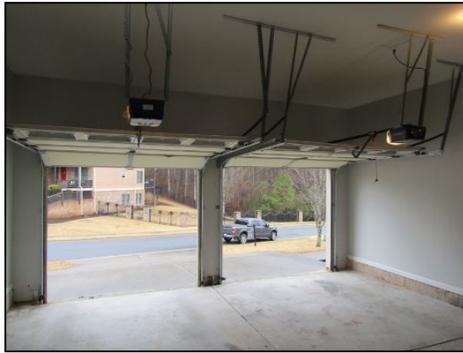
Functioned properly when tested at time of inspection.

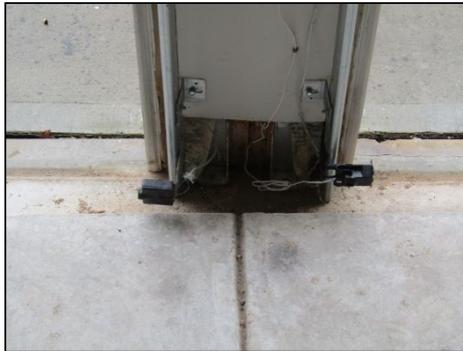
All safety features operated properly at time of inspection.

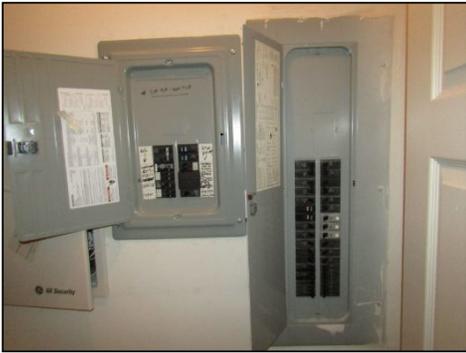
Panel visually labeled correctly at time of inspection.

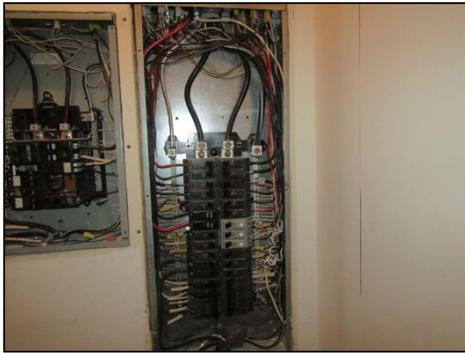
No major system or function concerns noted at time of inspection at main or subpanel box except where noted.

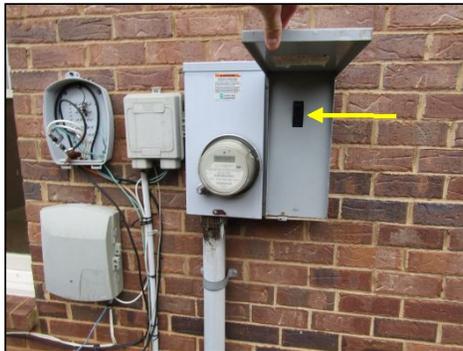
200 amp main breaker noted on exterior side of home.

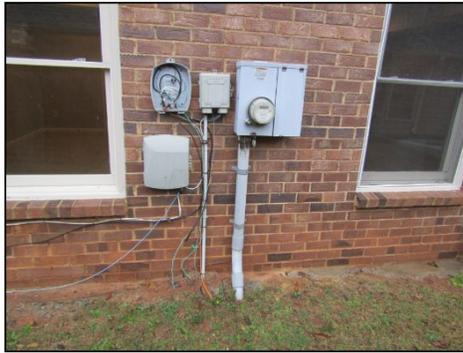
There is an underground service lateral noted.

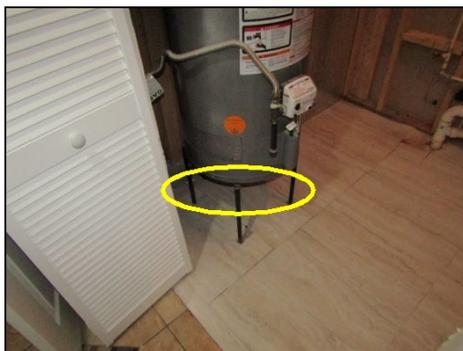
No overflow pan noted. While not required in unfinished slab areas, pan is suggested when finished area can be affected by leakage of the water heater. Recommend review or installing by qualified plumbing contractor.

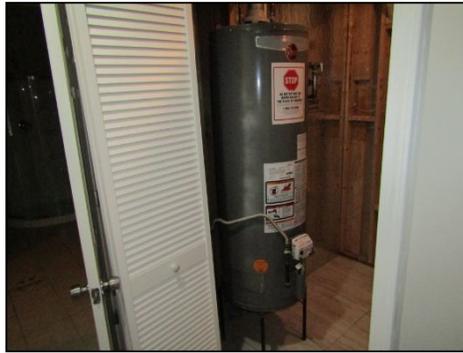
Water heater enclosure visually functional at time of inspection.

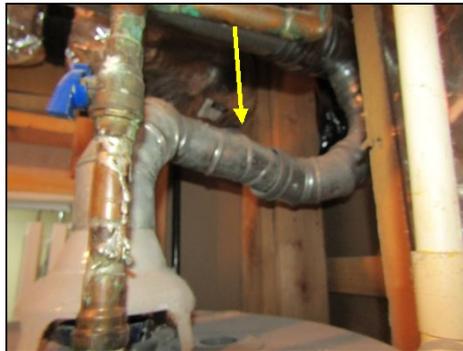
SAFETY CONCERN: The vent pipe from the natural draft gas water heater fails to rise 1/4" per foot. This can prevent the carbon monoxide from properly leaving the home. In the interest of safety, recommend review and repair by qualified HVAC contractor.

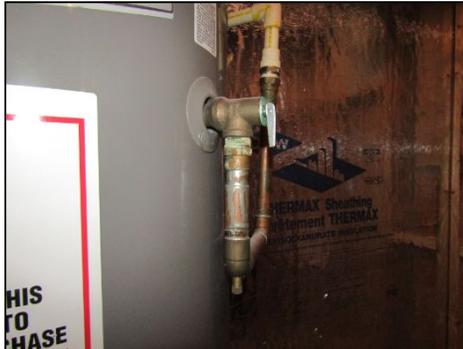
No deficiencies noted at time of inspection.

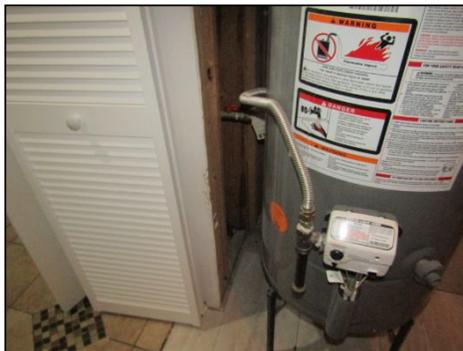
* Proper Sediment trap noted on gas line.

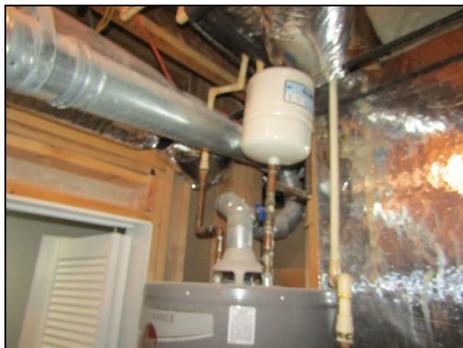
No deficiencies observed at the visible portions of the supply piping.

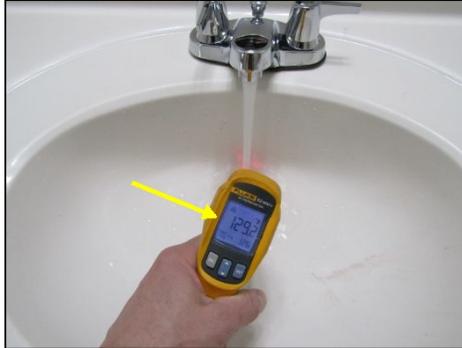
High water temperature noted. Recommend between 113 F and 125° F for the safety of children. Water temperature can be adjusted at the water heater.

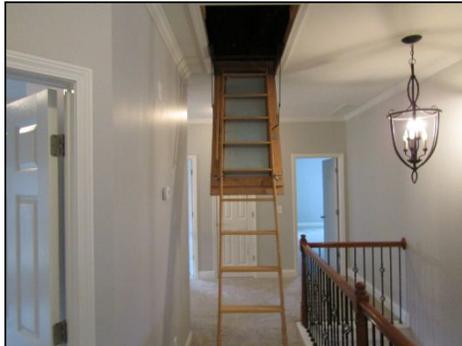
No deficiencies noted at time of inspection.

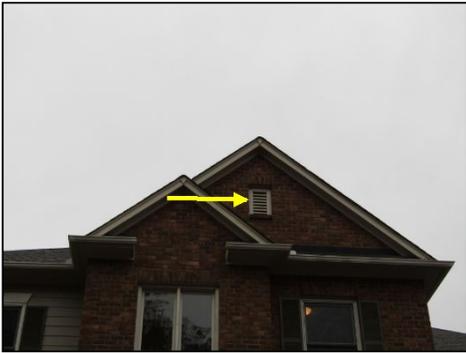
Gable vents noted.

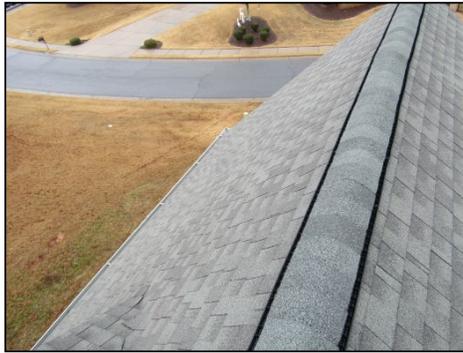
Ridge vents noted.

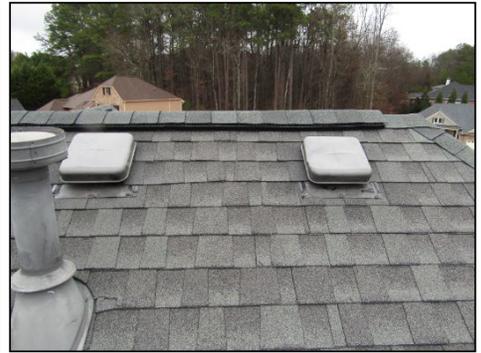
Turtle vents noted.

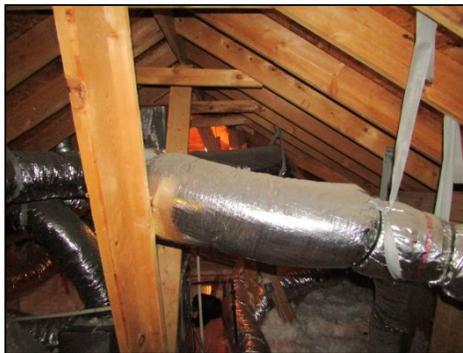
Duct work visually functional at time of inspection.

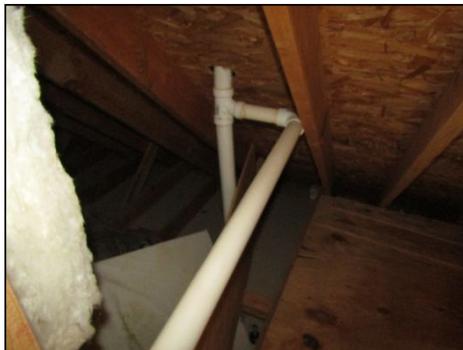
PVC plumbing vent pipe functional at time of inspection.

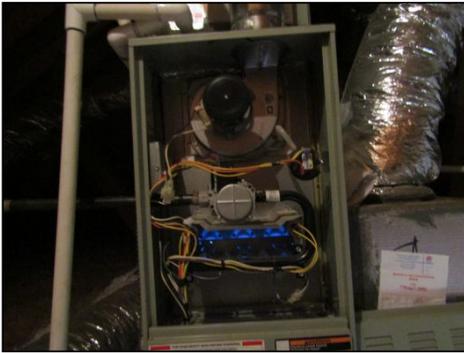
Functional at the time of the inspection.

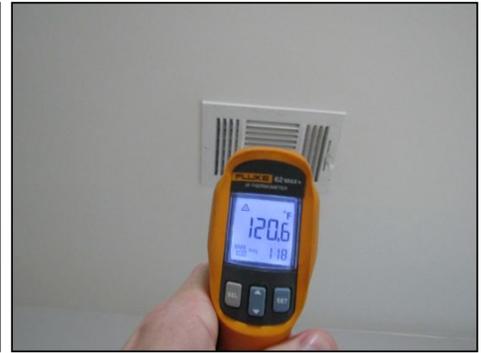
Acceptable heat reading noted at time of inspection.

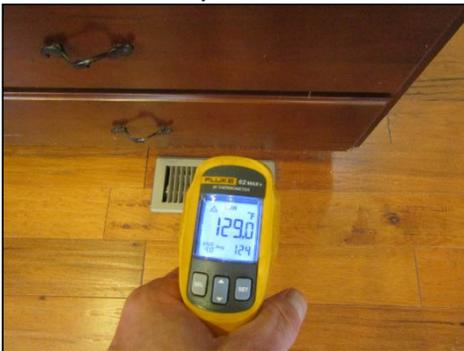
Acceptable heat reading noted at time of inspection.

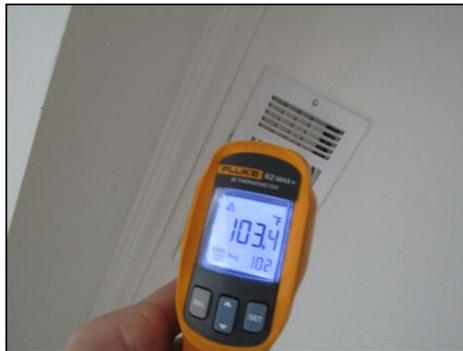
Acceptable heat reading noted at time of inspection.

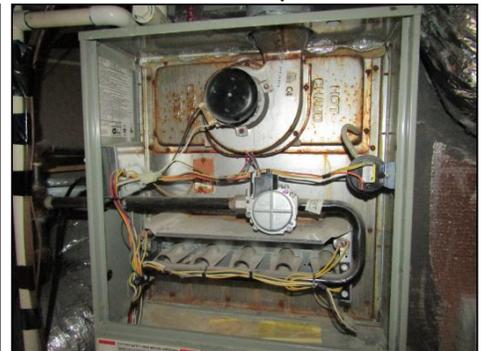
Functional at the time of the inspection.

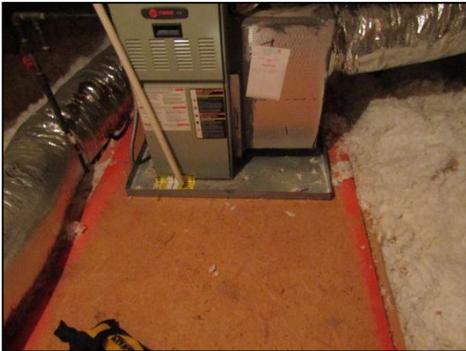
* Heater base functional at time of inspection.

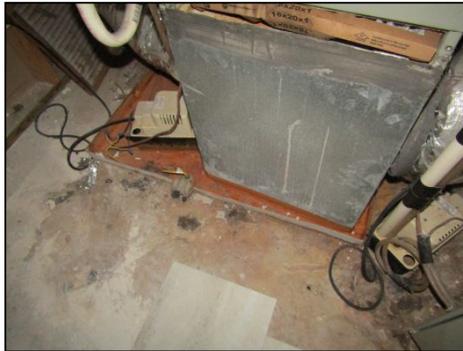
Heater base functional at time of inspection. Tub indicates previous leakage. Monitor and consult with previous owners for explanation.

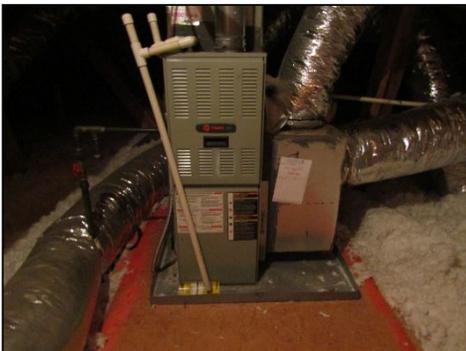
Enclosure visually functional at time of inspection.

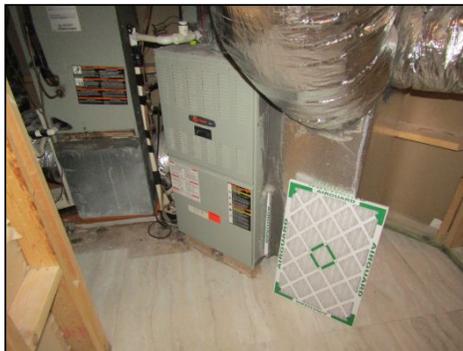
Enclosure visually functional at time of inspection.

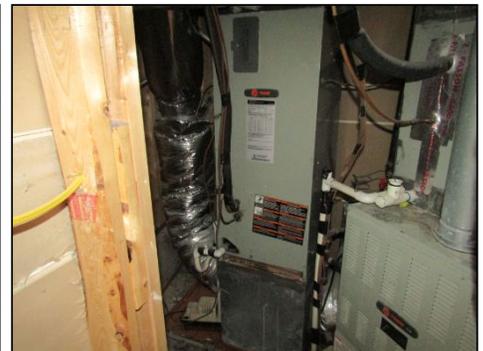
Enclosure visually functional at time of inspection.

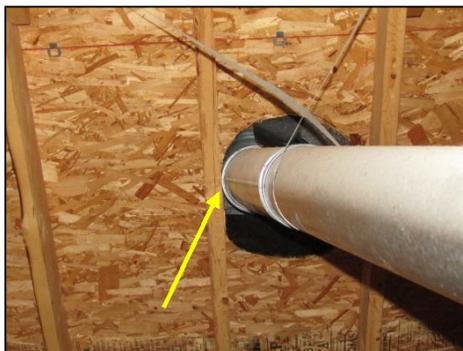
SAFETY CONCERN: Vent pipe is in direct contact with the roofing materials in attic. Note: Minimum furnace/water heater double wall vent pipe clearance from combustible material is 1". In the interest of safety, Recommend review for repair by qualified contractor.

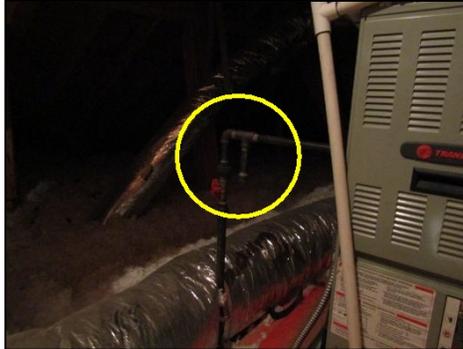
Attic HVAC: Improper sediment trap. Sediment present but not functional in its current installation. Sediment traps do as name notes, they trap sediment before it enter water heaters or HVAC systems and help prolong life. Recommend correction by qualified HVAC contractor.

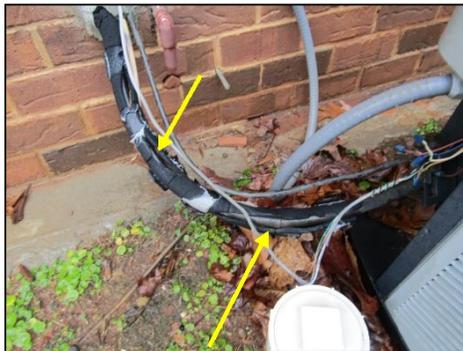
Insulation is deteriorated at refrigerant lines. This may effect the efficiency of unit. Recommend repairing or replacing by qualified HVAC contractor.

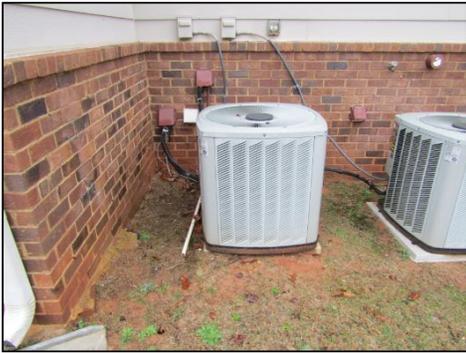
Functional at the time of inspection.

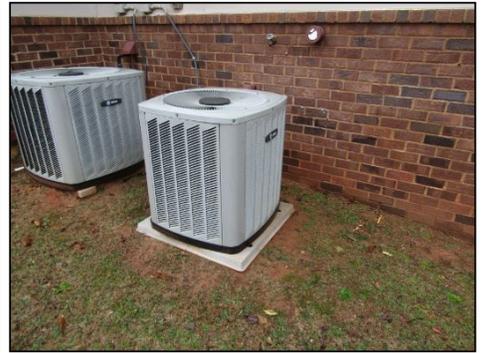
Functional at the time of inspection.

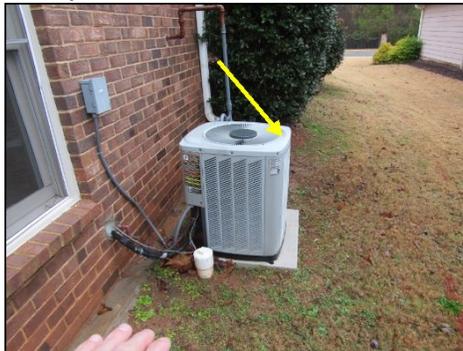
Left side AC compressor not level. When a compressor is out-of-level, the oil can separate and the compressor may operate without adequate lubrication. Recommend review and adjustment by qualified HVAC contractor.

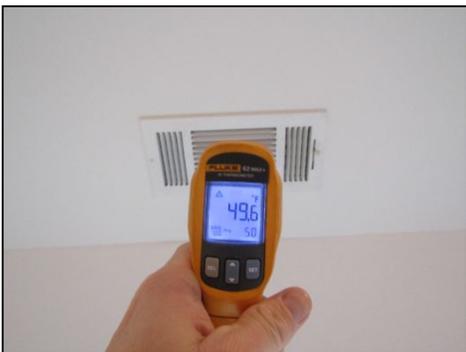
Upstairs A/C temperature split

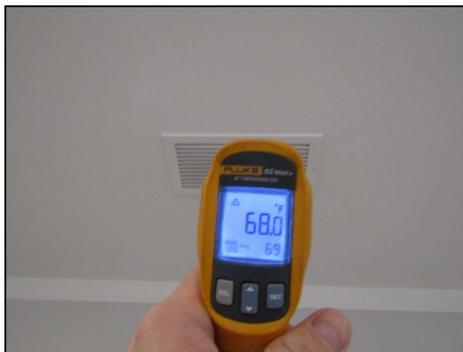
Upstairs A/C temperature split

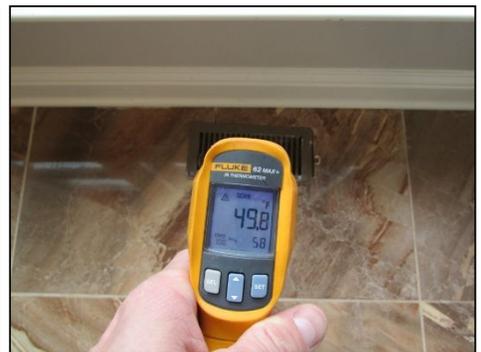
Main Level A/C temperature split

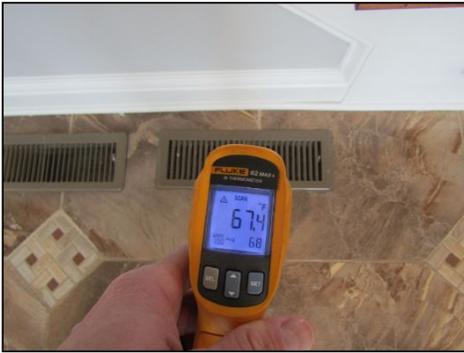
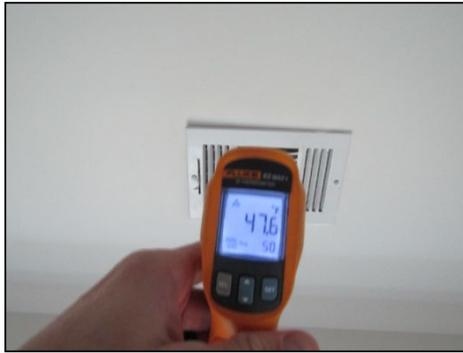
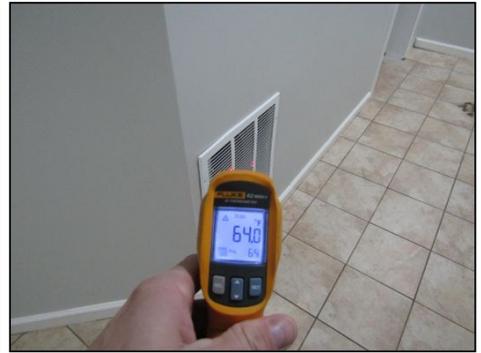
Main Level A/C temperature split Basement A/C temperature split Basement A/C temperature split

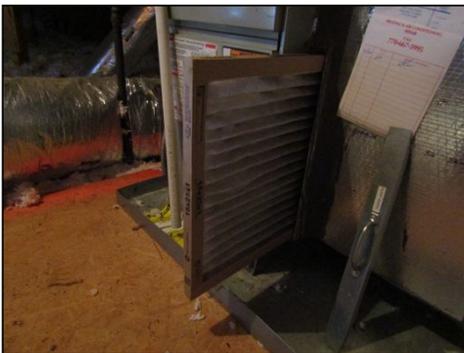
Filter functional at time of inspection.

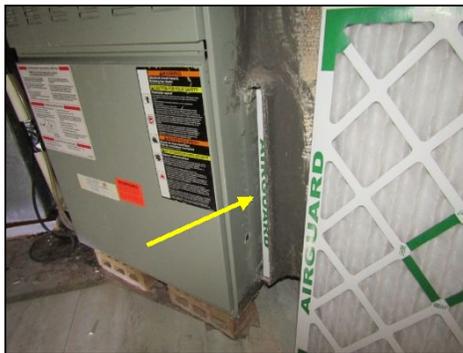
Filter covers missing. Recommend purchasing covers or keeping sealed with HVAC tape for proper functionality.

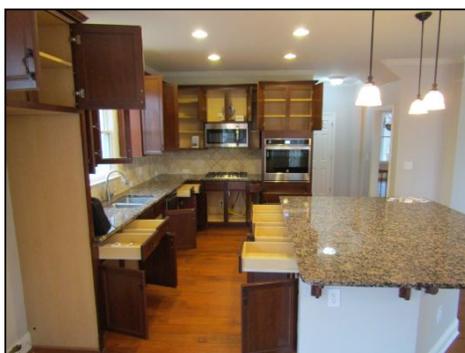
Cabinets visually functional but due show some cosmetic wear and tear at time of inspection.

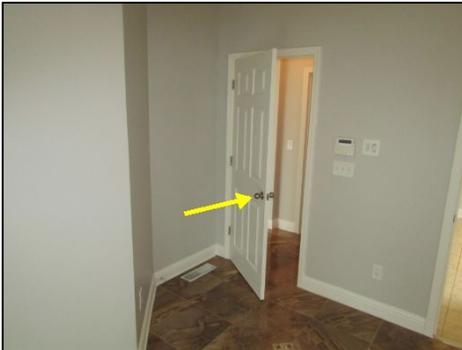
Master bedroom door lock was not functional. Recommend repair by a qualified contractor for proper functionality.

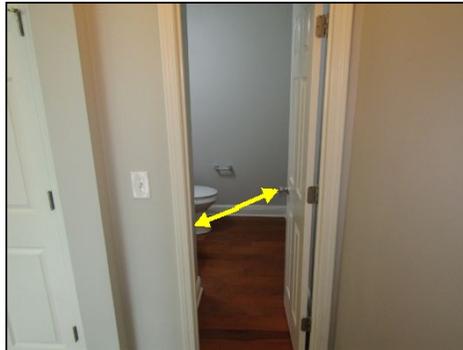
Some doors do not latch correctly. Recommend adjustment to door and/or striker plate by qualified contractor.

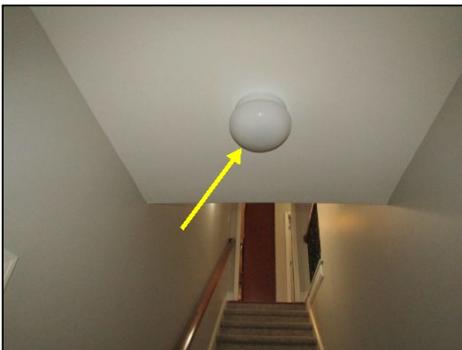
Light switch damaged or bulb inoperable. Recommend review with seller prior to close or review by qualified electrical contractor.

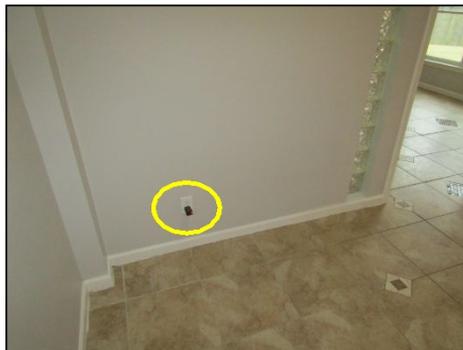
Outlet damaged / inoperable at basement, back, right room. Recommend review by qualified electrical contractor.

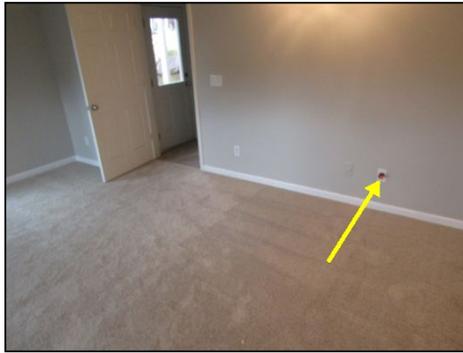
Broken prong in basement, back, left room outlet, preventing the outlet from functioning. Recommend repair by a qualified contractor.

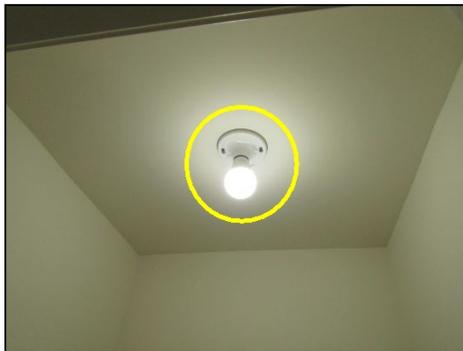
FIRE HAZARD: No globe at basement closet lights. This can cause a fire should stored items come in contact with a hot bulb. Recommend install globe or install new fixture by qualified electrical contractor.

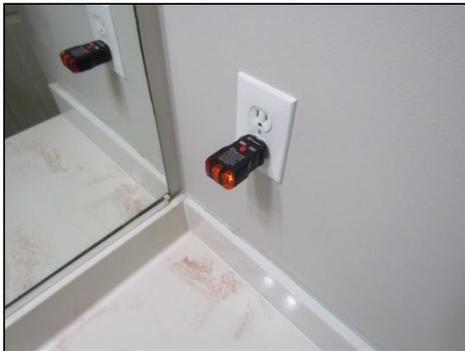
Interior GFCI outlets functional at time of inspection.

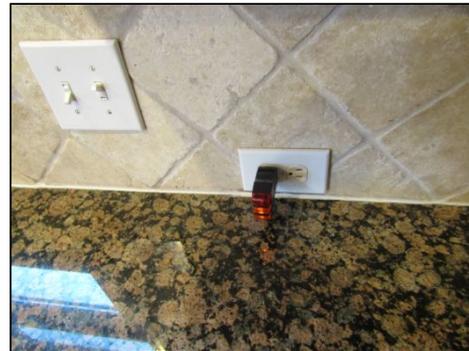
Interior GFCI outlets functional at time of inspection.

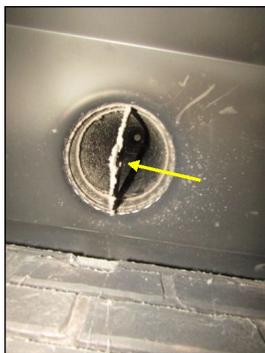
Damper worked properly at time of inspection but missing damper clamp. This device is used when gas fireplace is in use. It prevents carbon monoxide from entering the home. Recommend installing by a qualified contractor.

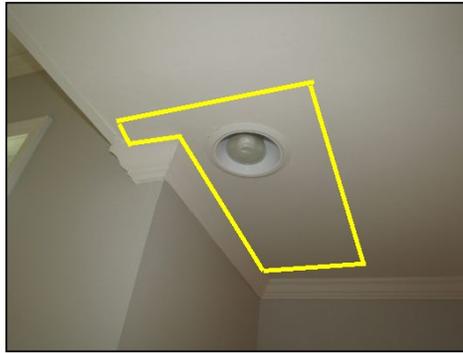
Signs of previous repairs noted. Check disclosure statement and sellers for explanation.

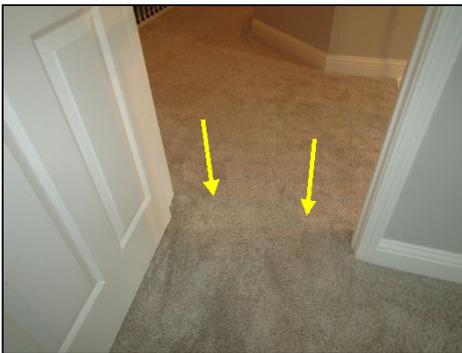
Carpet is loose and rolling in some areas. This is a trip hazard. Recommend review and repair by a qualified flooring contractor.

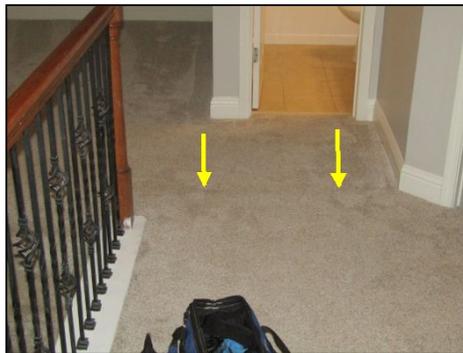
Carpet is loose and rolling in some areas. This is a trip hazard. Recommend review and repair by a qualified flooring contractor.

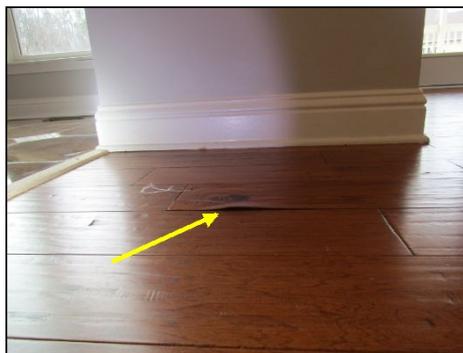
Hardwood floor in one area of dining room is lifting. No evidence of moisture intrusion. Recommend review by a qualified contractor.

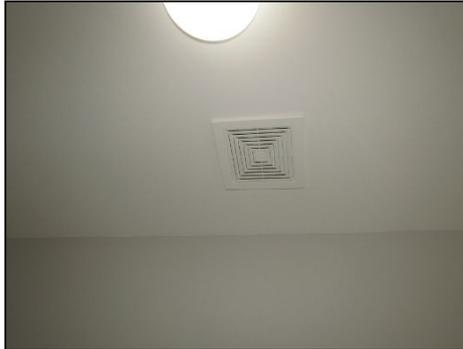
All exhaust fans functioned properly at time of inspection.

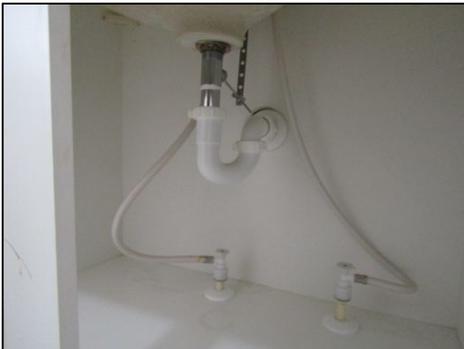
No sign of active leaks at bathroom plumbing were noted at the time of the inspection.

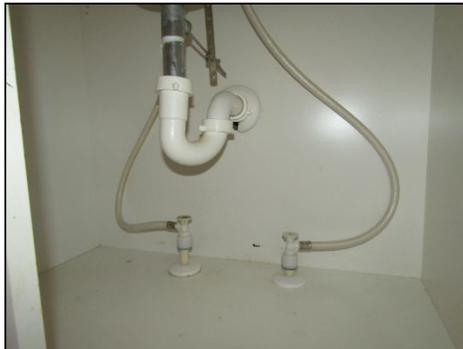
No sign of active leaks at bathroom plumbing were noted at the time of the inspection.

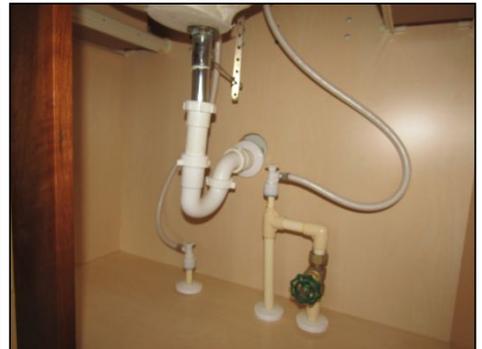
No sign of active leaks at bathroom plumbing were noted at the time of the inspection.

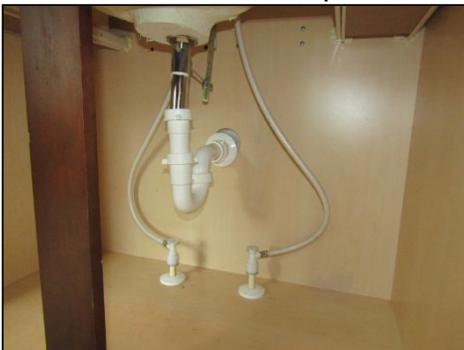
No sign of active leaks at bathroom plumbing were noted at the time of the inspection.

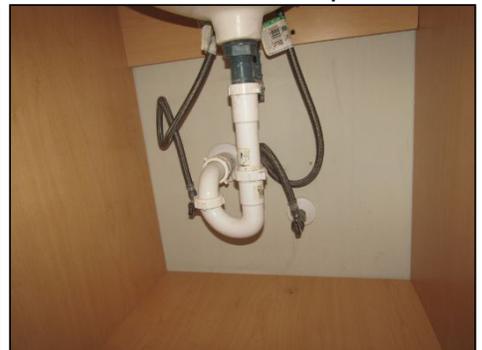
No sign of active leaks at bathroom plumbing were noted at the time of the inspection.

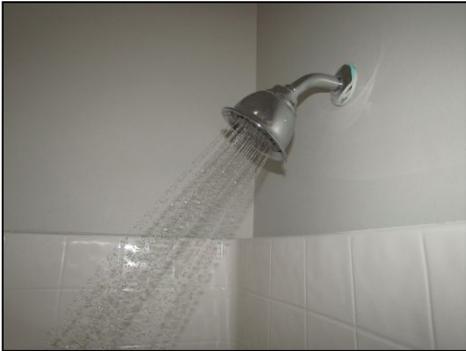
All showers functioned properly at time of inspection.

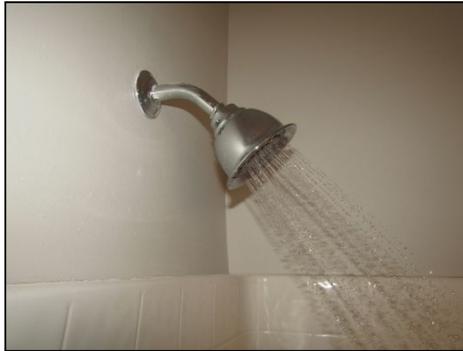
All showers functioned properly at time of inspection.

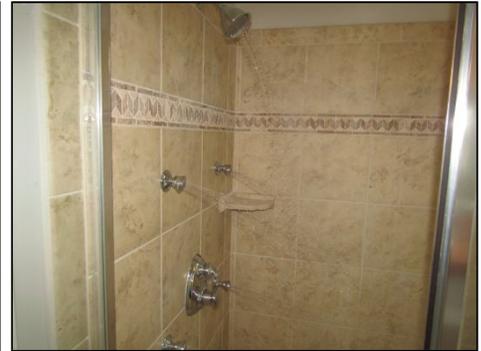
All showers functioned properly at time of inspection.

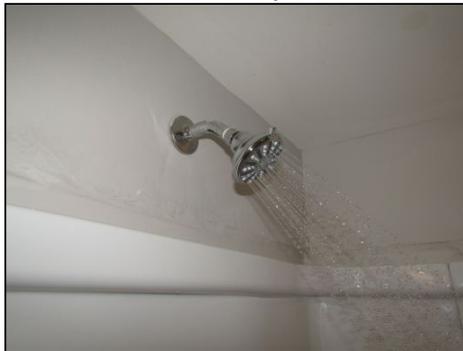
All showers functioned properly at time of inspection.

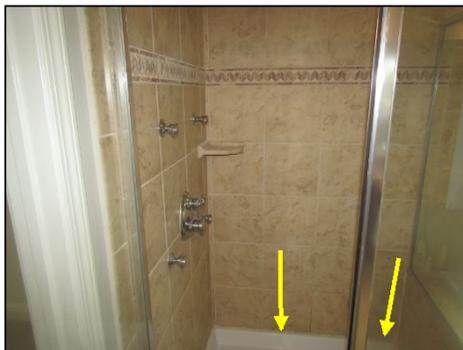
Missing grout and or caulk noted in master shower wall. This may allow moisture to penetrate walls and subfloor. Recommend review and repair by qualified contractor.

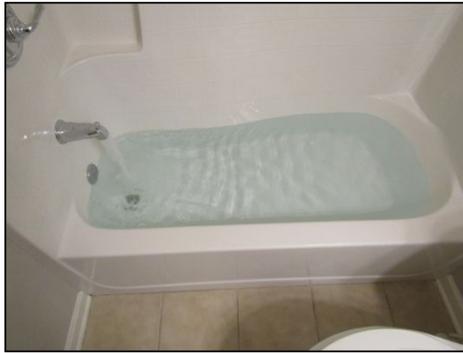
Tub and overflow functioned properly at time of inspection.

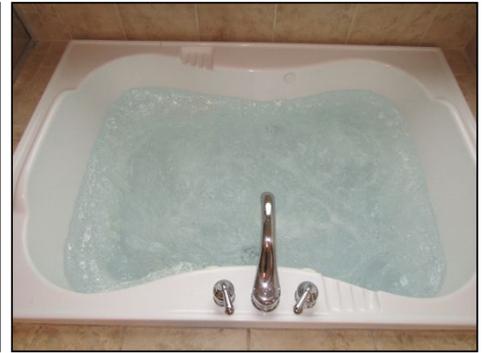
Tub and overflow functioned properly at time of inspection.

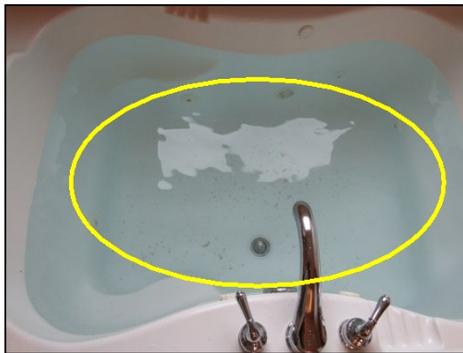
Debris was ejected from the jets during operation. Recommend sanitary flush to clean jets.

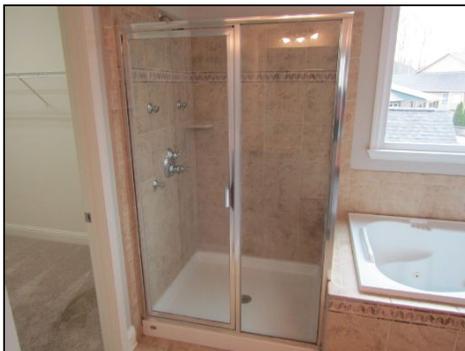
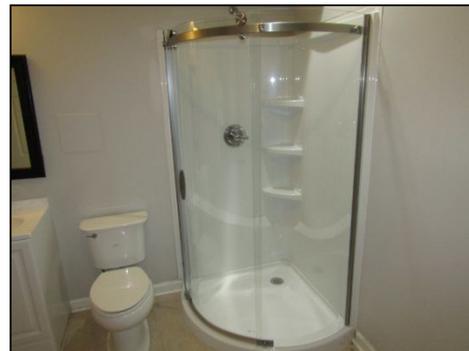
Enclosure functional at the time of the inspection. Enclosure functional at the time of the inspection.

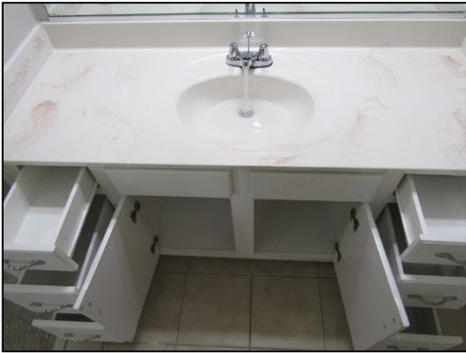
Faucet and drain functioned properly at time of inspection.

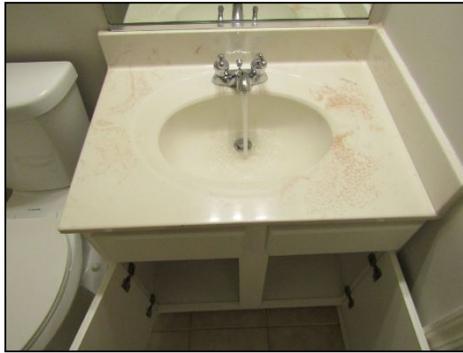
Faucet functioned properly but drain stopper missing or not operational.

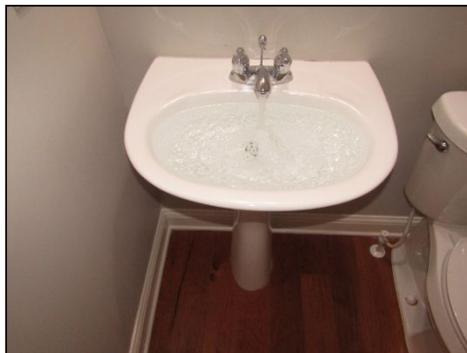
Faucet and drain functioned properly at time of inspection.

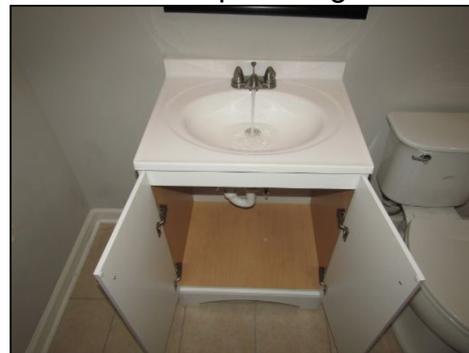
Faucet and drain functioned properly at time of inspection.

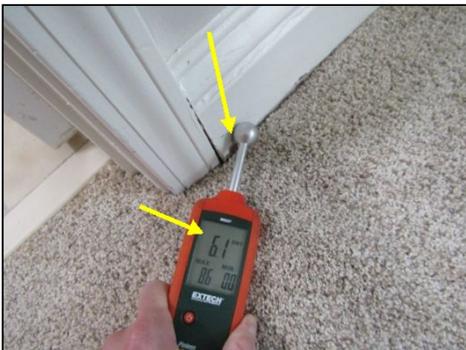
Jack and jill toilet was not functional at time of inspection. Toilet was empty and evidence of prior moisture at wall behind toilet may indicate a leak. Recommend review by a qualified plumbing contractor.

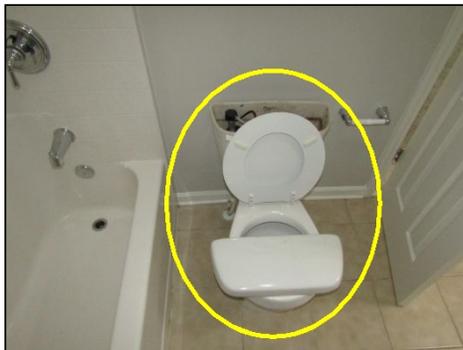
Jack and jill toilet was not functional at time of inspection. Toilet was empty and evidence of prior moisture at wall behind toilet may indicate a leak. Recommend review by a qualified plumbing contractor.

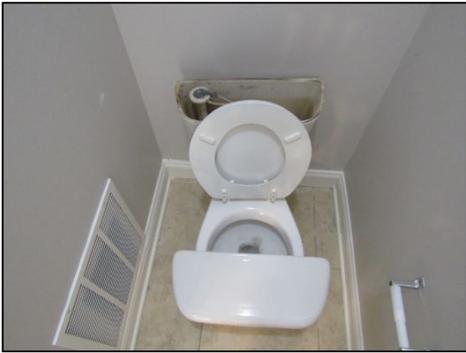
Toilet operated and functioned properly at time of inspection.

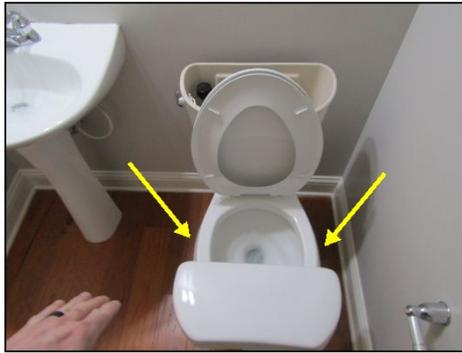
Multiple toilet bowls loose. The wax ring inside the unit must have a snug, secure fit in order to keep from leaking. Recommend repair by qualified plumbing contractor.

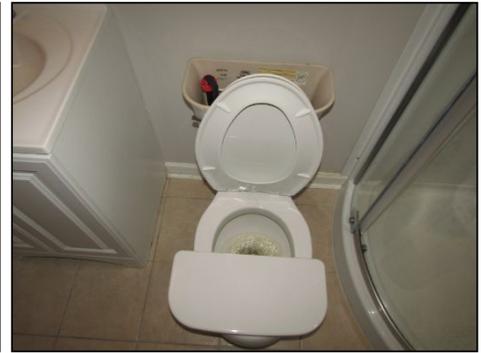
Toilet operated and functioned properly at time of inspection.

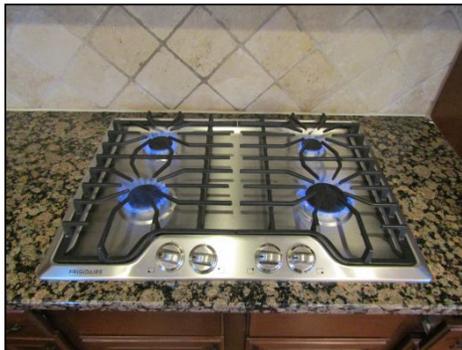
All burners functioned properly at time of inspection.

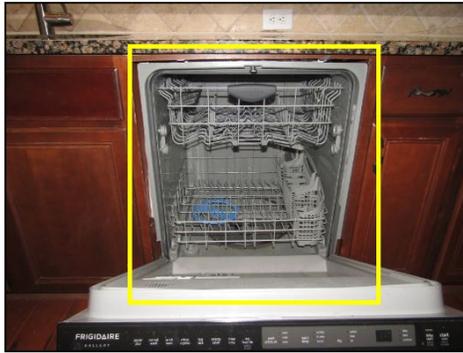
The dishwasher did not operate properly. No water present. Recommend review with seller prior to close or by qualified appliance contractor.

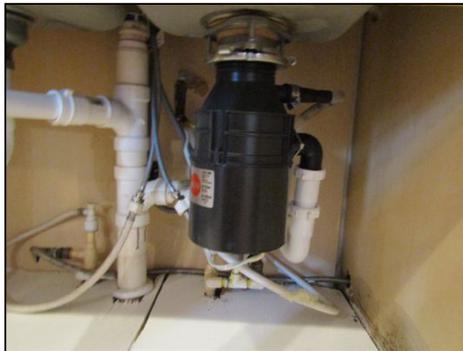
Disposal functioned properly at time of inspection.

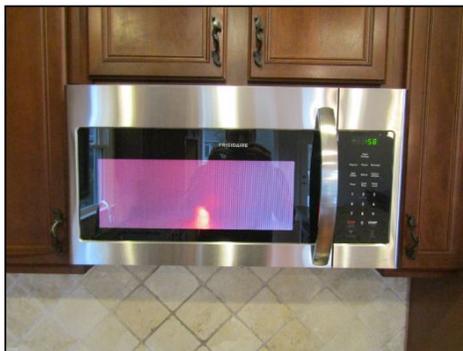
Microwave functioned properly at time of inspection.

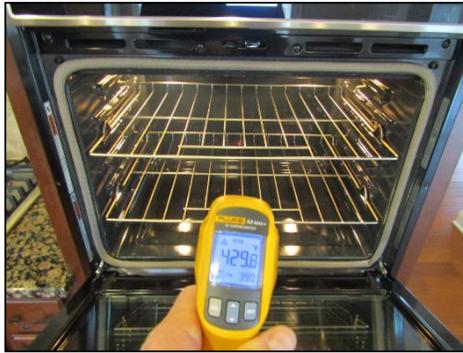
Oven(s) functioned properly at time of inspection.

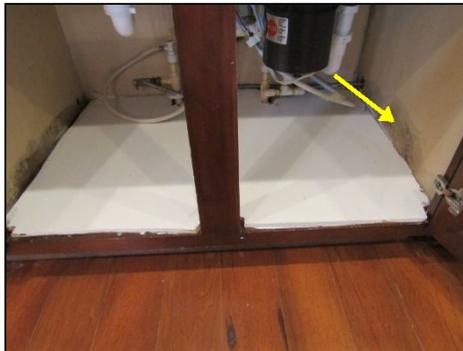
Signs of previous repairs noted under kitchen sink. No evidence of current leaks but slightly elevated moisture readings. Recommend review by a qualified contractor

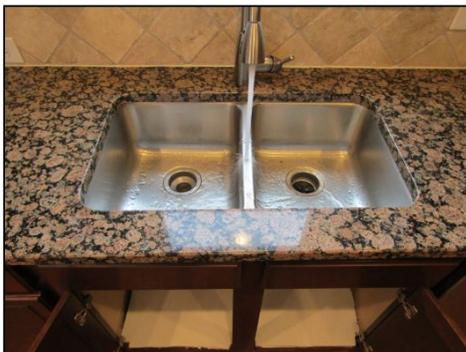
Faucet and drains functioned properly at time of inspection.

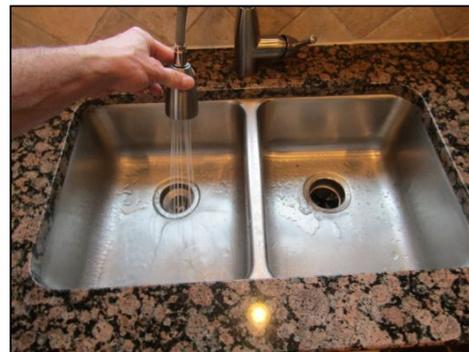
Sprayer functioned properly at time of inspection.

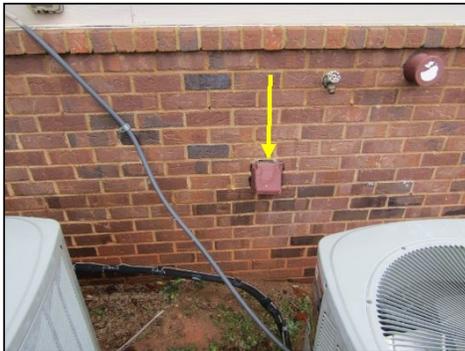
Dryer vent cover is secure with caulk only and it is separating from the home. Recommend securing and sealing to prevent moisture intrusion by a qualified contractor.

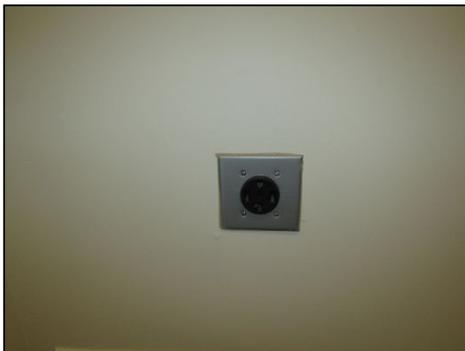
4 prong dryer outlet noted.

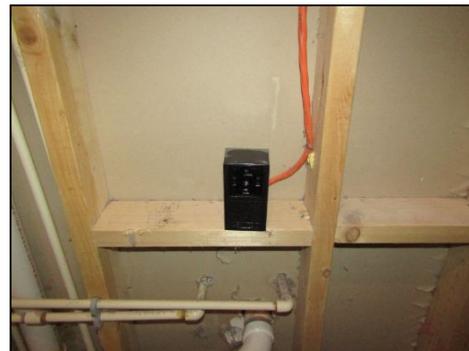
4 prong dryer outlet noted.

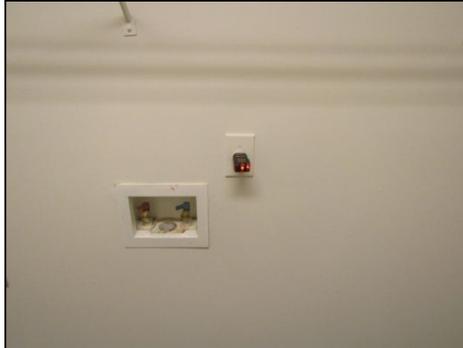
Outlet is not GFCI protected. While this was not a common building practice when the home was constructed, In the interest of safety, locations such as garages, unfinished basements, kitchens, laundry rooms, outside area and all plumbing fixtures within 6 feet should be GFCI protected. Recommend review by qualified electrical contractor.

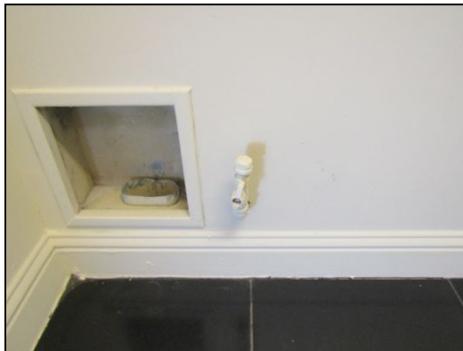
Gas valve visually functional at time of inspection.

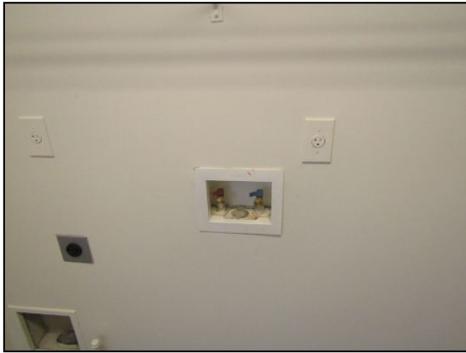
Plumbing and drainage visually functional at time of inspection.

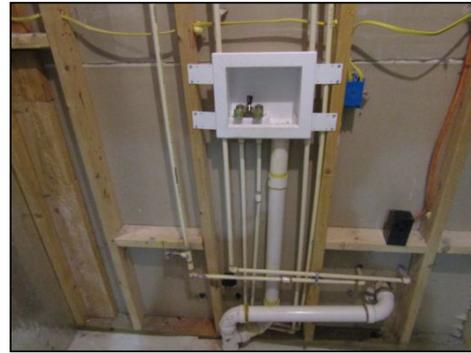
Plumbing and drainage visually functional at time of inspection.

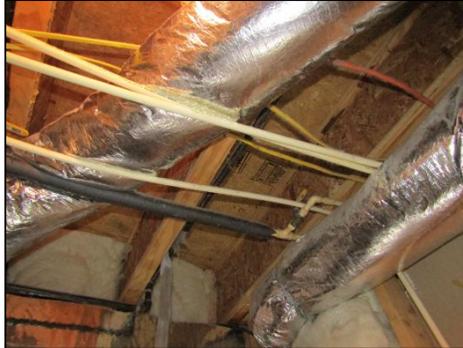
CPVC supply lines noted

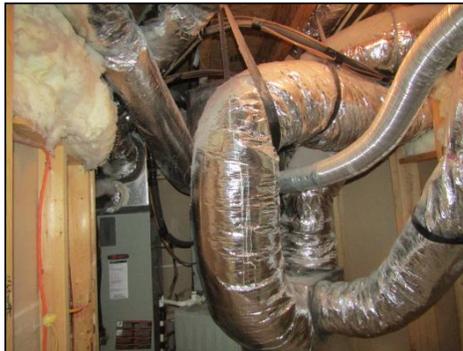
Limited view due to finished areas. Visible portions of ductwork functional at time of inspection.

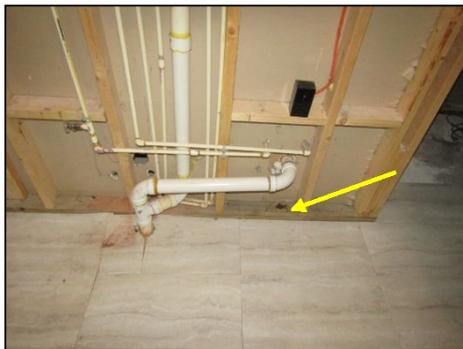
Active leak noted at basement kitchenette sink. Recommend repair by a qualified plumbing contractor to prevent moisture damage.
