Trademark Home Inspections

Property Inspection Report

112 Newcastle Walk, Woodstock, GA 30188

Date of Inspection: 12/29/2019 Time: 9:00 AM

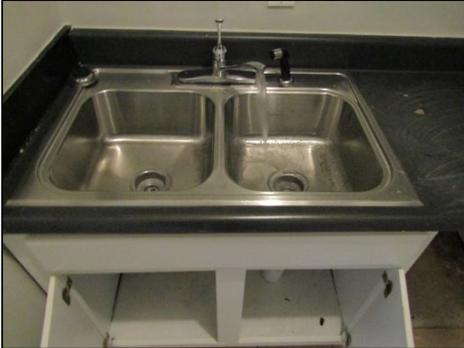
Sink operated properly when tested

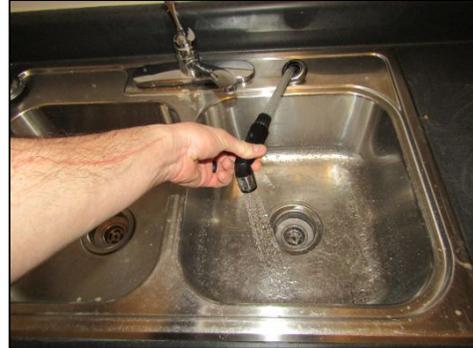
Sprayer operated properly when tested
