HomeCheck Property Inspections, LLC

Home Inspection Report

**1225 Roswell Manor Cir
Roswell, GA 30076**

Inspected on Sun, Jan 26 2020 at 9:00 AM

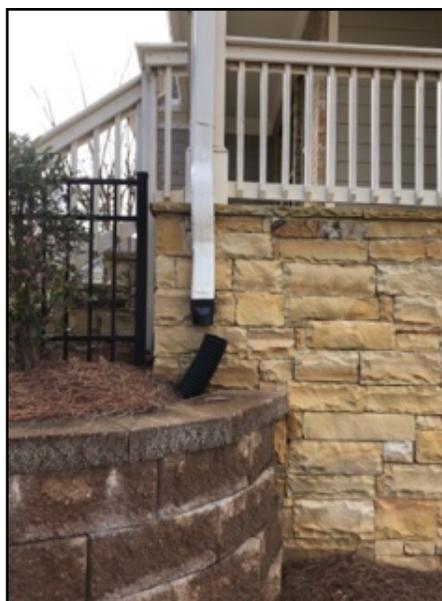
Figure 5-2

- 3) Comment 5: Gutter drain line disconnected at front right side of house. Gutter water directed down exterior wall can cause foundation damage. Recommend reconnecting drain line.

Gutter drain line disconnected at front right side of house. Gutter water directed down exterior wall can cause foundation damage. Recommend reconnecting drain line.

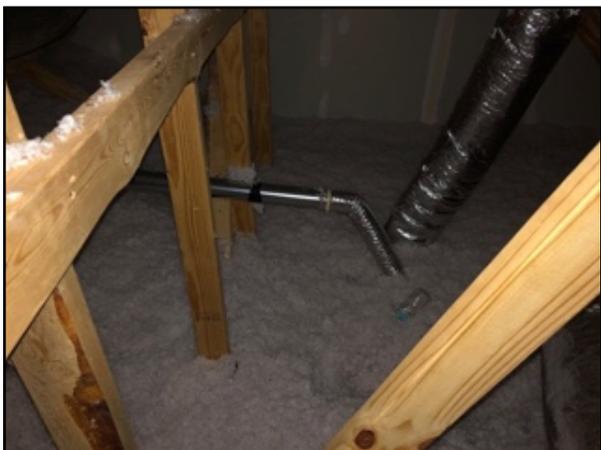
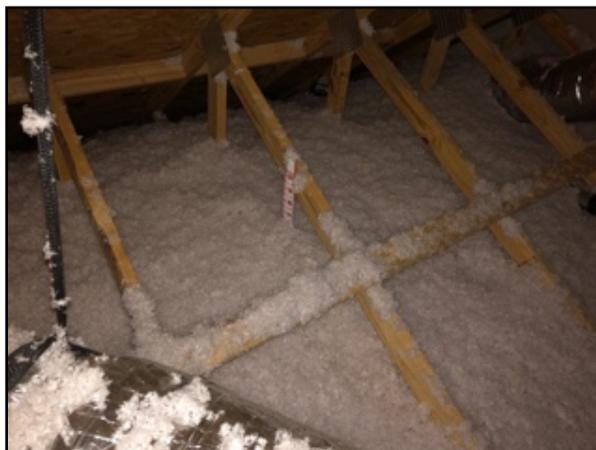
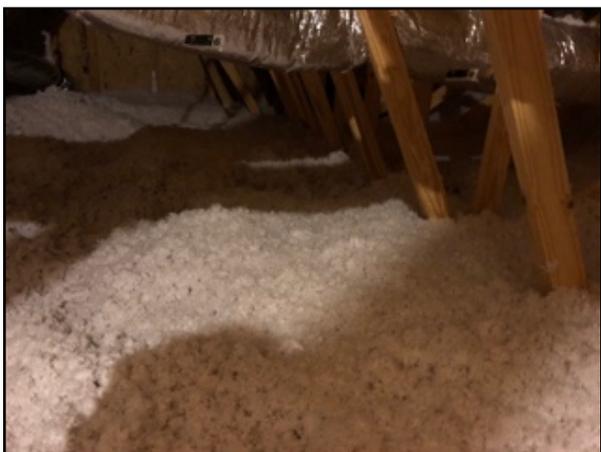
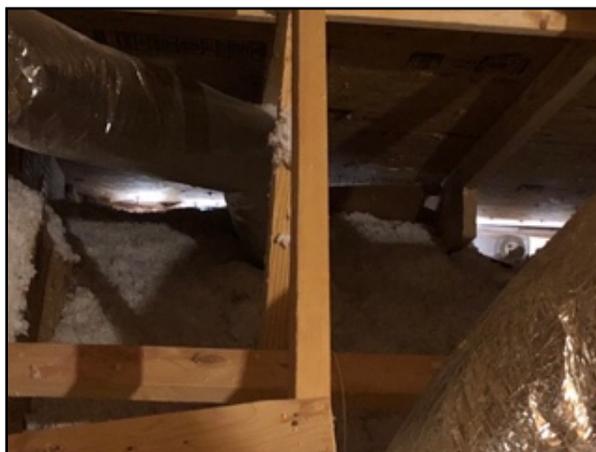
Very Good Attic Insulation: Overall, insulation levels are typical for a home of this age and construction. Any further insulation improvements will help to reduce utility costs. Any exceptions to this opinion are noted in this section.

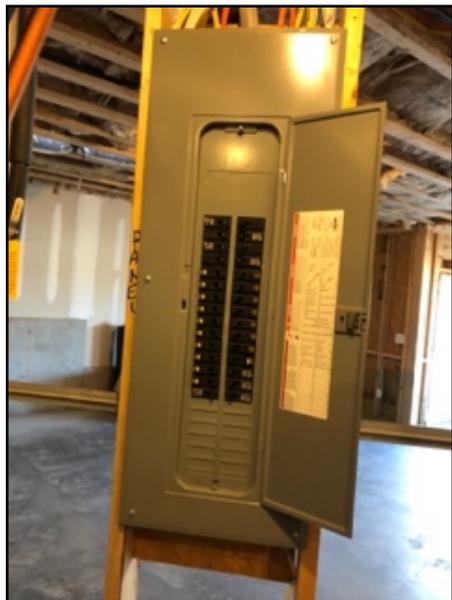
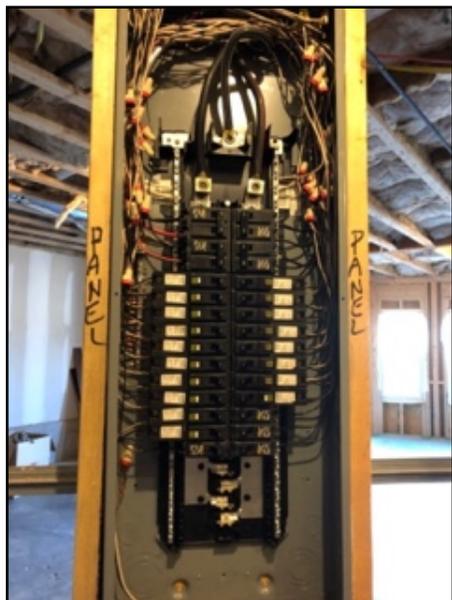
The size of the service (200 amps) appears to be sufficient for typical electrical requirements of a home this size. Inspection of the electrical system did not reveal the need for repairs, unless noted in other sections of this report.

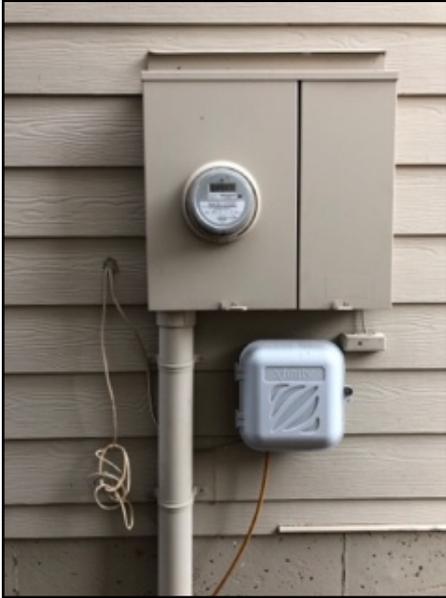
Figure 12-1

Comment 12:
Underground electric service with meter.

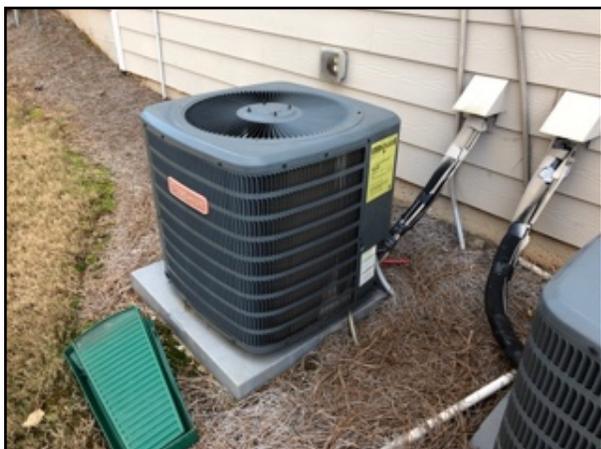
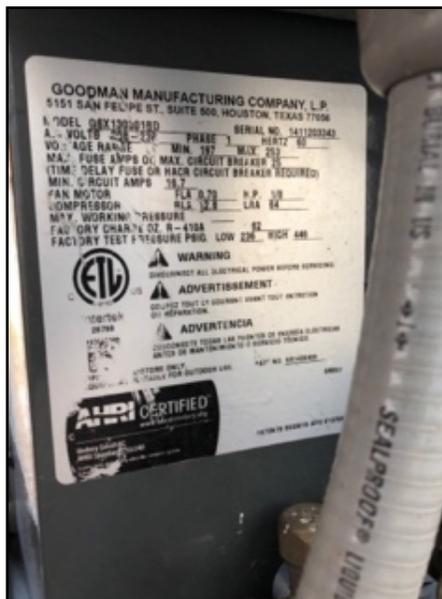
Comment 16:
Outdoor AC unit installation and manufacturer's label.

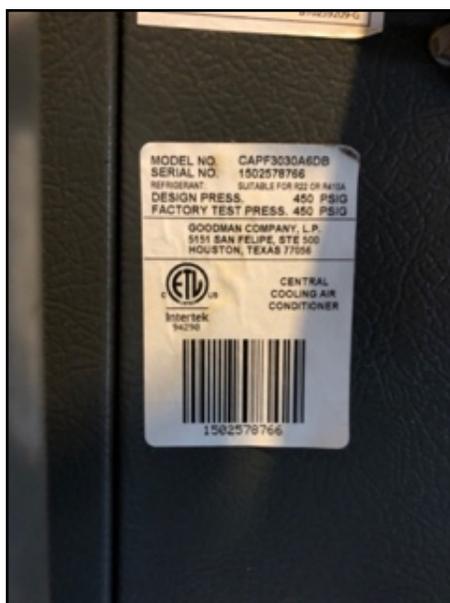
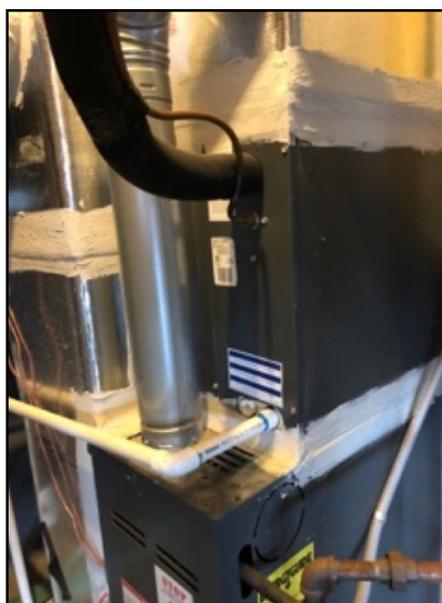
Comment 17:
Indoor AC unit installation and manufacturers label.

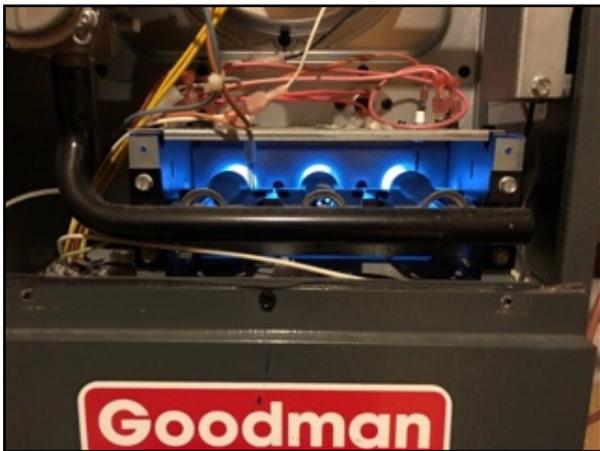
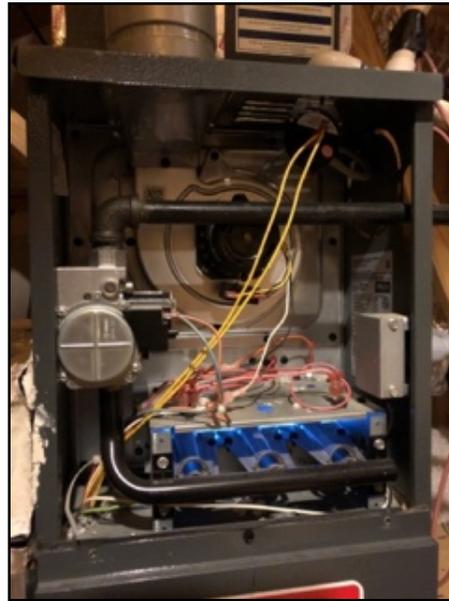
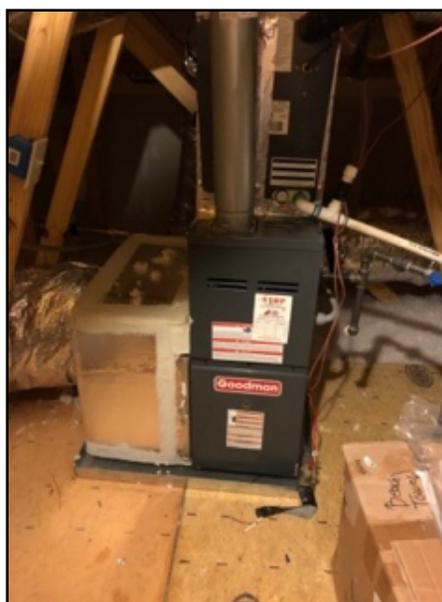
Furnace installation, manufacturer's label and indoor AC unit installation. Good unless otherwise noted below.

Furnaces over 10 years old should be checked, cleaned and serviced yearly by a licensed contractor.

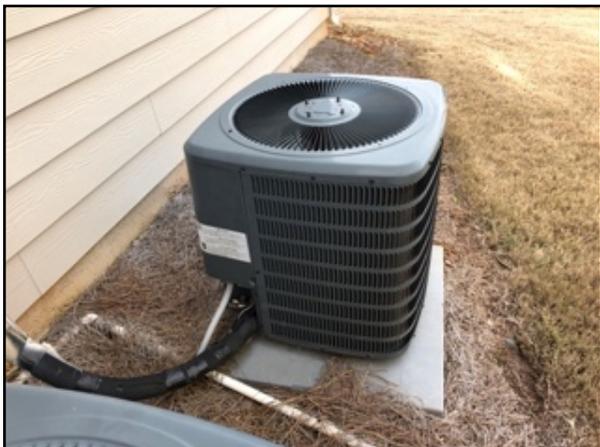
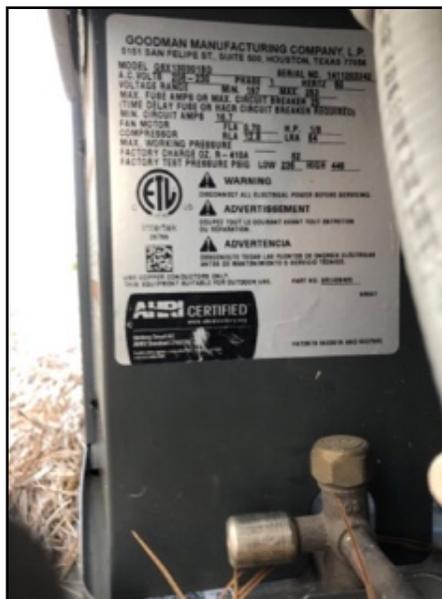
Comment 20:
Outdoor AC unit installation and manufacturer's label.

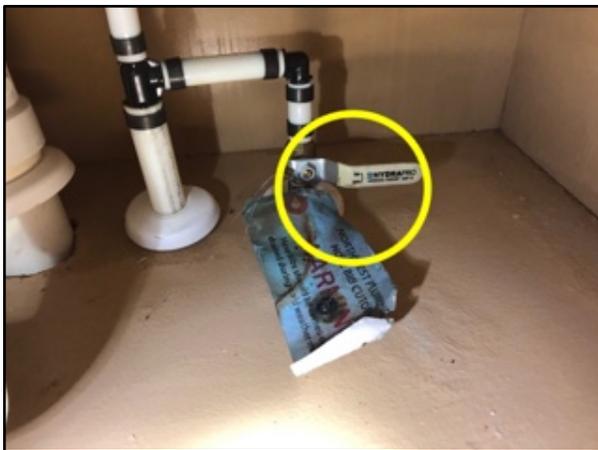
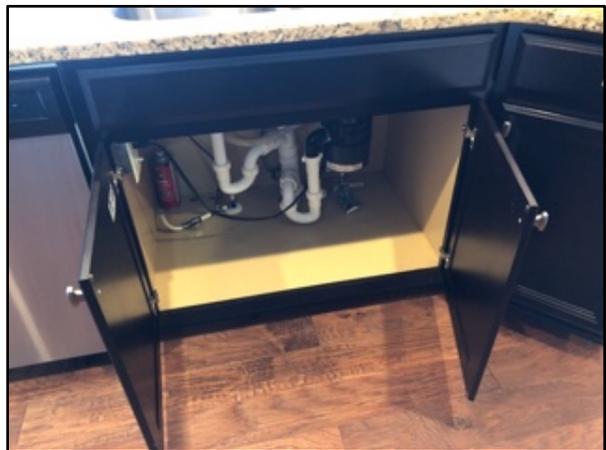
Exterior water faucets were turned off at branch line shut off under kitchen sink for winterization purposes. Therefore water pressure was not tested with a gauge, but pressure seem sufficient at all fixtures throughout the house at time of inspection.

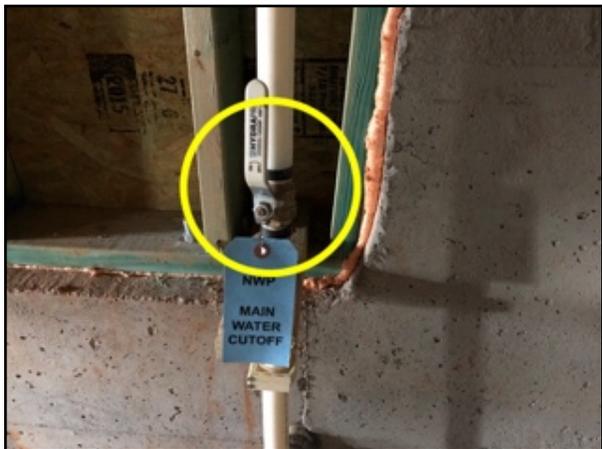
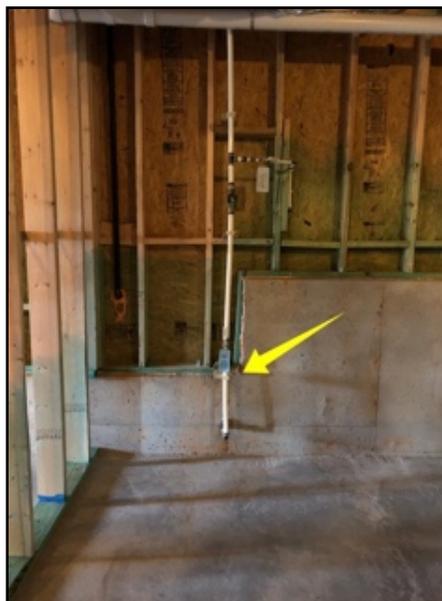
Water main shut off valve located in basement. See photo.

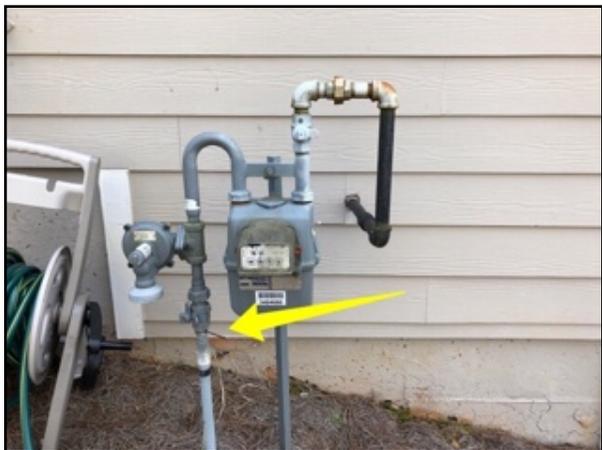
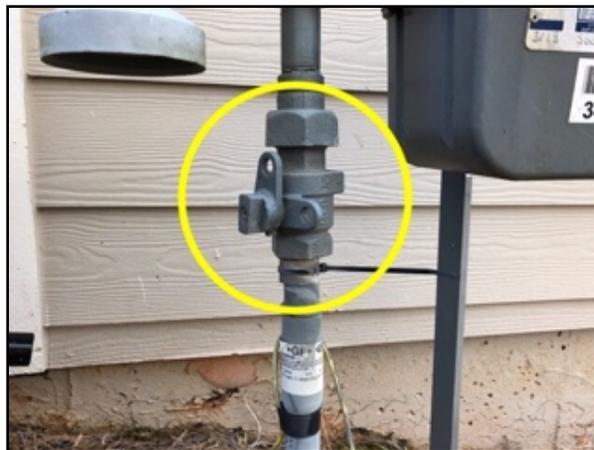
Gas utility main service with pressure regulator, meter and shutoff valve. Shutoff valve location noted in photo.

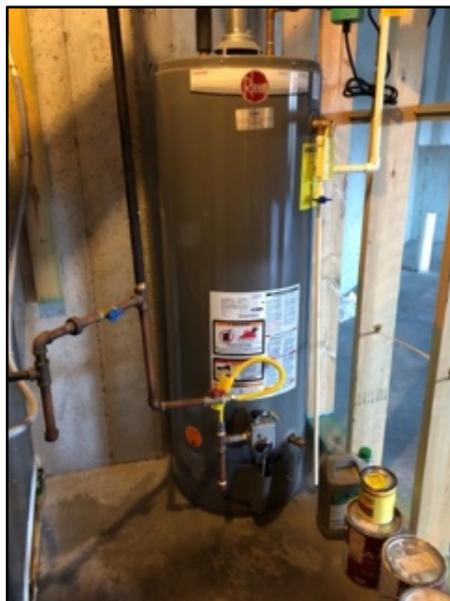
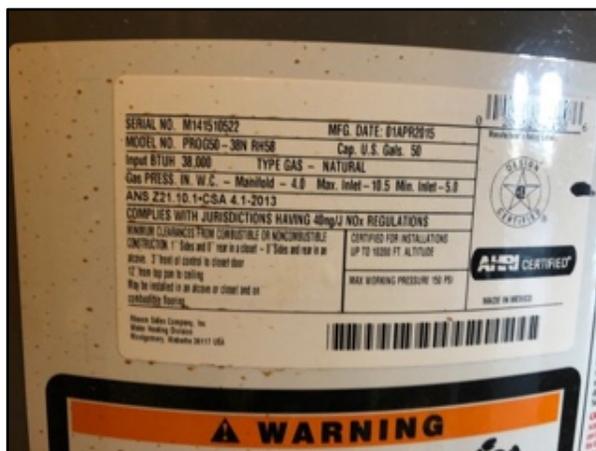
Comment 25:
Water heater installation with manufacturers label.

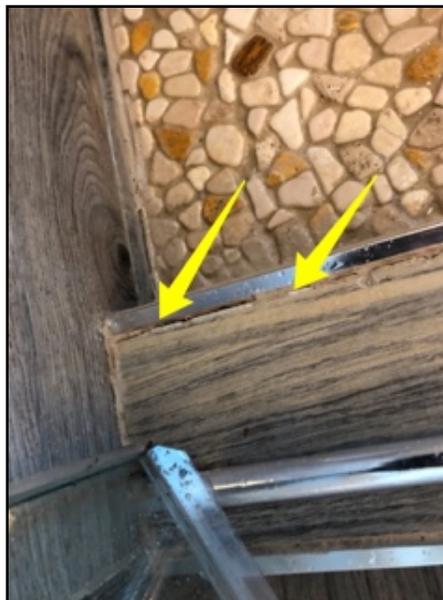
Figure 27-2

8) Comment 27: Tile in master bathroom shower stall door opening should be re-grouted to prevent moisture intrusion and wood rot. Recommend qualified tile installer repair.

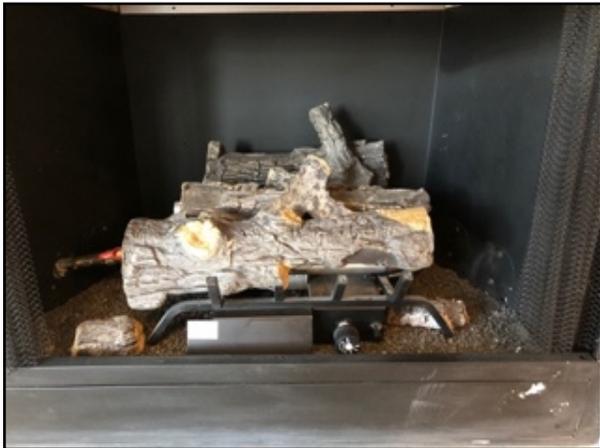
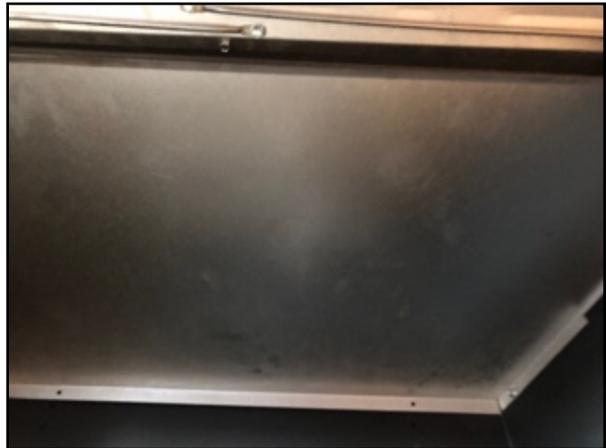
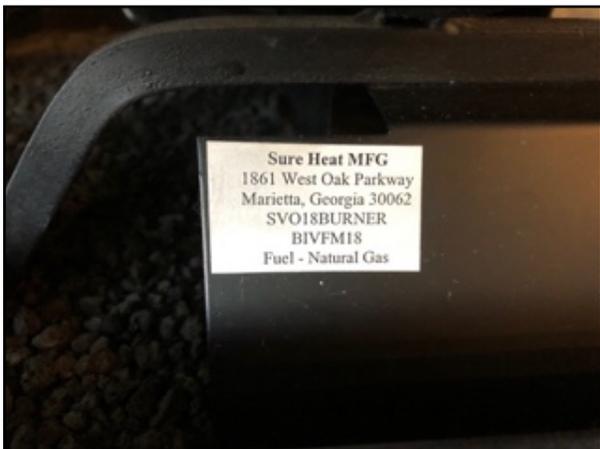
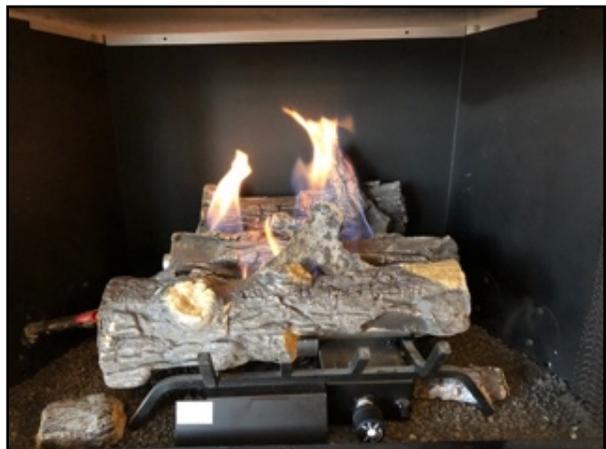
Ventless gas log appliance installation, shut off valve and manufacturers label. Tested and return to off position.
