1289 Whitlock Ridge Dr
Marietta GA 30064

1/16/2020

Capstone MHT Dev, Inc dba HouseMaster
1110 Seale Drive
Alpharetta, GA

Standard Home Inspection - WDI

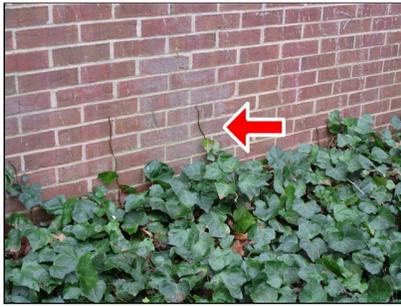
1.0 SIDING (Picture 1) Trim ivy

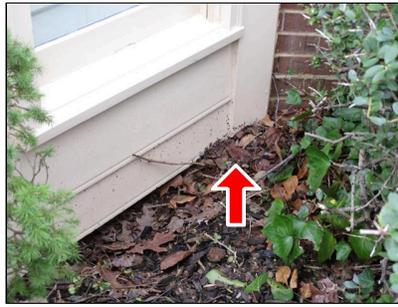
1.1 SIDING 2 (Picture 1) Wood/ground contact

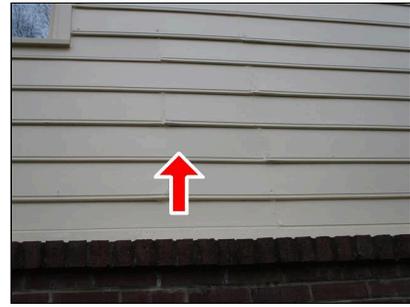
1.2 SIDING 3 (Picture 1) Monitor cut ends

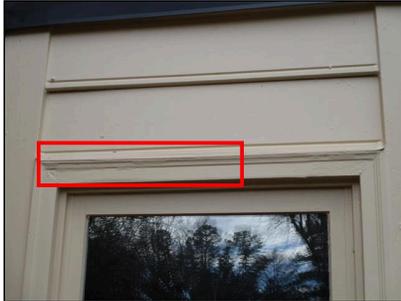
1.3(1) WINDOWS (Picture 1) Mild deterioration

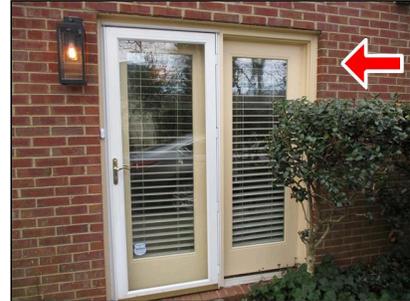
1.4 ENTRY DOORS (Picture 1) Monitor entry

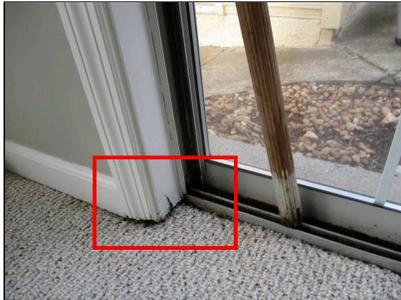
1.4 ENTRY DOORS (Picture 2) Water intrusion

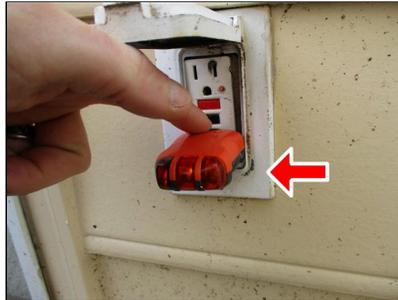
1.7 ELECTRIC / GFCI(S) (Picture 1) Not tripping

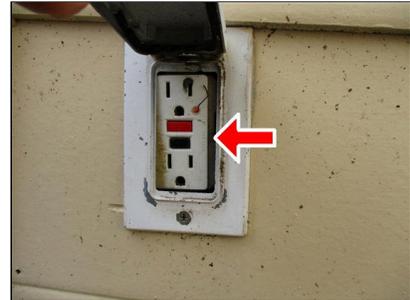
1.7 ELECTRIC / GFCI(S) (Picture 2) Receptacle off center

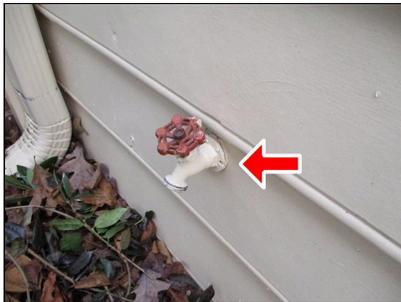
1.8 EXTERIOR FAUCET(S) (Picture 1) Add backflow preventer

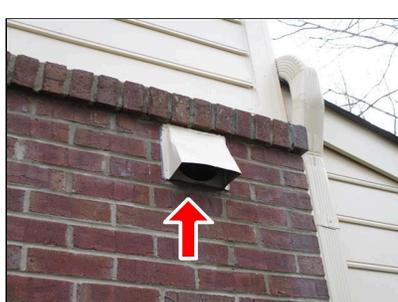
1.9 EXTERNAL VENTS (Picture 1) No screen

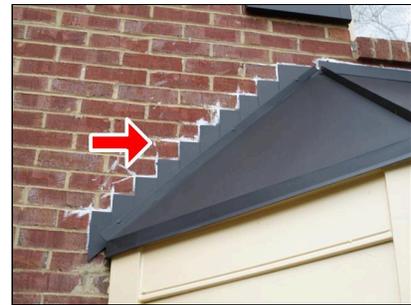
3.1 ROOF COVERING 2 (Picture 2)
Not sealed

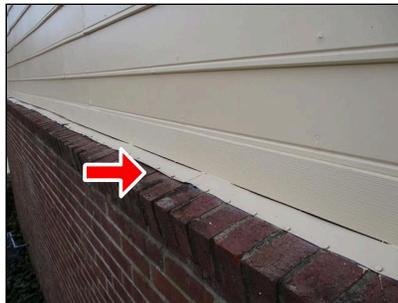
3.2(2) EXPOSED FLASHING
(Picture 1) Nailed flashing

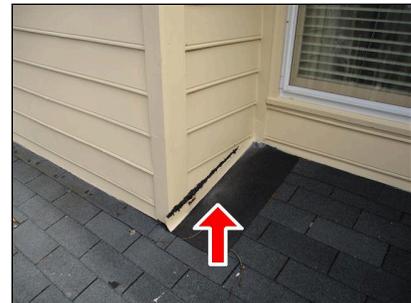
3.2(3) EXPOSED FLASHING
(Picture 1) Check flashing

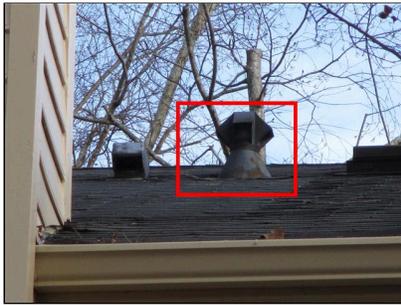
3.4(2) VENTILATION COVERS
(Picture 1) Unused vent

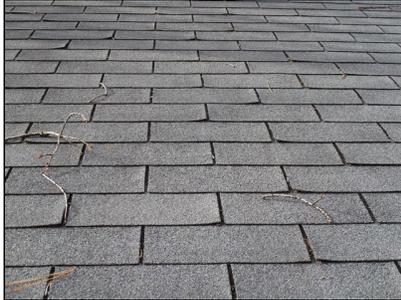
4.0 ROOFING (Picture 1) Normal wear

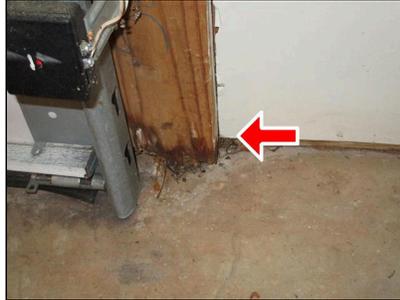
4.1 EXPOSED FRAMING (Picture 1) Water staining

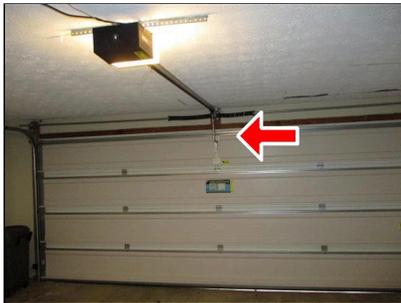
4.7 DOOR OPERATOR(S) (Picture 1) No reverse

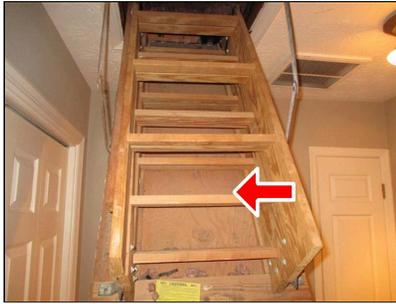
5.4(1) ATTIC STAIRS (Picture 1) Add insulation

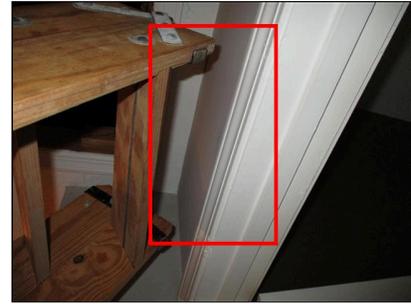
5.4(2) ATTIC STAIRS (Picture 1) Obstructed operation

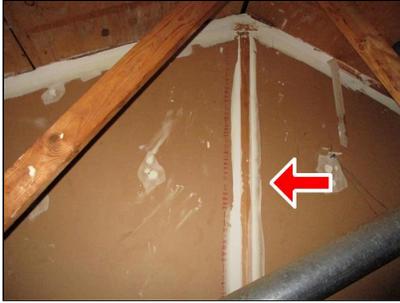
5.5 FIREWALL (Picture 1) Firewall

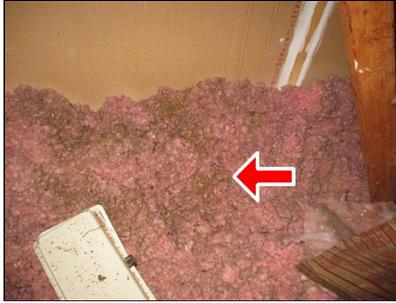
5.6 RODENT ACTIVITY (Picture 1) Nest

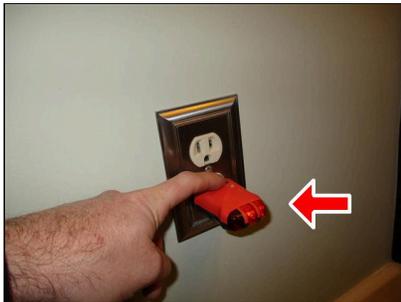
6.6 ELECTRIC / GFCI (Picture 1)
No GFCI

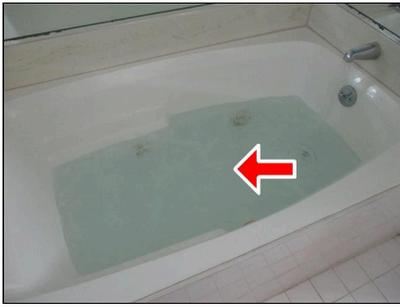
6.16(1) JETTED BATH (Picture 1)
Tub operation

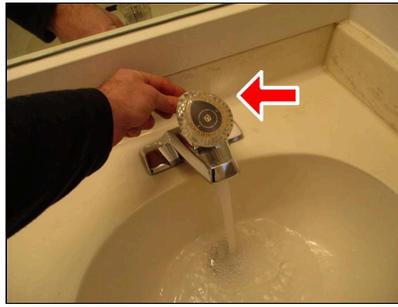
6.18 SINK(S) (Picture 1) Check
handle/stopper

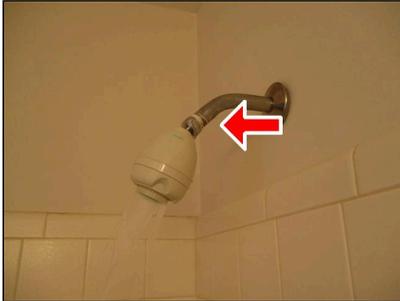
6.20 BATHTUB (Picture 1)
Leaking

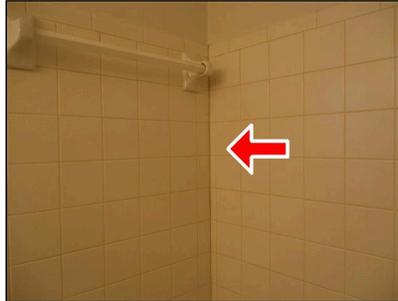
6.21 WALL TILE (Picture 1) Seal
as needed

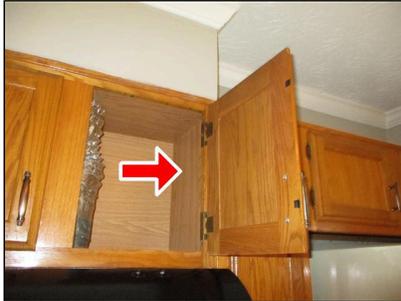
7.8 CABINETY (Picture 1)
Loose hinges

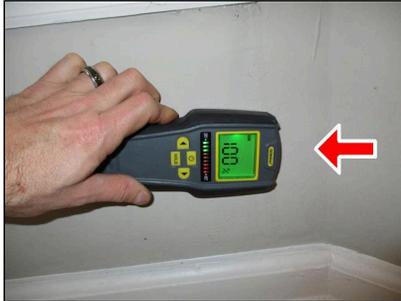
8.1 WALLS (Picture 2) Moisture 100%

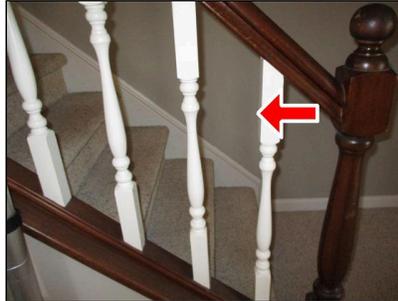
8.4 RAILINGS (Picture 1) More than 4 inches

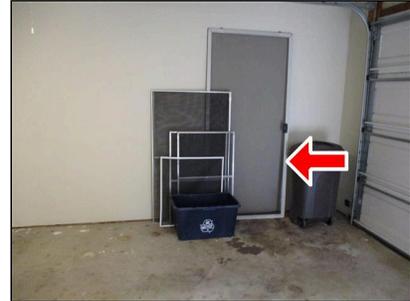
8.5(1) REPRESENTATIVE WINDOWS (Picture 1) Screens

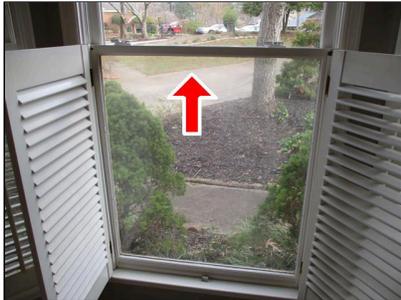
8.5(2) REPRESENTATIVE WINDOWS (Picture 1) Stuck window

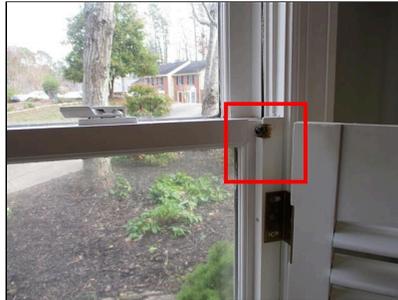
8.5(2) REPRESENTATIVE WINDOWS (Picture 2) Locked/key?

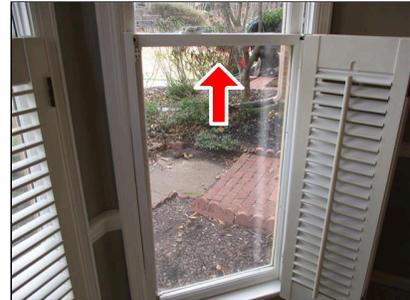
8.5(2) REPRESENTATIVE WINDOWS (Picture 3) Stuck window

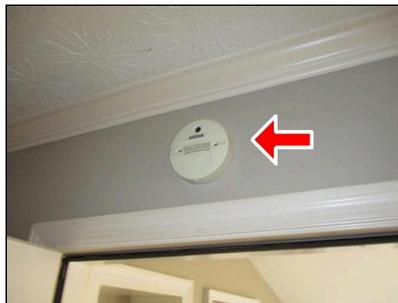
8.8(2) DETECTOR ALARM TEST (Picture 1) Expired detector

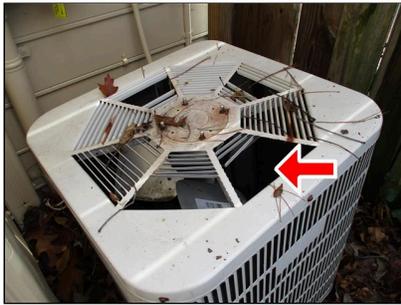
10.2(2) OUTDOOR UNIT - 1
(Picture 1) Safety concern

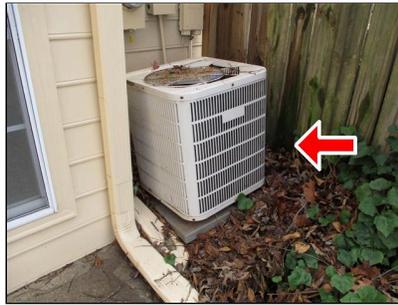
10.2(3) OUTDOOR UNIT - 1
(Picture 1) Leaning unit

10.2 (3) The outdoor unit base should be maintained in a reasonably level position. The coils will require periodic cleaning; clearance from vegetation/obstructions should also be provided. The pad for the outside condensing unit for the HVAC system is undermined. Back fill the pad to prevent movement.

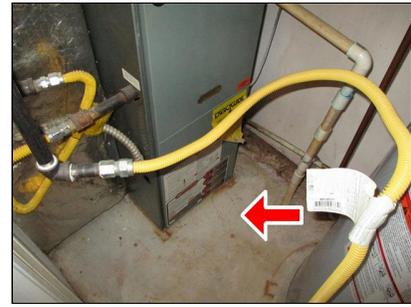
●			10.3 INDOOR BLOWER / FAN Rated fair due to age, monitor and repair as needed.
		●			10.4 CONDENSATE PROVISIONS - 1 (1) Noted missing moisture cutoff switch and drip pan. Because the unit is in a finished area of the home, recommend adding as needed. (2) Noted undetermined plastic drain line terminating into condensate line; recommend checking with seller regarding purpose.
		●			10.5 DUCTWORK See note 11.6
●					10.6 THERMOSTAT - 1

10.4(1) CONDENSATE PROVISIONS - 1 (Picture 1) No pan/switch

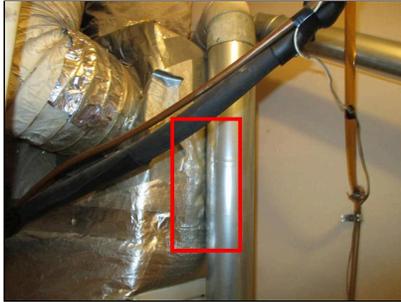
11.4 VENT CONNECTOR 1
(Picture 1) No clearance

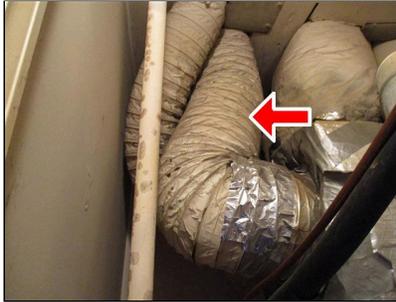
●				11.5 BLOWER 1 Rated fair due to age, monitor and repair as needed.
●				11.6 DISTRIBUTION SYSTEM Noted some visible duct work is not insulated; add as needed for energy conservation and to prevent condensation. Also noted incorrect tape at duct and plenum connection, temperature rated foil tape and/or mastic should be used to seal vent. Duct tape will peel and fail over time.

11.6 DISTRIBUTION SYSTEM
(Picture 1) No insulation

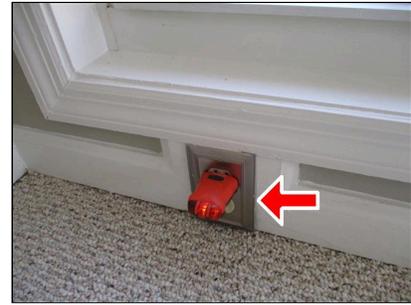
12.4(1) REPRESENTATIVE DEVICES (Picture 2) Check wiring

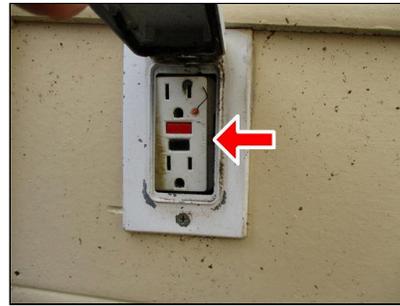
GFCI noted, however, test operation indicated unit malfunctioned or did not work properly. All related circuitry should be inspected by a qualified electrician. Unit is not tripping when tested and receptacle is not secured correctly in the box.

1.7 (Picture 2) Receptacle off center

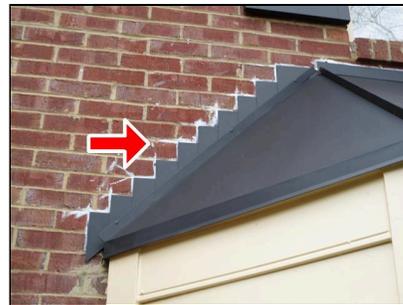
Typically metal sheathing is a superior roofing material than composite shingles; however the rubber grommets may dry and crack over time and allow water penetration. Also noted no sealant at brick veneer and flashing over roof covering as well as signs of water intrusion at bay window; repair as needed. See note 8.1

3.1 (Picture 2) Not sealed

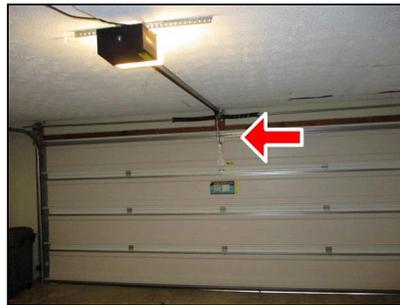
The door operator did not reverse when met with resistance. Some older units do not have this safety feature; correct as required.

4.7 (Picture 1) No reverse

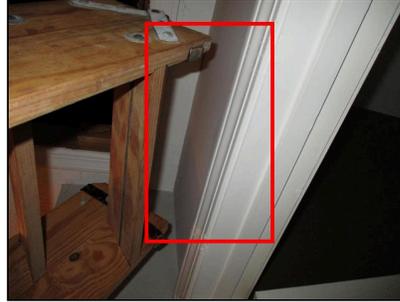
5.4 (2) Noted stair operation is obstructed by door/moulding and causing damage to door moulding when operated; repair as needed.

Obstructed operation

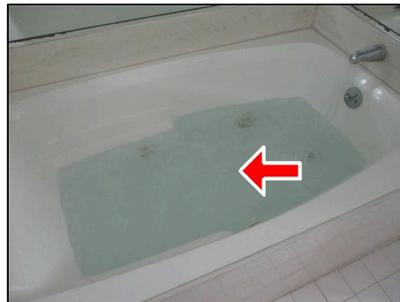
6.16 (1) A limited check of the bathtub jets indicated there was water flow and aeration. A complete evaluation of the jetted bath system or its effectiveness was not performed. Recommend review of operational and maintenance procedures with the homeowner and/or a qualified serviceman. Jetted tubs often sit for long durations without regular use, even in cases where the home is occupied. While we fill the tub and operate controls, a standard home inspection cannot recreate normal everyday usage of the tub and components. We recommend reviewing operational history with the owner and having the system inspected by a qualified service technician prior to usage to determine if service is needed or any other potential concerns need to be addressed.

Tub operation

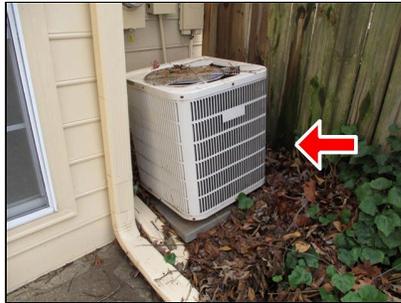
Leaning unit

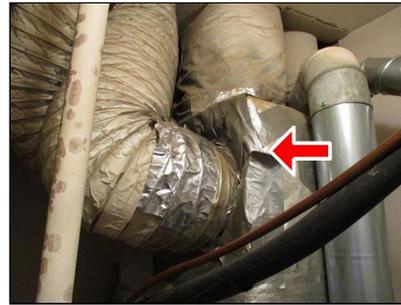
11.6 (Picture 2) Incorrect tape

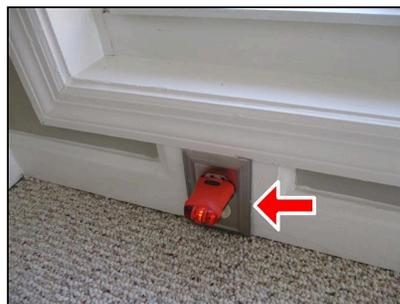
Check wiring

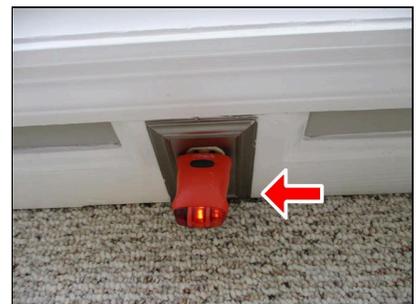
Check wiring

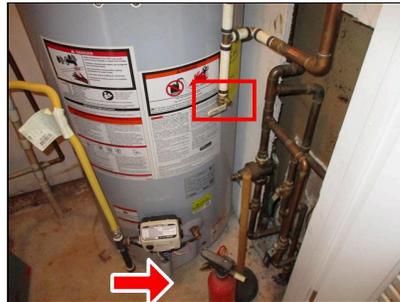
The drain tube for the TPRV valve has been improperly reduced; add 3/4 pipe to within 6 - 24 inches (depending on manufacturer instructions) of the floor with no reducers.

14.4 (Picture 1) Drain tube/no pan
