Inspection Report

4502 Chartley Cir

Roswell, GA 30075

Wednesday, February 19, 2020

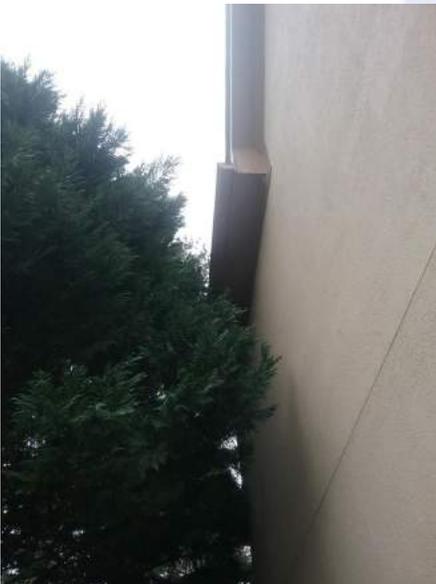
23: Trees are touching or overhanging the left side of the roof. Recommend trimming to avoid roof surface damage and wildlife entry.

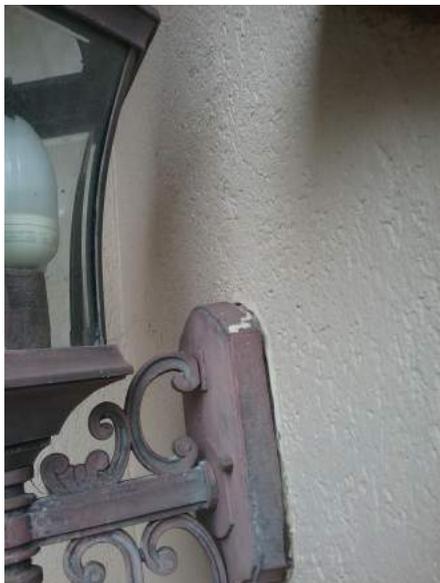
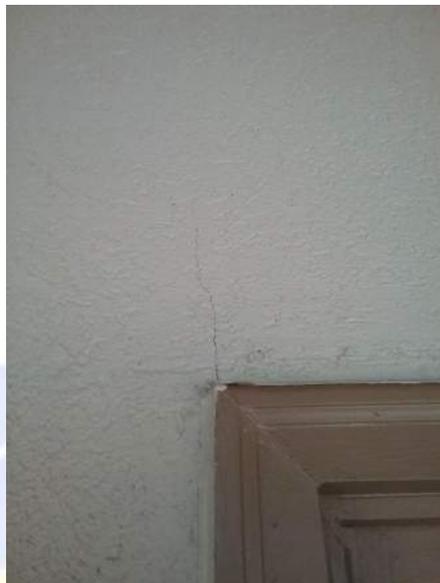
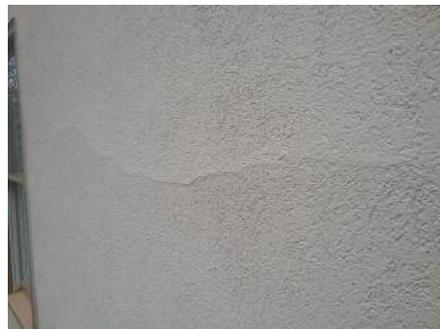
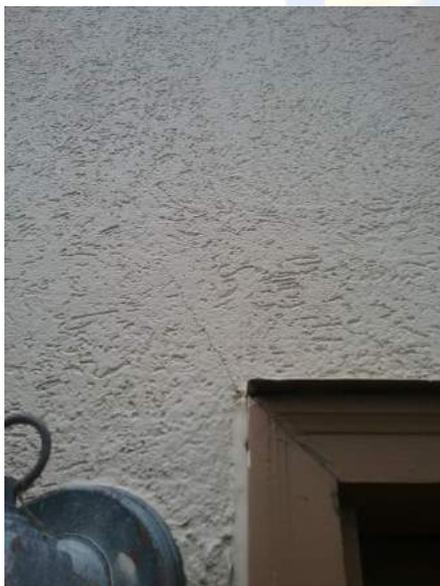
28: As typical maintenance for stucco siding ensure all wall penetrations and junctions between dissimilar materials remain caulked and painted to prevent moisture damage and possible moisture intrusion.

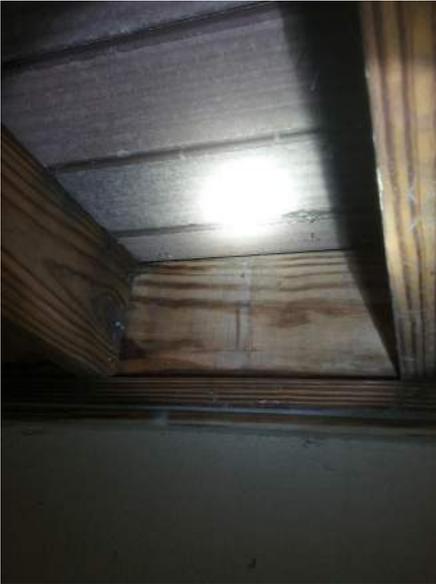
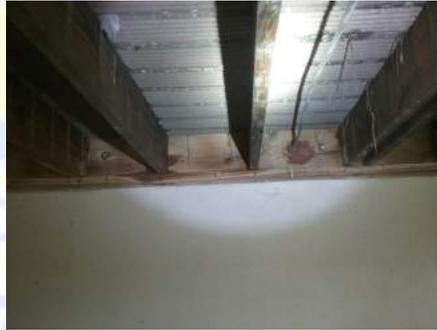
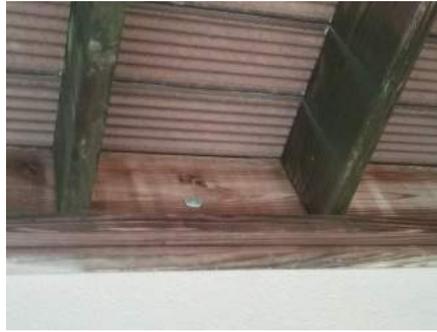
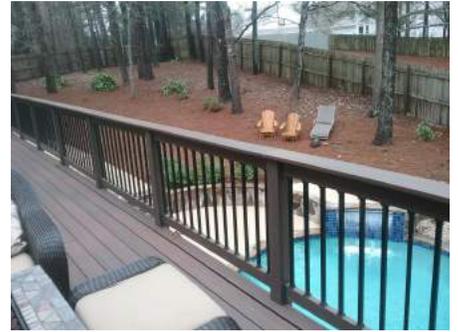
39: The deck was observed to have several deficiencies including but not limited to improper attachment over siding, no visible flashing at the house junction, lag bolts primarily attaching deck to house, improperly notched 4x4 guardrail support posts, loose guard rails, loose hand railings and missing lateral bracing on the support posts in need of further evaluation and repairs by a licensed deck contractor.

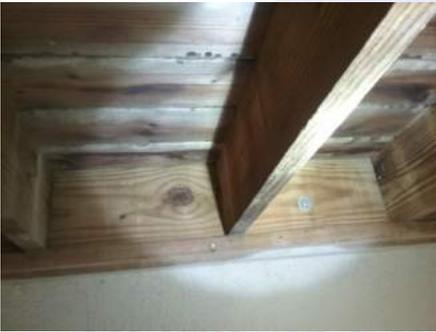
40: Front balcony was observed defects including but not limited to: improper attachment over siding, and no visible flashing at the house junction

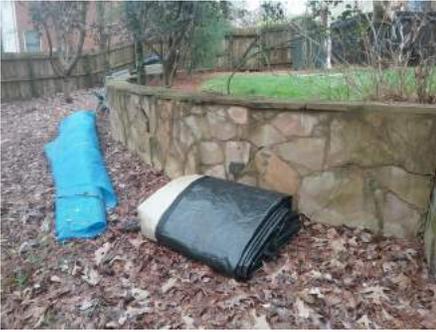
42: Recommend a hand railing around the top of the wall when the wall height is 30 inches or more above grade.

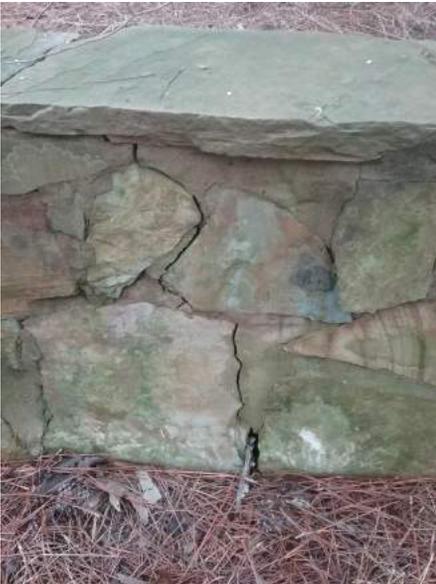
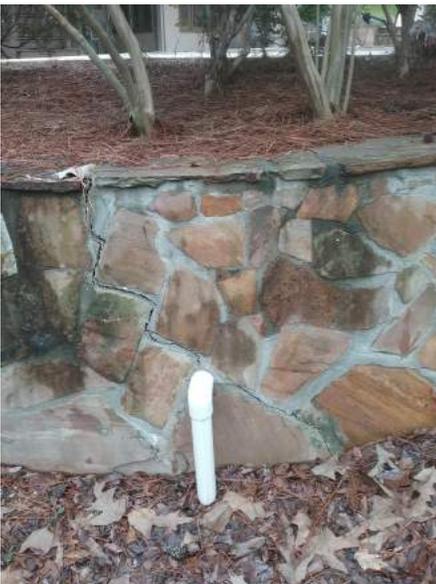
43: Settlement displacement/Cracks noted. Monitor in future years and budget to replace depending on the movement over the next few years.

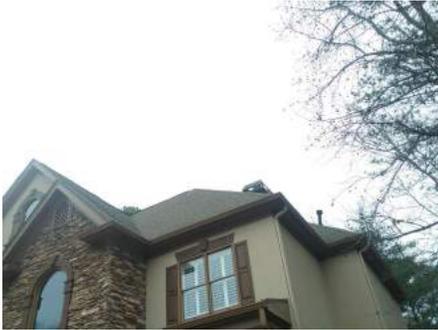
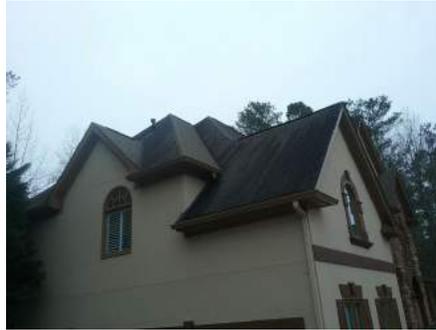
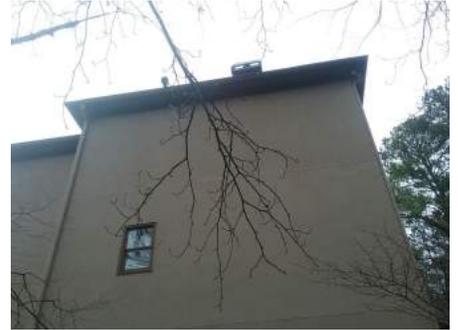
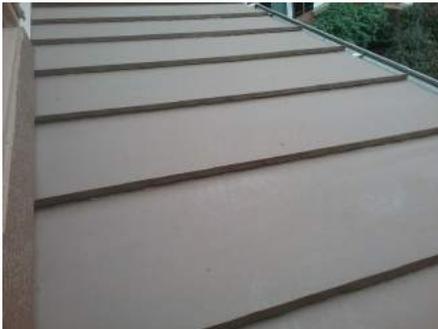
46: Unable to fully access due to height/pitch/weather/type . We recommend areas not visible at the time of inspection be evaluated by a licensed roofer before due diligence or closing.

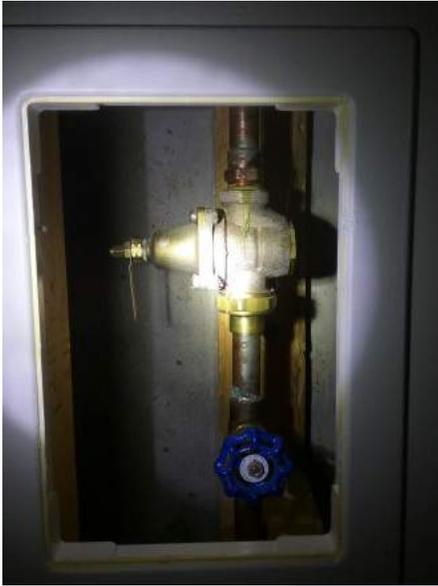
LOCATION OF MAIN SHUTOFF

56: Basement right side wall.

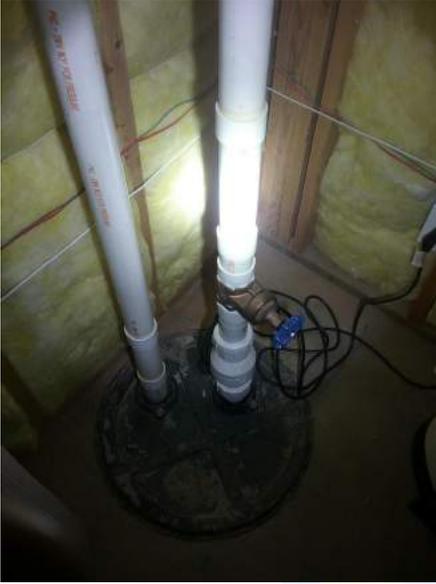
EJECTOR PUMP

67: The house is equipped with a sewer ejector and was observed to operate serviceably and was located in the rear of the lower level to pump the sewage up to the level of the drain exiting the house. We recommend sewage ejector and lift station pumps have alarms in case of failure. The average life for a pump is around 10 years depending on use. While the unit was operating when tested at the inspection, we cannot determine remaining life expectancy or when this unit will fail.

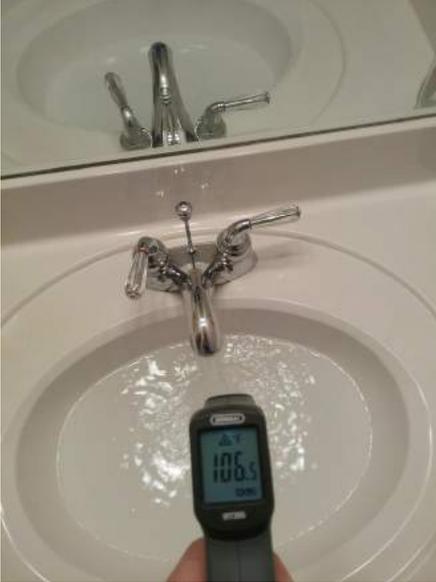
WATERHEATER OBSERVATIONS/COMMENTS

71: Operating with no sign of leakage at time of inspection. Aside from any listed defects tested hot water fixtures were serviceable at the time of the inspection. We recommend routine maintenance be performed per manufacturer installation instructions, generally the water heater should be drained once a year.

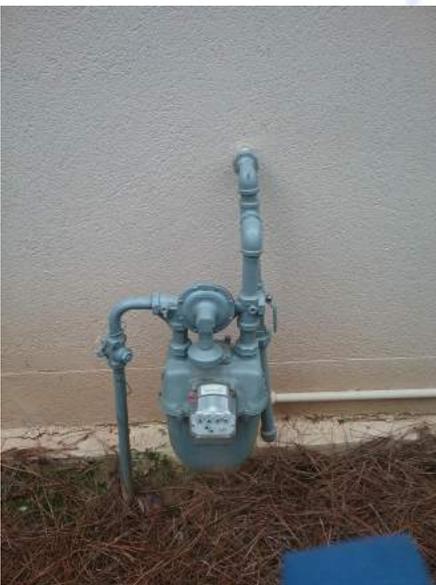
LOCATION OF GAS METER

73: Exterior right side

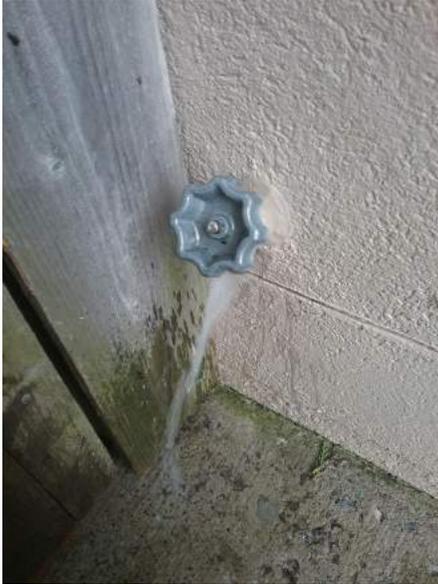
HOSE BIBB OBSERVATIONS/COMMENTS

74: The exterior hose bibbs were observed to operate in serviceable condition aside from any listed defects.

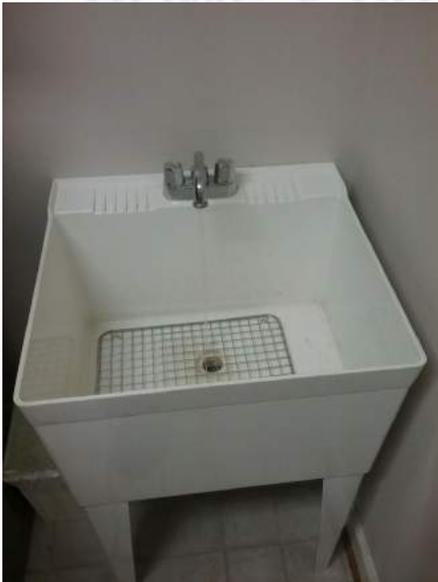
UTILITY SINK OBSERVATIONS/COMMENTS

75: Operational

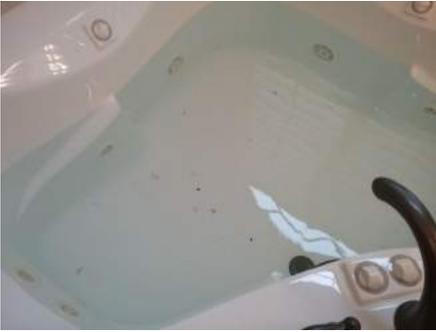
84: Tub jets need cleaning as indicated by the stuff coming out of the jets when operated.

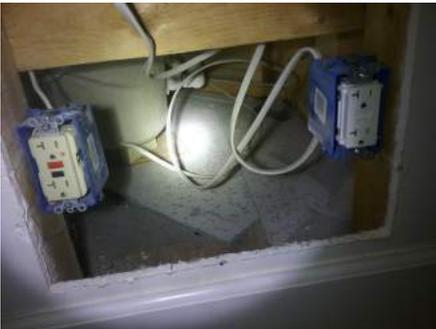
85: No access to tub jet motor. Without access to the tub jets repairs will be difficult.

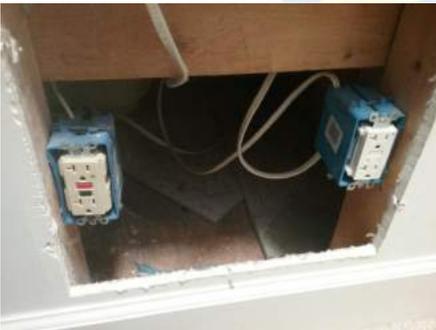
86: Outlets near hydro pump motor are missing cover plates

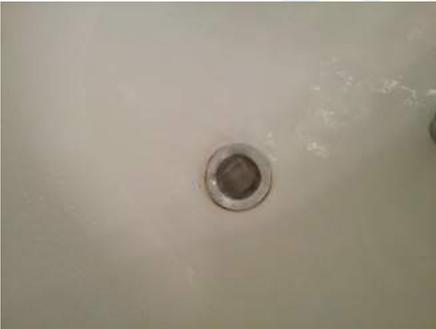
88: The tub stop is missing components

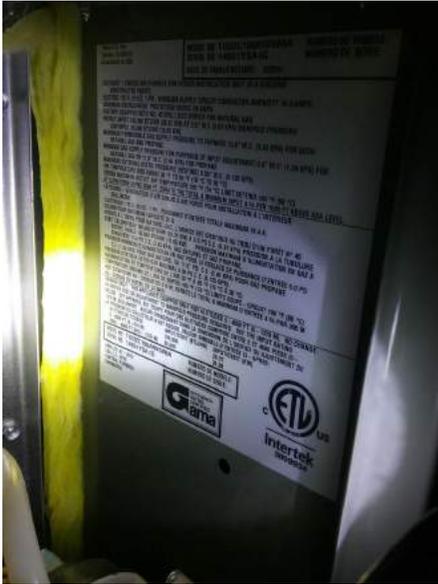
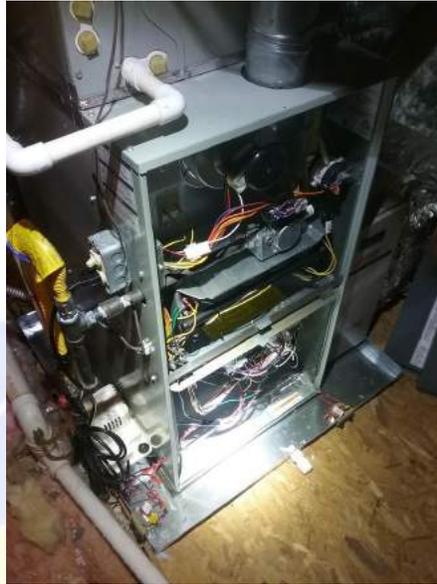
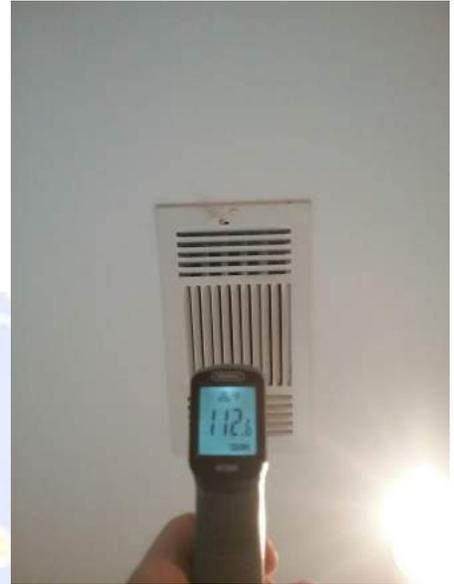
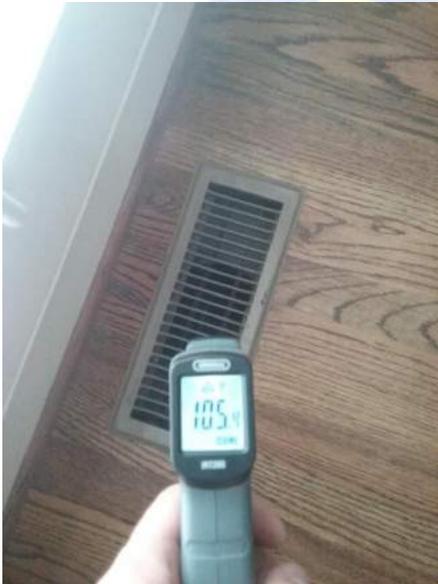
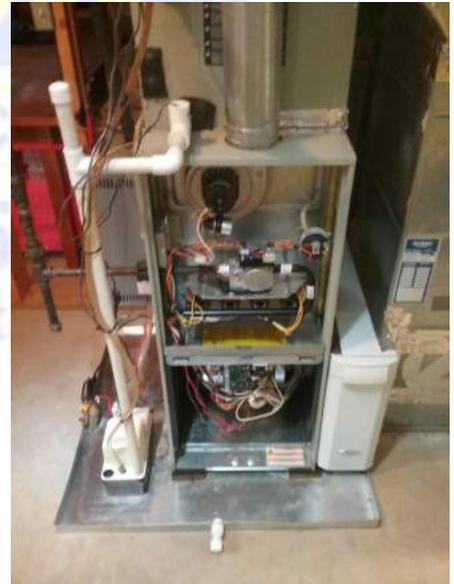
HEATING SYSTEM CONDITION

93: Excluding any listed defects, the HVAC unit was observed to operate in servicable condition when tested with normal operating controls. We recommend routine service (generally twice a year) per manufacturer installation instructions to ensure proper performance and to uphold any applicable product warranty.

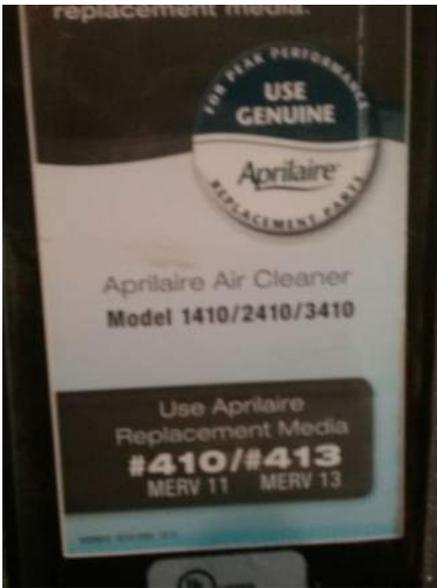
AIR FILTERS

94: Suggest cleaning/changing filter every 30-60 days.

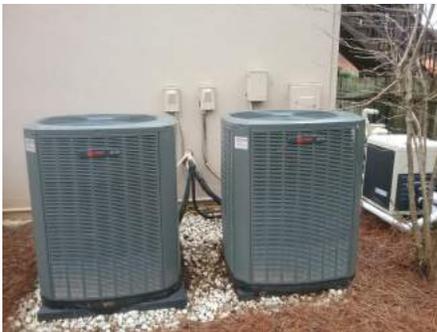
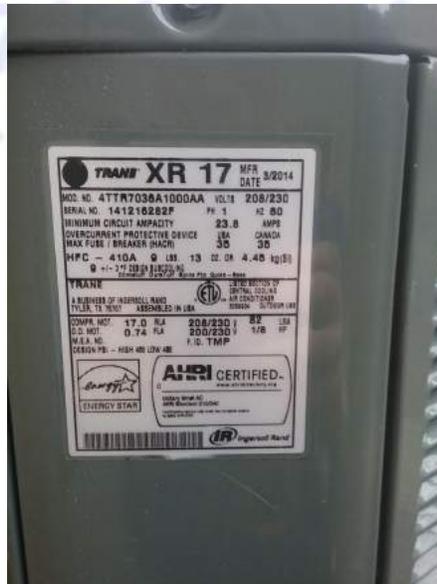
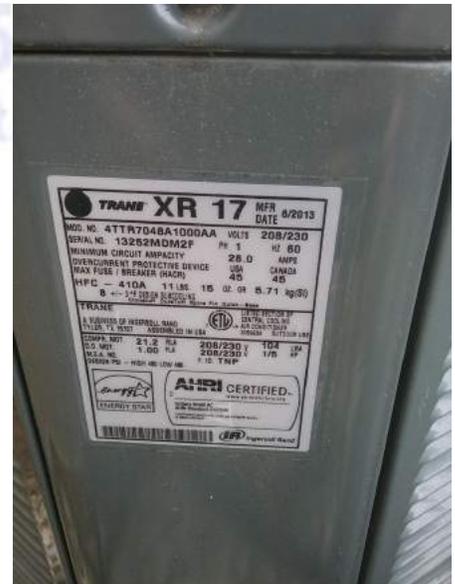
AGE OF UNIT

96: Manufactured in 2013 and 2014 Central AC units are expected to last 10-15 years with periodic repairs and proper maintenance. The compressor is the heart of the system. When that breaks it usually signals the need for a new unit. Most other problems get repaired.

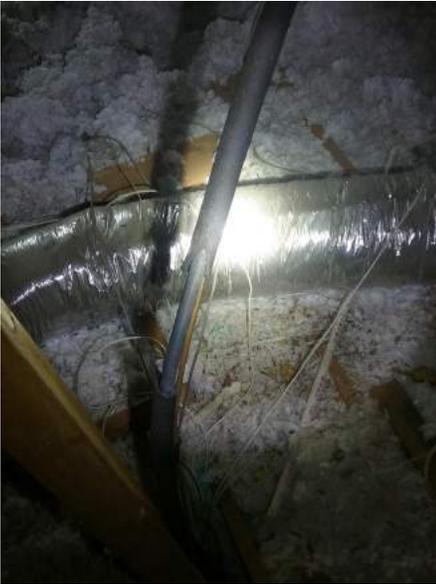
100: The suction line insulation is damaged in the front center attic and is needed for proper operation. Repairs are not expensive and will have a positive impact on the operation of the unit.

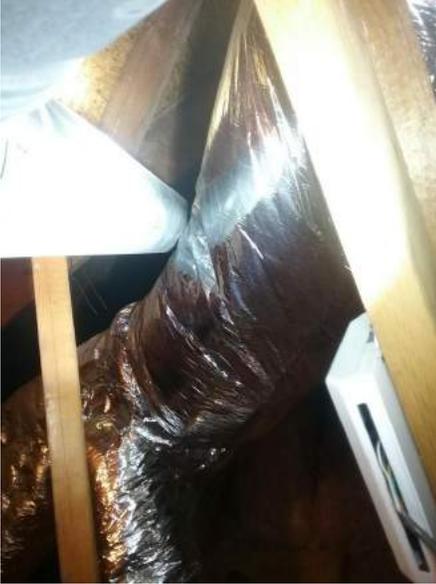
104: Inadequate clearance at the HVAC ductwork from flue pipe

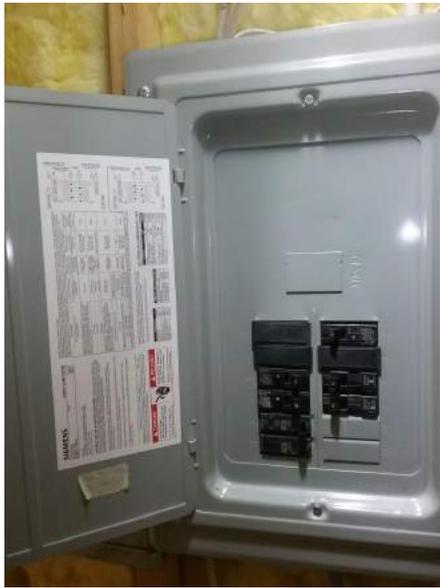
PANEL CONCERNS

112: Panels are without the benefit of complete labeling.

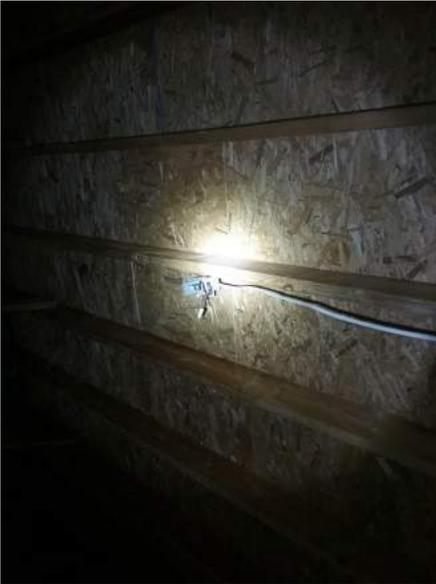
ATTIC ELECTRICAL

118: Wire connections were observed that were not in a closed junction box. All wire connections need to be located inside a closed box for safety reasons.

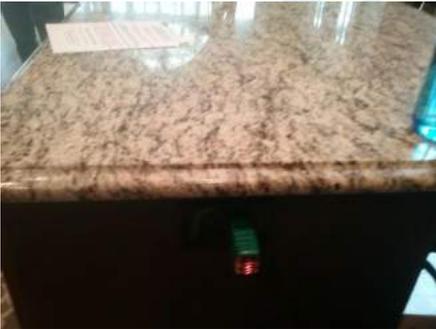
123: Recommend GFCI outlets be installed in kitchen outlets. While a homeowner is not required to upgrade older outlets, pre 1991 to GFCI protection we recommend all outlets in potentially wet areas be updated to increase safety for all occupants.

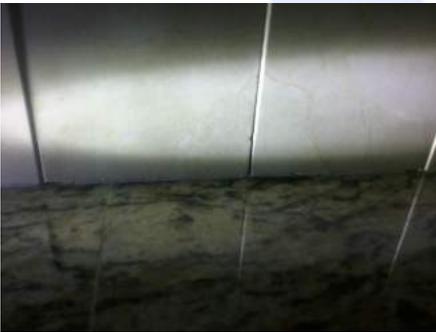
127: Grout/caulking is missing in some areas.

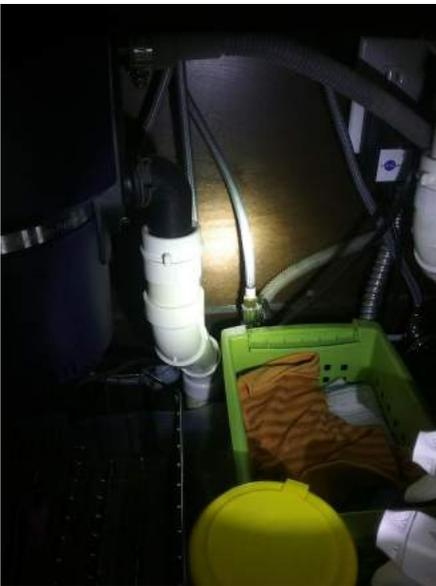
131: Plumbing trap not visible under the kitchen sink, however is likely covered by finishing materials.

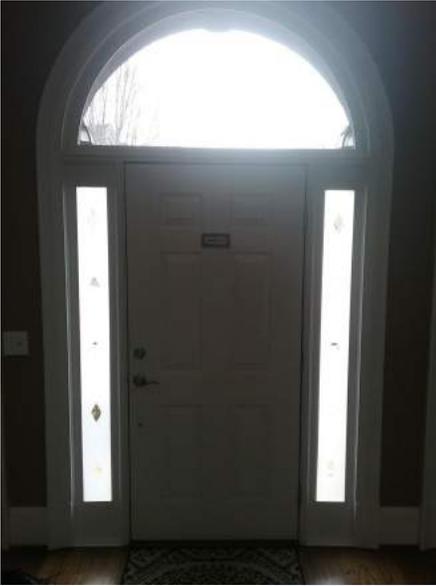
143: Door sagging and not square in the opening.

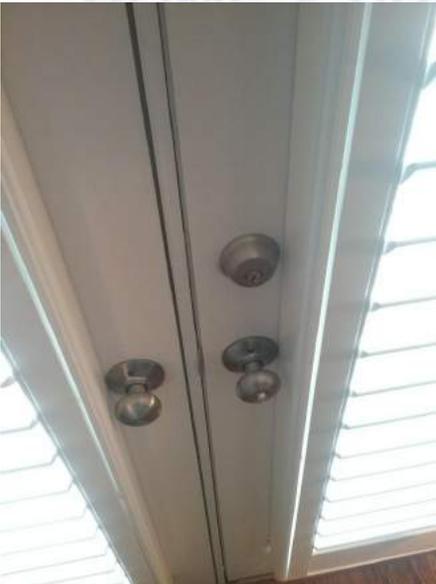
144: Although not a defect for houses built prior to 2010, it is recommended that double keyed dead bolt locks to be replaced with thumb flip style at exterior fire egress doors . These locks were installed at all exterior doors.

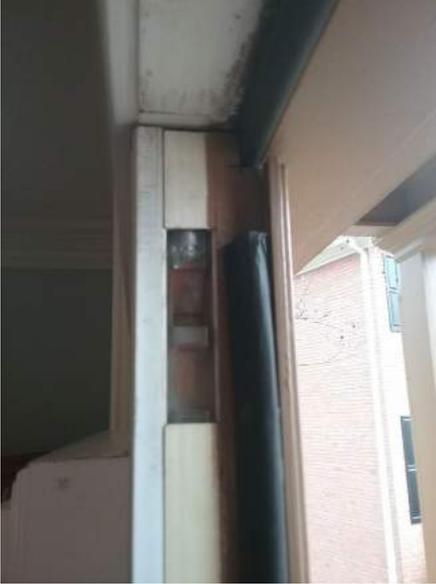
145: Adjustment needed for proper operation at balcony door

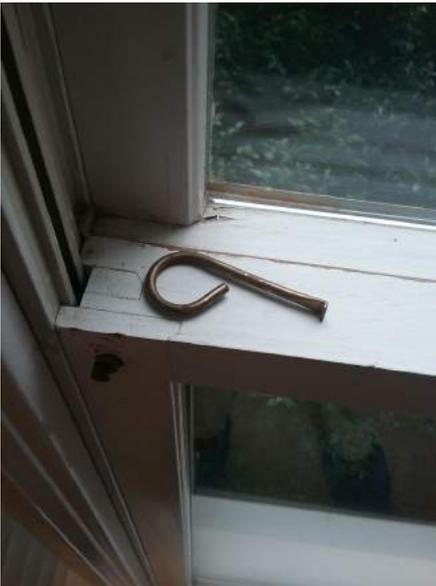
151: Basement windows have additional locking mechanisms installed. Recommend a key for each room be supplied

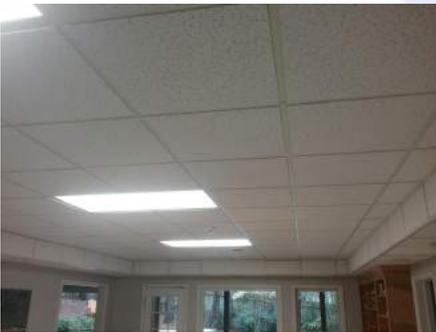
155: Acoustical ceiling tiles installed in a metal grid. In an older home these tiles may contain some asbestos.

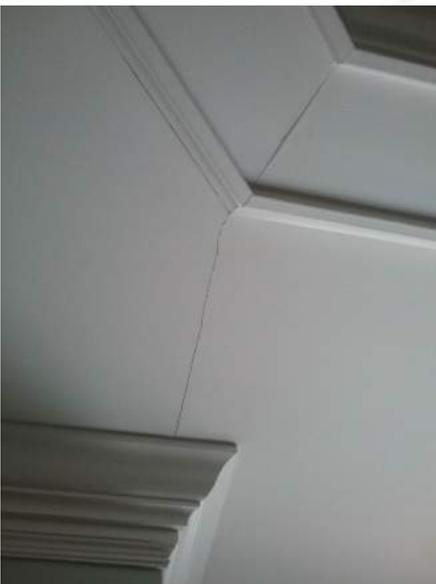
156: Nail pops and or minor drywall holes/cracks were observed in a few areas. Although common for the age of the home this is a minor problem that is easily corrected by a licensed general contractor.

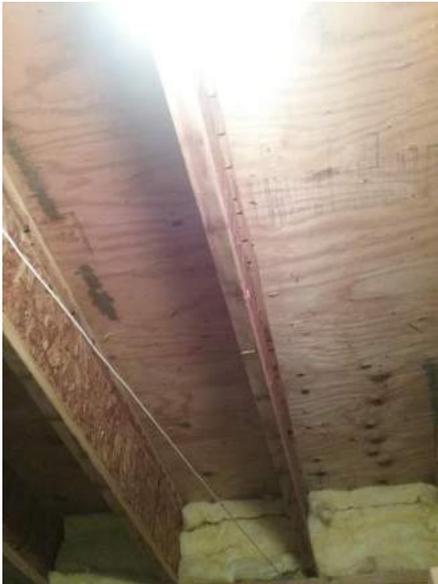
162: Recommend adding underfloor insulation

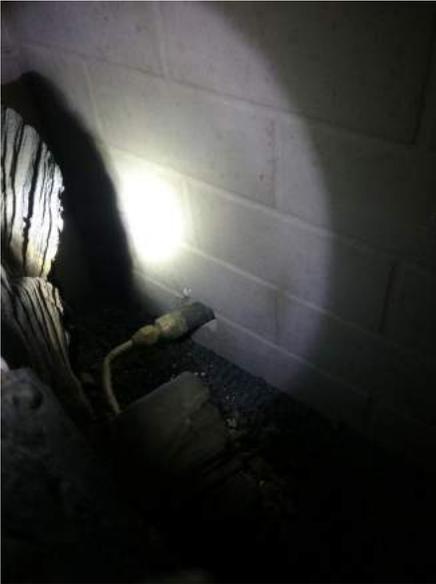
167: Gaps are visible between the brick and gas pipe junction. If burning embers get into the gaps it may be a fire hazard. We recommend sealing all gaps around the firebox.

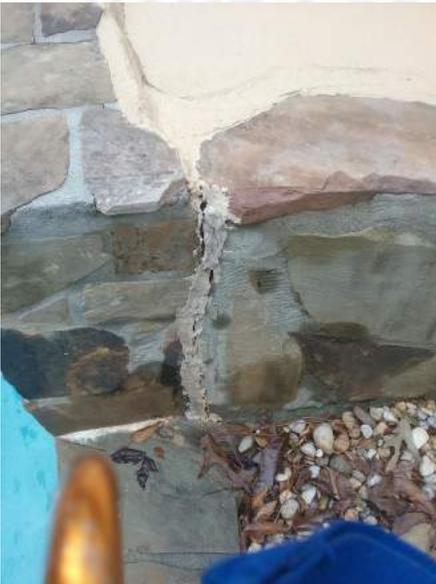
179: Waterfall feature's stone veneer appears to be possibly shifting away from decking. Recommend monitoring in future for further movement

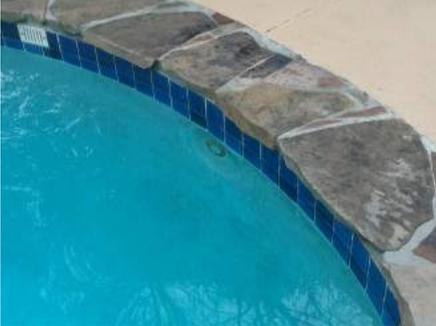
182: Not operable. If a defective bulb is at fault, replacement may cost \$50 or more. Otherwise, further evaluation and repairs will be needed by a licensed electrician.

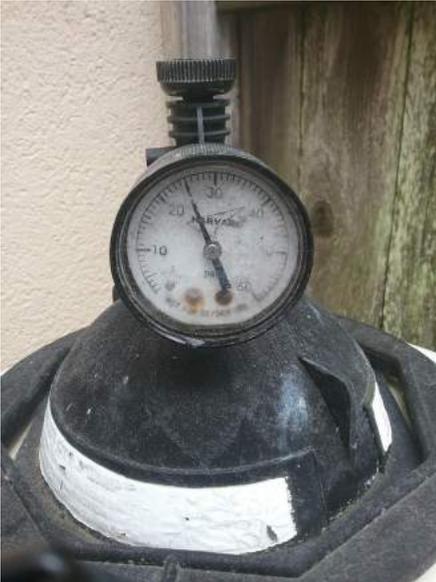
191: A higher than normal pressure indicates the need for filter cleaning or replacement.

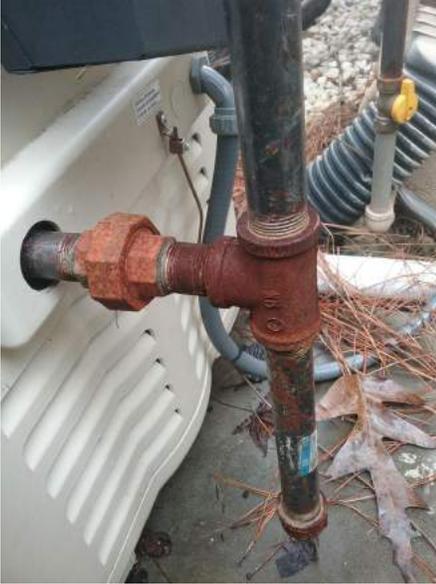
194: Gas supply line is rusting, recommend rust preventative paint be applied
