Inspection Report

Property Address:
14080 Crabapple Lake Dr
Roswell GA 30076

Residential Inspector of America, Inc

Date: 2/8/2020

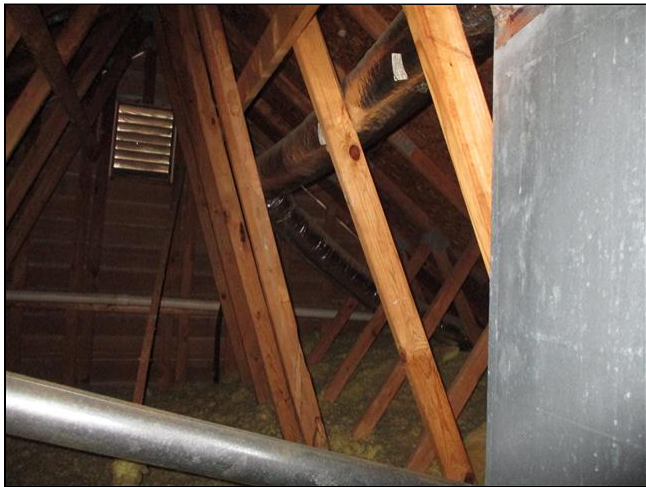
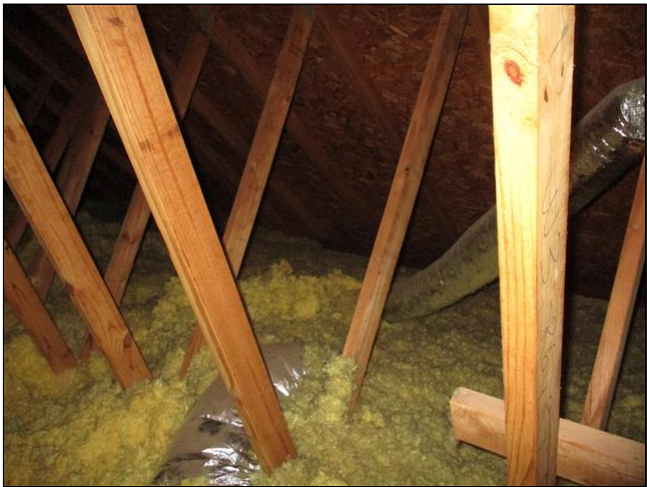
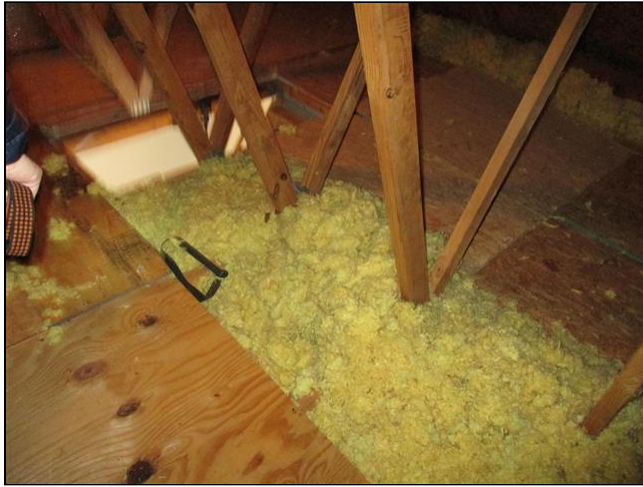
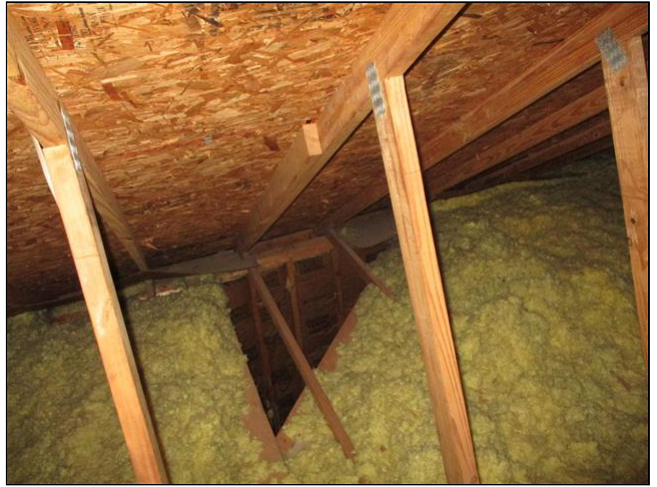
Views of attic framing and insulation. Attic space entered and inspected from the closest locations possible.

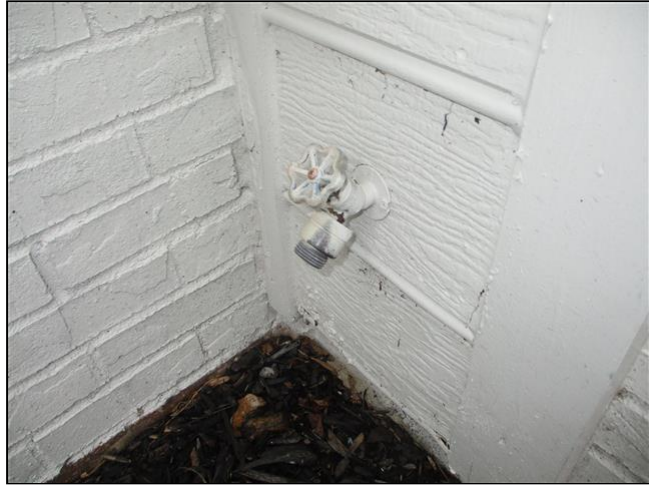
Exterior hose bibbs are shutoff for winter and not tested.

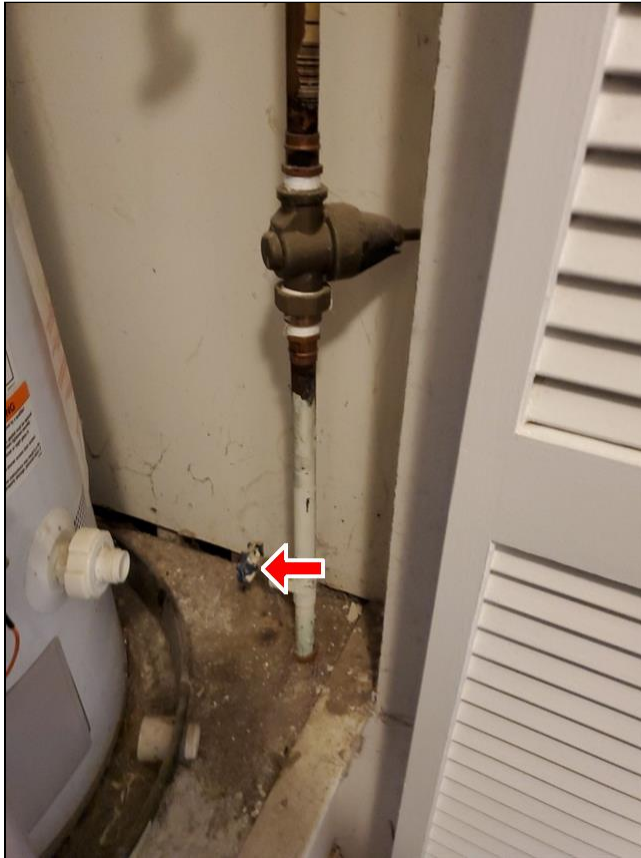
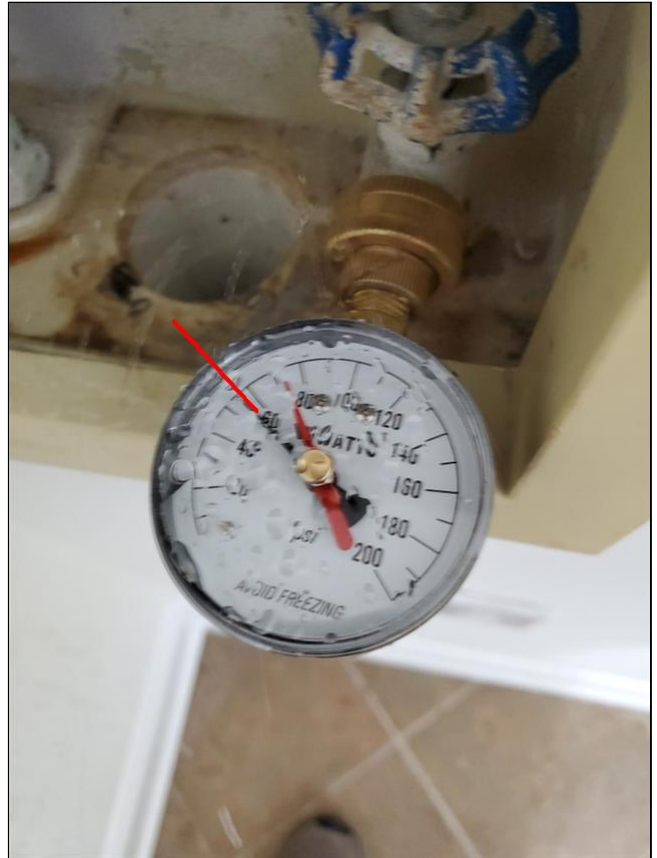
The main water shut off is located by the water heater.

house water pressure is optimal

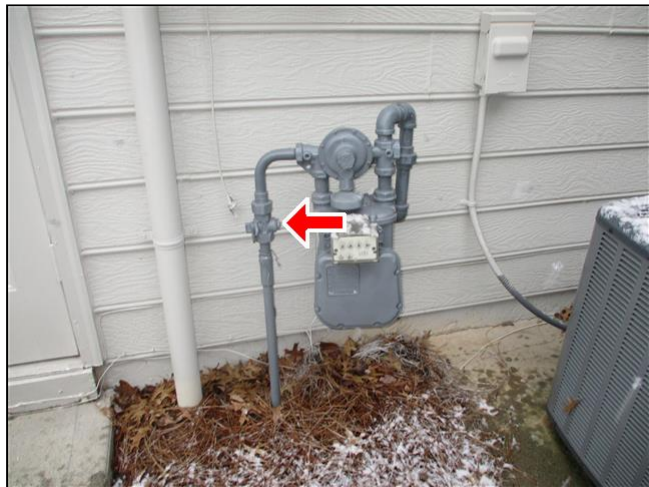
Main gas shut off is at the meter.
