# Inspection Report

**Property Address:**  
530 Silver Pine Trail  
Roswell GA 30076

**Residential Inspector of America**  
**Inspector: Todd Rymer**  
**3276 Buford Dr., Ste. 104-306**  
**Buford, GA 30519**  
**770.476.4963**

<b>Date:</b> 3/16/2020	<b>Time:</b> 09:00:00 AM	<b>Report ID:</b> 031620KP567
<b>Property:</b> 530 Silver Pine Trail Roswell GA 30076	<b>Customer:</b> Michael Herzog	<b>Real Estate Professional:</b> Vanessa Westfall Keller Williams

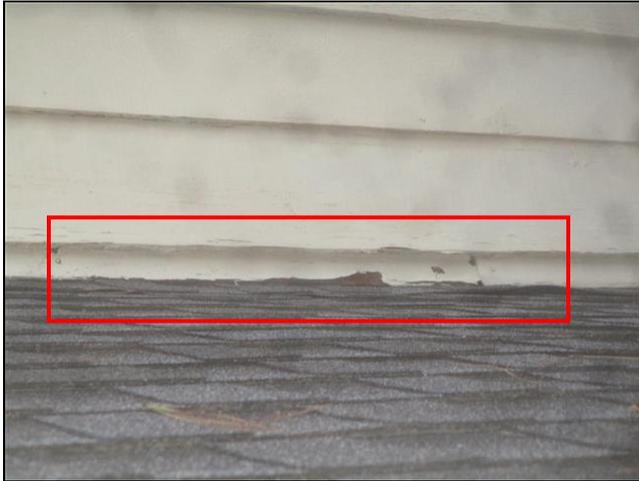
1.0 Item 3(Picture) Above front entry

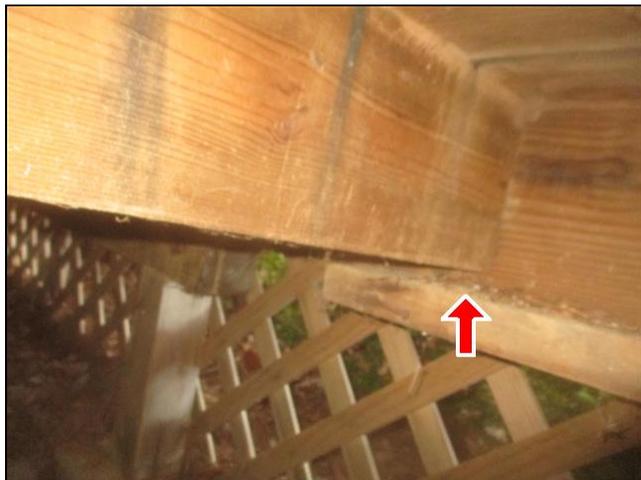
Decks usually last about 20-25 years (depending on weather conditions) before needing replacement. Older decks were not built to code standards that exist for modern decks. Multiple observed concerns noted with the front porch of the home. See photos. Due to the age and observed concerns associated with the front porch, it is recommended that the front porch be further evaluated by a professional deck contractor and all repairs/corrections made as required to ensure that the front porch is structurally sound and safe to use.

1.3 Item 5(Picture) Many front porch joists do not have fasteners/are not adequately supported

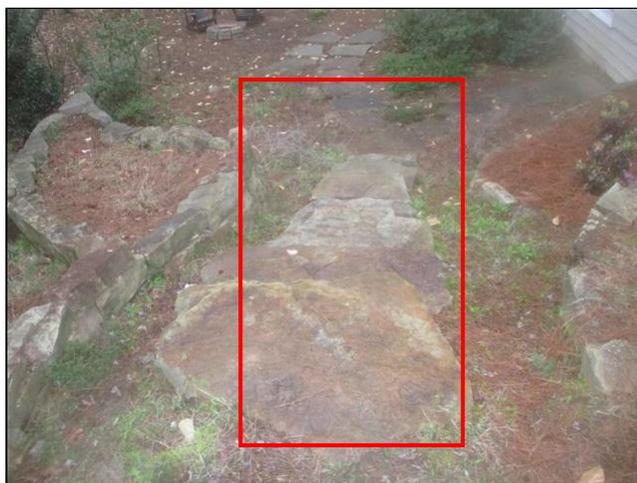
1.4 Item 5(Picture)

(4) Exterior walkway/stairs at left side of home would not meet modern safety standards. Use with caution/ resolve any concern prior to closing.

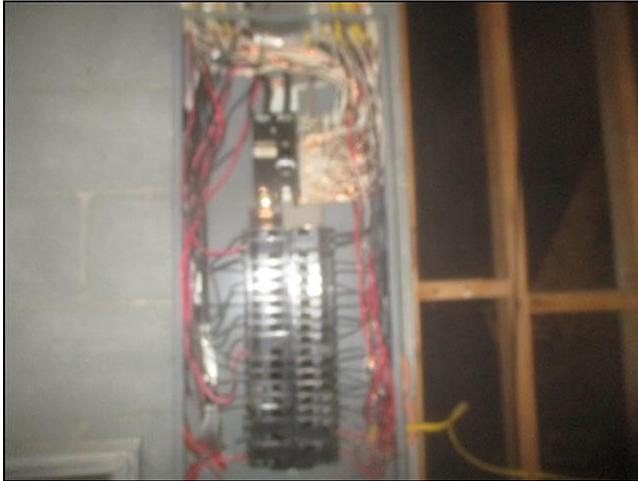
(1) View of panel. Panel was inspected for function (not modern code compliance). Building codes and standards have changed over the years.

Panel is not completely/clearly labeled.

7.2 Item 1(Picture) View of panel

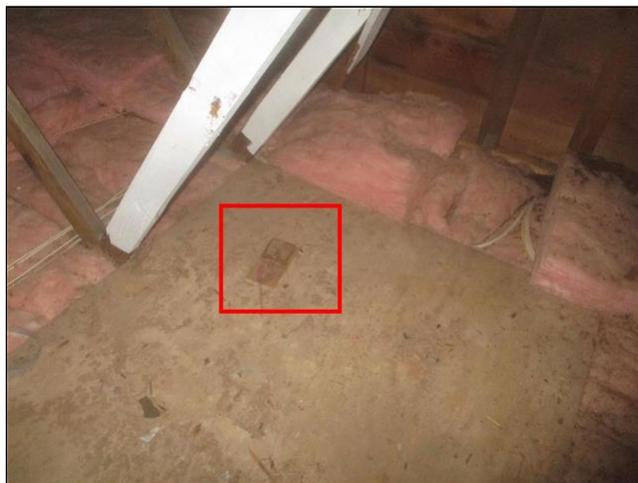
9.8 Item 2(Picture) Rodent trap in attic

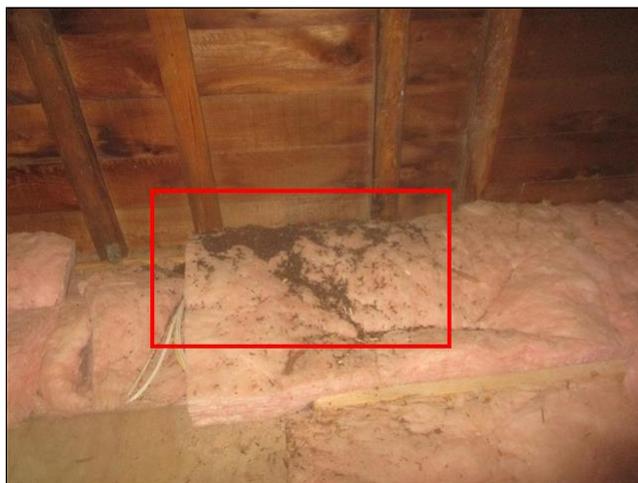
9.8 Item 4(Picture) Bat droppings
